STRUCTURAL AND CONSERVATION SOLUTIONS FOR THE TREATMENT OF THE SEA FRONT WALLS OF OLD AKKO (ACRE), ISRAEL

Eng. Yaacov Schaffer¹, Jacob Sharvit² and Dror Planer²

Abstract. *Between the years 2009-2013, the southern sea wall of the Old city of Akko underwent planned rehabilitation and conservation works funded by the Old Akko Development Company. The southern section of the wall, measuring some 300 m long with an average height of 8 m, was severely damaged by years of marine erosion and flaws in the ancient structural foundation techniques that were comprised of materials unsuited to a marine environment. Moreover, stabilization and rehabilitation attempts carried out in the 1930's of the 20th century also caused irreparable damage to the wall's foundations. The ancient city and its walls are subject to statutory limitations and considerations, as it has been declared an antiquity site by the Israel Antiquities Authority and a world heritage site by UNESCO, and is also a modern bustling town. In addition to these limitations, there are implementation restrictions for construction inside an ancient port, lacking the option to carry out works in an underwater environment. These limit

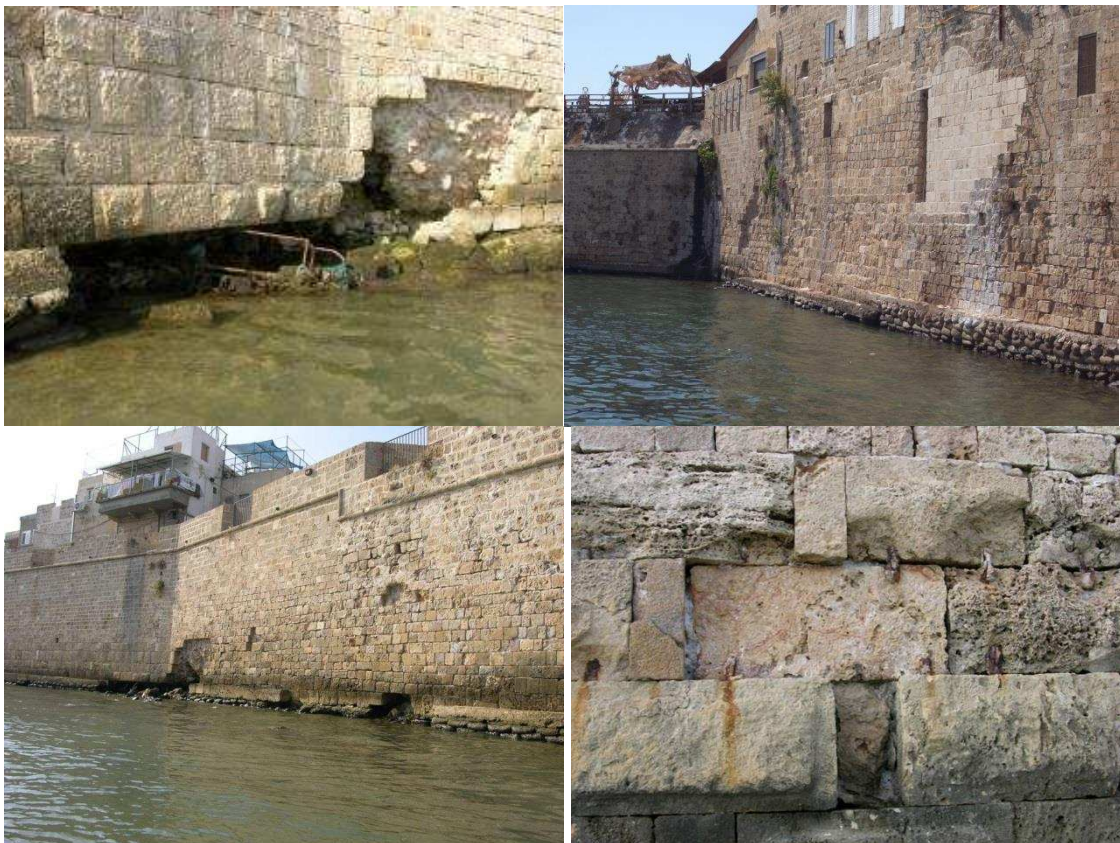
- The foundations of the sea walls were extremely deteriorated and the structural intervention in the years 1940-1970 didn't stabilize their condition.[Fig. 1a, 1b, 1c, 1d].

- There were missing stones and large gaps in the lower part of the wall at water level, large cracks and buckling, possible detachments of the exterior stone leaf, with space between it and the interior core, missing mortar between stones and missing pointing,

Fig. 1a, 1b, 1c,1d Part of the engineering failures of the sea wall

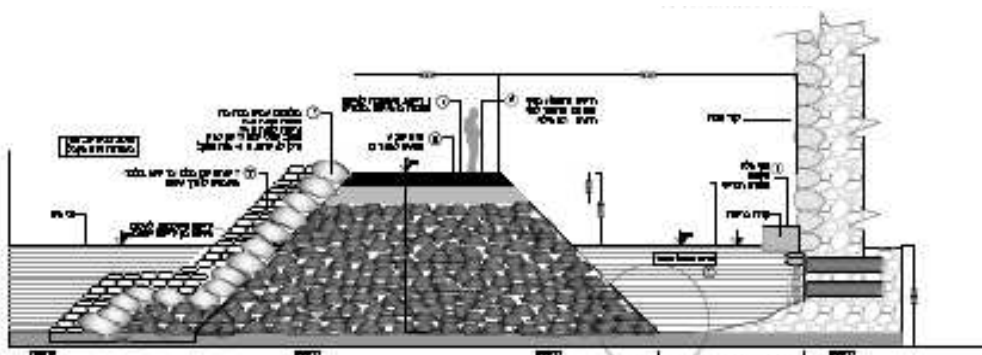
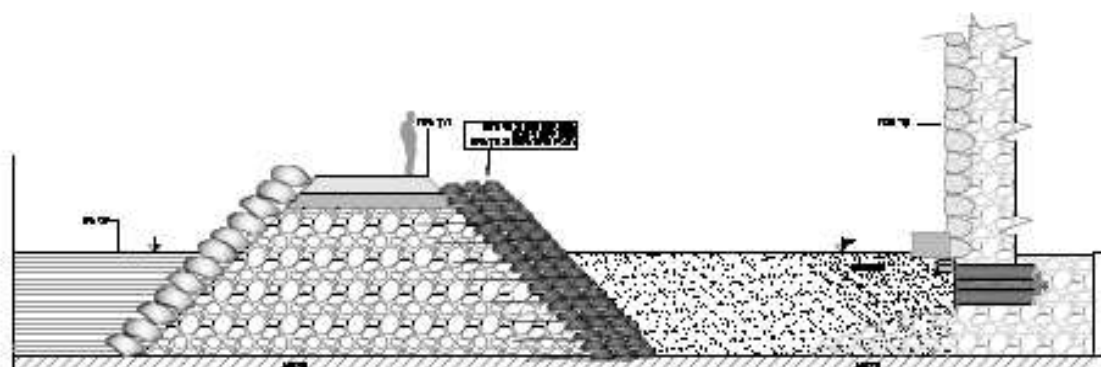
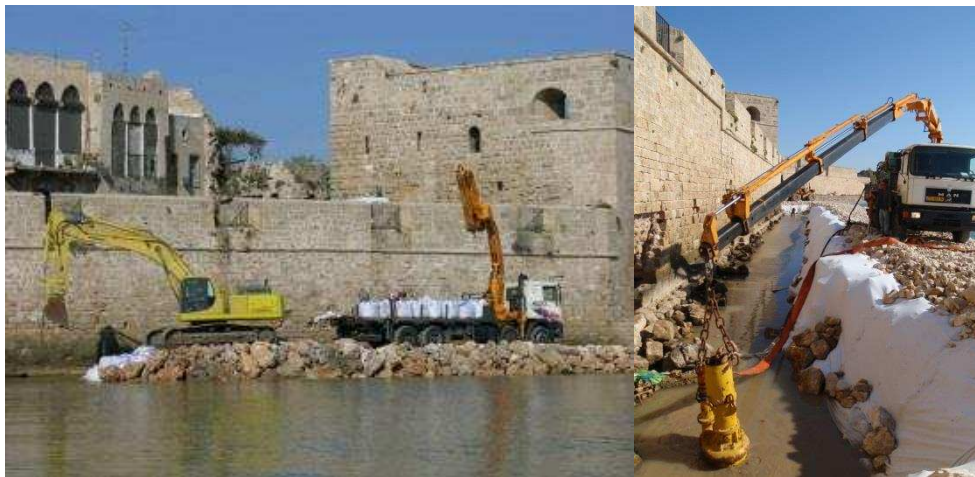
Fig. 2a The temporary rampart

Fig. 2b The temporary rampart Second stage

Fig. 2c The temporary rampart

A temporary rampart was constructed parallel to the wall at a distance of 6m, to create a dam which would allow drying the land in front of the wall. The rampart served also as a road for the mechanical vehicles and conveying equipment. [Fig.2a,2b,2c]. The rampart was built with an inner pyramidal shaped section piled with a double layer of large synthetic sacks, filled with natural clay sediments. Each layer of bags was separated from the upper one with a double layer of geotechnical cloth. The exterior layer of the rampart was built with large boulders placed on the bank facing the sea to act as a barrier against the sea waves. Crushed kurkar gravel was spread over the upper side of the rampart, creating a large 4 m wide. The cross-section of the rampart was a pyramid with a 30-45° slope; its foot 4 m from the wall, some 2 meters above sea level. In the next strips, the base of the rampart was removed to a distance of 6 m from the base of the wall.

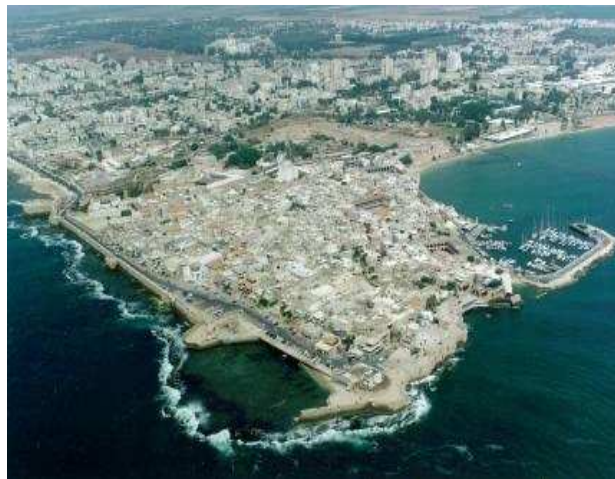
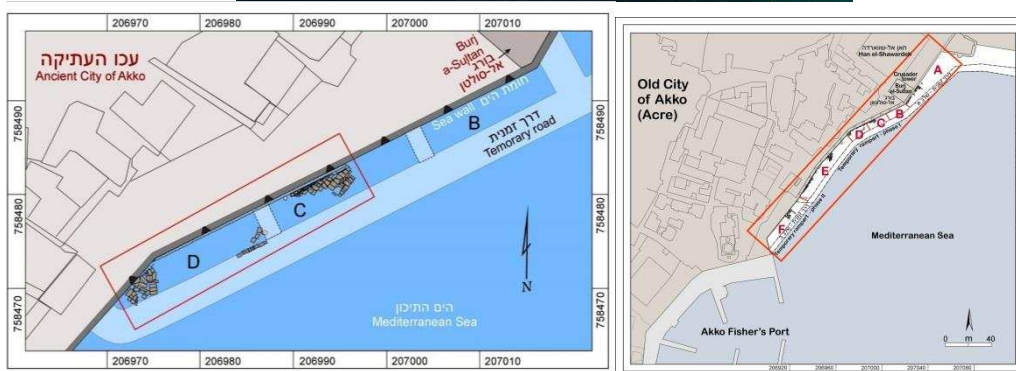
Fig 3a, 3b, 3c Old Akko and the section of the treated section and its "working pools"

The area between the rampart and the seawall was divided into 6 separate "working pools" (areas A-F; Fig.3a, 3b, 3c) and the seawater was pumped out of each 2 pools in turn, enabling contemporaneous archaeological excavation and engineering conservation work. Excavation trenches were dug alternately, with the "stich and un-stich" or "cuci scuci" method, until the completion of the sequence strip along the wall. During the clearing and cleaning process, huge amounts of building debris and garbage was removed to a sorting site; chiseled stones were separated from the field stones and debris, and were returned to the wall to be used in the reconstruction process. The foot of the wall was excavated down to the bedrock and temporary reinforcement scaffolding was erected.

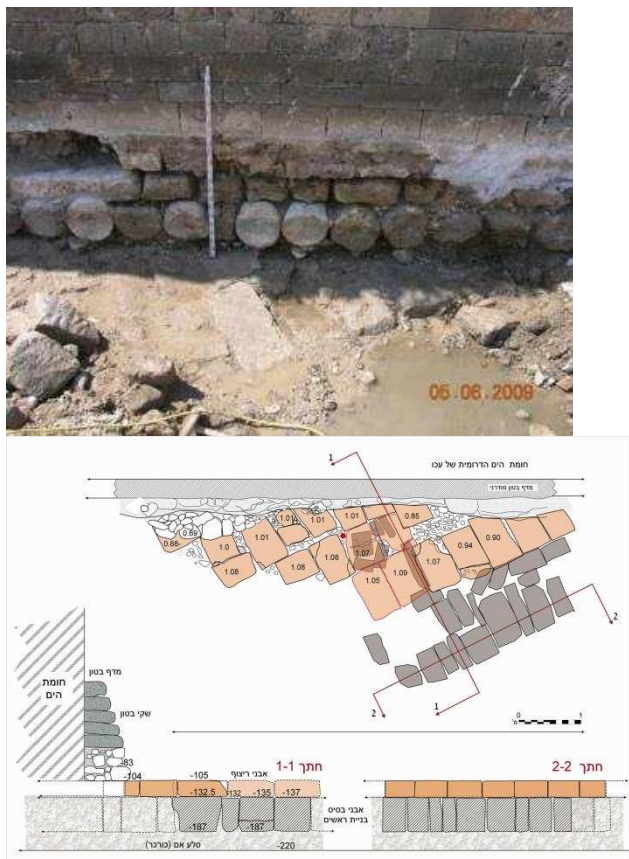
Fig. 4, 4a, Foundation of type C.

Nearby the southern edge of the Ottoman pyramid-form foundation an impressive floor was exposed built of stone slabs each measuring 0.8x0.4x0.15 m. The length of the exposed floor area is some 30m and it continues both northwest underneath the wall and southeast under the temporary dam. The stone slabs were placed on a layer of cut kurkar stones arranged in the header technique. A test pit was dug under the floor revealing a sealed layer of sludge that characterizes the bottom of a harbor; containing numerous Hellenistic finds (3th-1st cent. BCE), attesting to the fact that the platform was built during the Hellenistic period and probably functioned as a docking platform. While constructing the wall during the Ottoman period, a line of columns was placed on part of the Hellenistic floor as the foundation for the wall. This shows that the Ottomans were aware of the Hellenistic floor and used it as a foundation for the wall (Fig.4, 4a, 10). The existence of the quay was also known during the British Mandate as is apparent from a Mandate map based on Marino Sanudo's 14th cent CE map (Makhoully and Johns 1946, [7]:).

Engineering solution has been applied as planned.

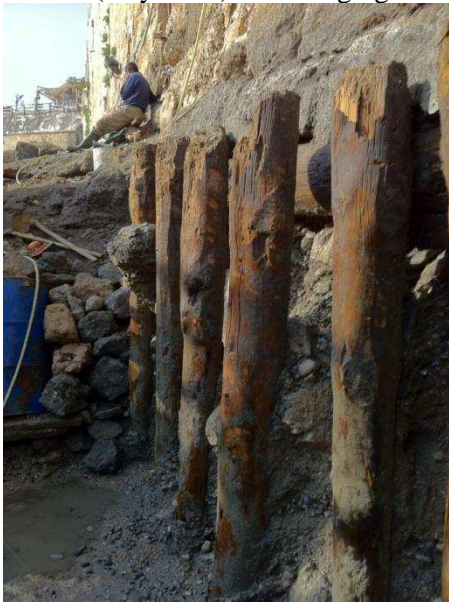
Fig. 5 Foundation type F

- 1) A rectangular structure with a row of wooden posts inserted into its top; the posts continue to the west and east of the structure for a total of some 100 m long.
- 2) A row of wooden posts some 3 m high with diameters of 20-30 cm; most of them are inserted each 30 cm and in some points, right next to each other (Sharvit, *et. al*, 2013) The bottom tip of each post was sharpened to a point and fitted with a metal spike, some 50 cm long. The spike was made of a 20 cm long cast tip and three wings. The metal spike

was intended to facilitate the insertion of the post into the ground levels and the wings were intended to prevent removal of the posts. A horizontal wooden frame was fixed with iron nails to the upper sections of the wooden posts. The first stone layer of wall, consisting of large hewn stone blocks with chiseled frames, was placed over the timber frame. The stone blocks had been dismantled from the Crusader fortress at Atlit and shipped by sea to Akko (Winter 1944b; Makhoully and Johns 1946). The posts are made of a species of trees that grow in the north-east of the Mediterranean (Turkey, Cyprus) – the *Pinus Brutia*, were dated to the years 1816-1846. This finding shows that this section of the wall was constructed after the city was conquered by Ibrahim Pacha of Egypt, ousting Abdalla Pacha in 1831. It's known that he employed the engineer Declaretto from Italy (Dichter 2000), who brought the post & frame foundation system that was used in Venice (Goy 2006) for enlarging needed areas and rebuilding sea walls (Fig 5, .13).

Engineering solution has been applied as planned.

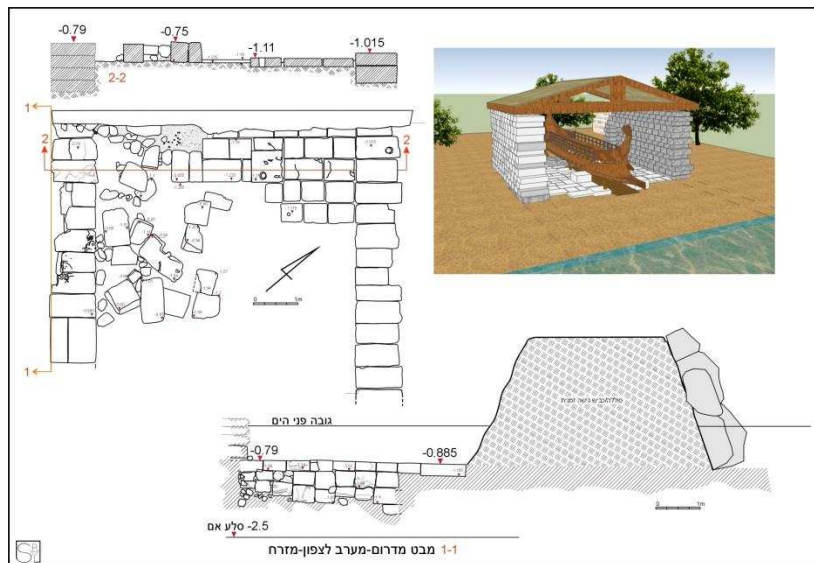
Fig. 6 Foundation type G

A rectangular structure 5 m long and 8 m wide with an east-west orientation that continues underneath the Ottoman building, as well as seaward continuation underneath the temporary battery. The structure is built of two thick walls made of large cut kurkar stone slabs that were laid in the header technique (Phoenician style) and in between them is a stone paved floor some 6 m wide with a slight seaward slope. (Fig 6,14)

In the center of the floor there is a 40 cm wide and 20 cm deep groove. In some of the nearby paving stones there are perforations (ca.10 cm diameter) that may have served to hold vertical timbers for supporting ships. At the end of the floor close to the rampart (facing the sea), there are a number of collapsed large building blocks that belonged to the wall. In the nearby excavation trench a number of large detached mooring stones were found. They may have served as part of the dock or for tying ships. Finds discovered in the foundations of the structure are dated only to the Hellenistic period. The structure's location, its size and building technique all point to an installation intended for hauling ships (slipway) or for storing vessels for dry docking, probably a ship-shed (Nauskenea). It seems that the central groove was made to accommodate a ship's keel and protect it during hauling; while wooden poles propped up the vessel during treatment. Similar installations have been studied in many sites around the area of Mediterranean, such as: Piraeus, Bauindinai, Korfu –Greece, Sarkuzi-Sicily and others (Baika 2003; Blackman 2003; Raban 2011) (Fig.6, 14)..

Engineering solution has been applied as planned.

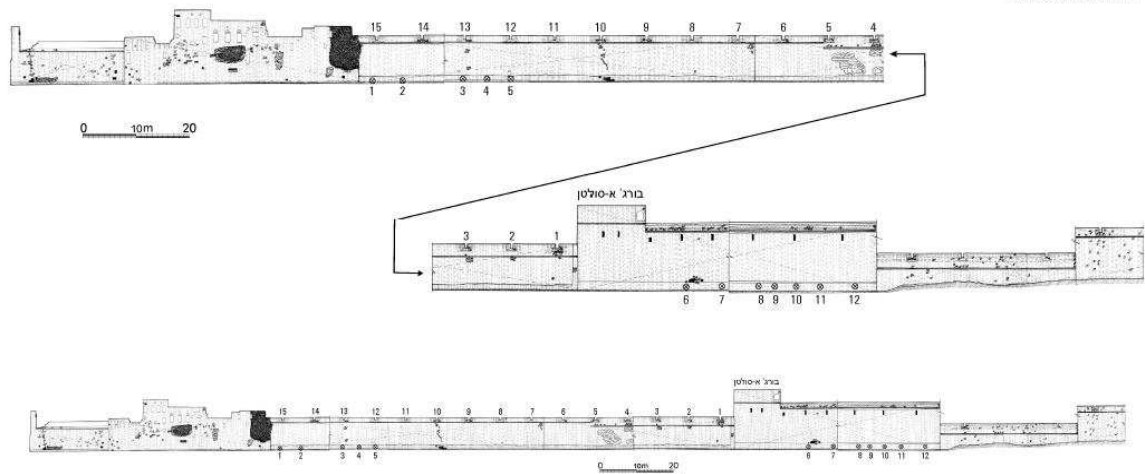
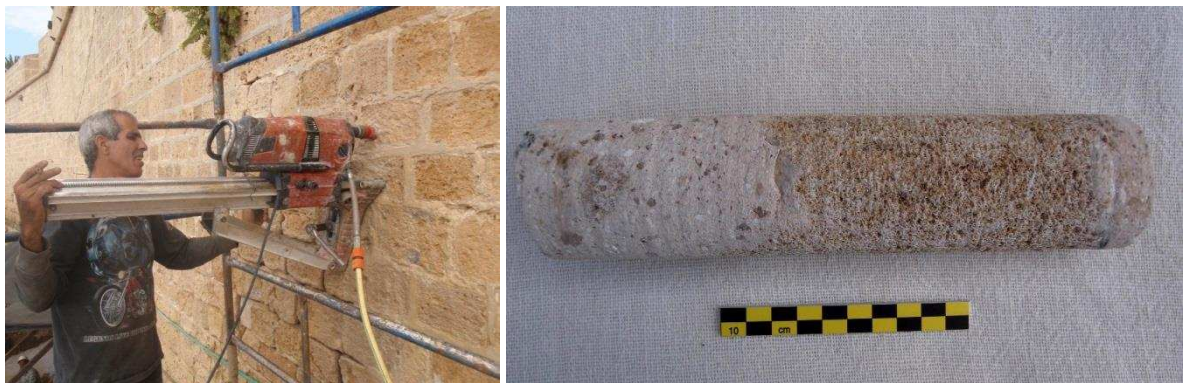
Fig. 7 a, 7b, 7c Drilling of "cores" in the sea walls

Drillings no. 3, 4, 7 penetrated into the cavity of a structure, probably a vault. It is not yet clear whether the vault is whole or rubble of a collapsed vault. It seems as if the drillings penetrated through the foundation courses of the wall that were built with chiseled kurkar-stone 1 m thick and filled with field stones and aggregate.

Drillings no. 5 and 6 were undertaken at a height of 7 m above sea level, from two sides of a crack that was seen in the wall underneath the "balustraria". The drilling revealed that the width of the outer stone layer is 1 m and behind it there is a muddy filling aggregate. Analyses of the array of vaults revealed that the drillings penetrated into a wall supporting a roofed vault built for the canon's platform.

Drilling no.8 was undertaken at the southern seawall of the Burj-el-Sultan tower. The drilling revealed that the wall was constructed of chiseled kurkar stone 1m wide and behind it 2 m' of aggregate filling containing small stones. Behind the aggregate filling is a cavity and small stones. Examination inside the Burj-el-Sultan tower two story vaulted rooms revealed that the lower vault was used as a water reservoir.

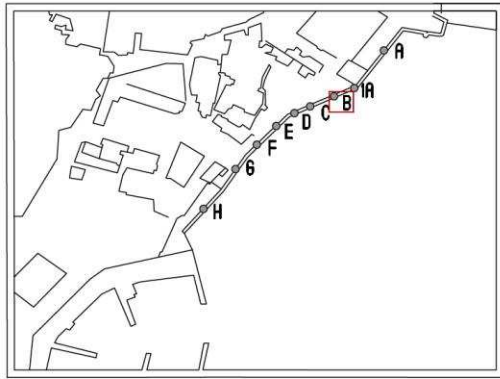
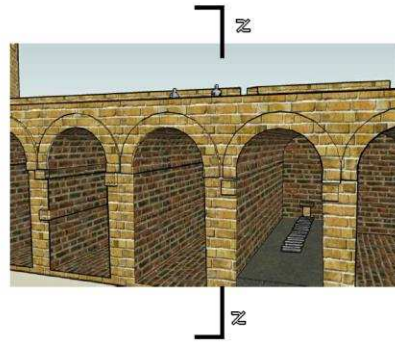
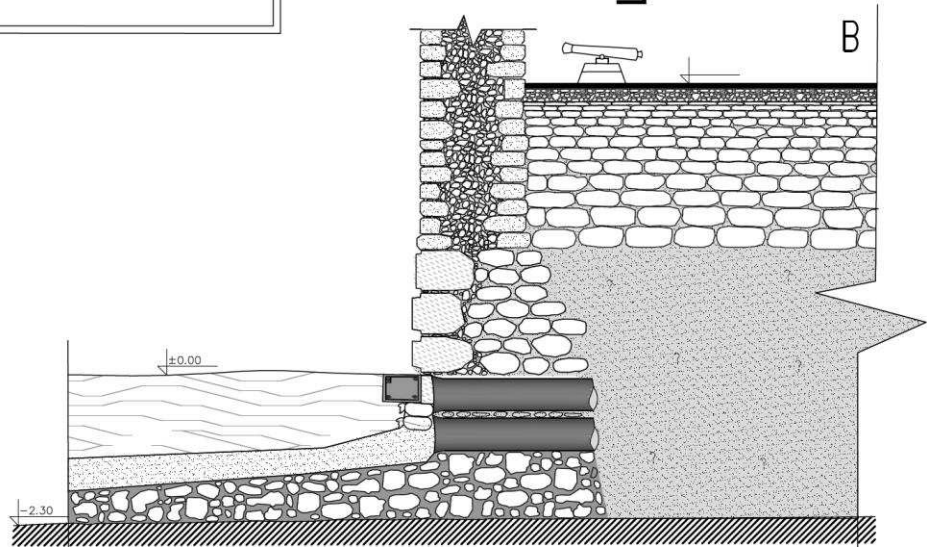
Fig.10 sect. B Emphasizing the work of horizontal core-drilling in the engineering stabilization of the seawalls
