Proceedings
PRO 78

Historic Mortars and RILEM TC 203-RHM Final Workshop HMC2010

Proceedings of the
2nd Conference and of the
Final Workshop of RILEM TC 203-RHM

**2nd Historic Mortars Conference and
RILEM TC 203-RHM Final Workshop
HMC2010**

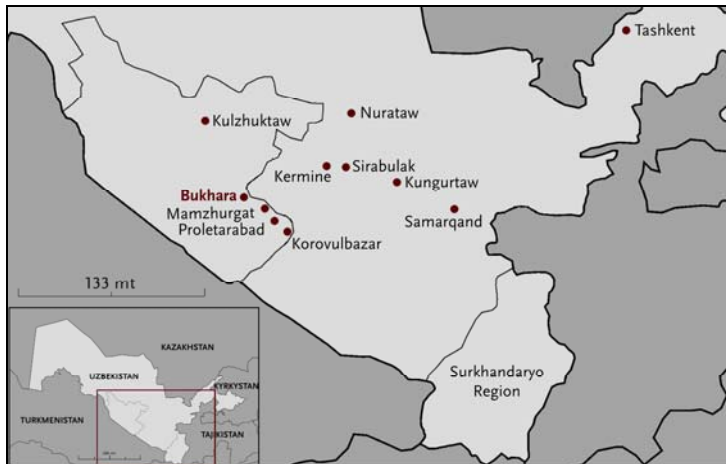
Fig. 5 Gypsum, celestine, quartz and limestone deposits in the region of Bukhara

Limestone: The deposits of Korovulbazar (about 43 km in the southwest of Bukhara) and Proletarabad (about 25 km in the southwest of Bukhara) are characterized by grey or greyish and fine grained limestone [2, 3].

Thermal waters: The deepwater sources in the region of Bukhara contain a high percentage of strontium (> 300mg/l).

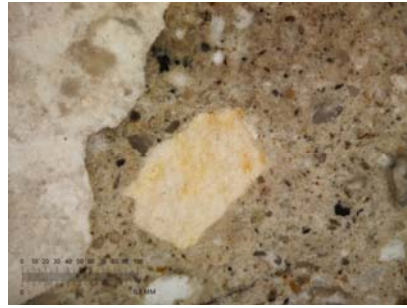
Fig. 7 Sample no. BZ059, 50x

BZ059 (Table 1, Fig. 7): the FTIR-spectrum bears great resemblance with sample no. *BZ028*. The occurrence of calcium oxalate in combination with calcium oleate and proteins indicates the use of whey.

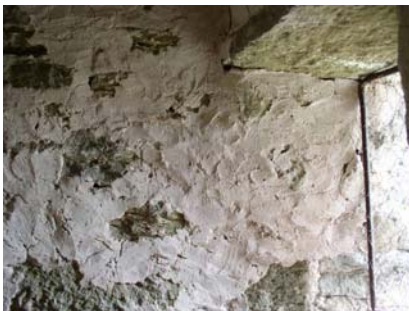
Fig. 1 Medieval joints in the tower of Linde church. Hard lime rich white mortar with very fine graded sand. Traces of tools used when applying the mortar.

Examples of historical mortar investigated ocular are shown in Figs. 1-6. By performing an ocular investigation lots of information can be read. Tool marks, additives as well as bigger binder and aggregate particles are visible. Those surfaces have been found on the medieval churches on Gotland both outdoors in the joints and indoors on the attics.

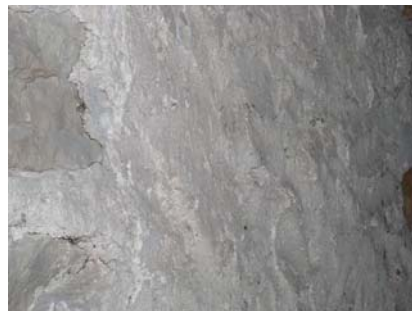
Fig. 2 Remaining plaster on a Romanesque choir still left on the attic of Norrlanda church. Very lime rich with fine graded sand. Traces from tools.

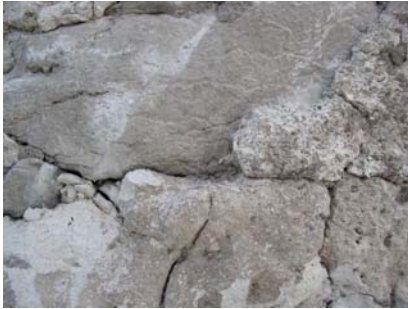
Fig. 3 Two types of old mortar on the west façade of Othem church. They are both white and lime rich. One with fine graded sand and the other with larger rounded sand particles.

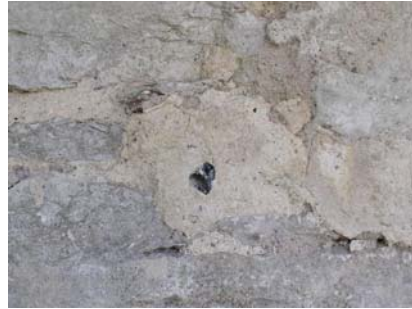
Fig. 4 Remains of wood and coal in an extremely lime rich mortar on Norrlanda church. A very hard and compact mortar.

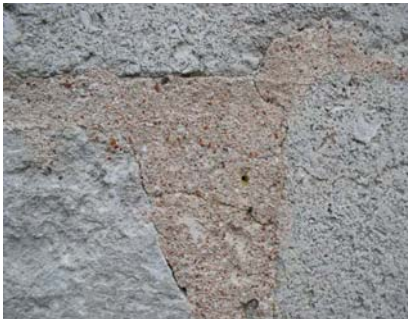
Fig. 5 Joint on Fardhem church containing crushed red bricks. Pink secondary mortar based on lime.

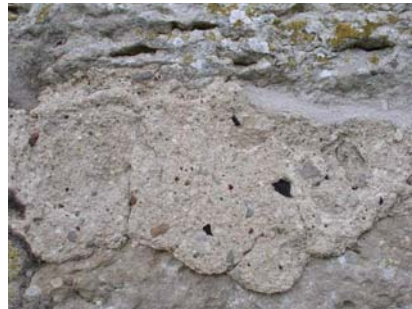
Fig. 6 The joints at the ruin from a citadel at Gothem. A bit yellowish lime mortar with large sand particles and remains of large coal particles.

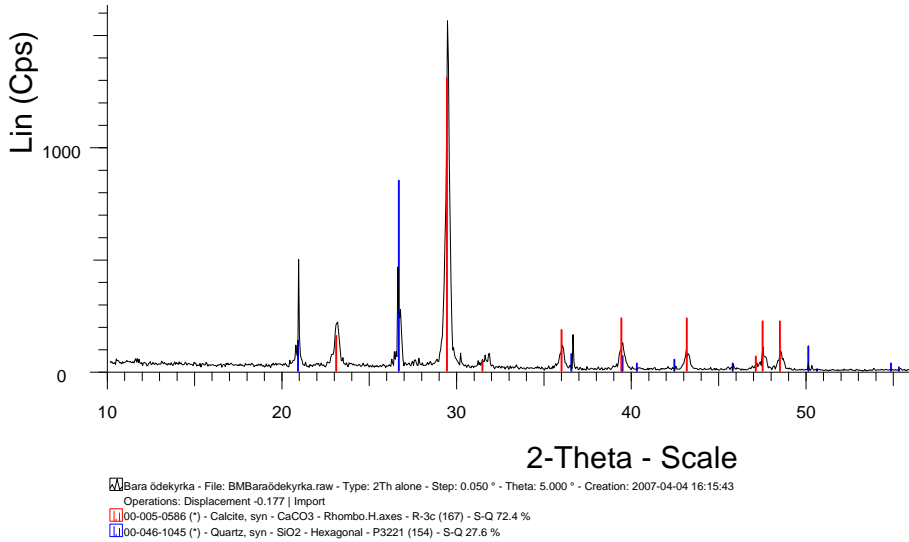
Fig. 10 X-ray diffraction made on a medieval mortar sample from Bara church ruin on Gotland. The sample only contains CaCO₃ (kalcit) and SiO₂ (quartz); carbonated lime and quartz sand.

Mineralogical analysis by X-ray powder diffractometer can be used as a complement to the optical methods mentioned above. Thus, the crystalline matter present can be detected and identified, see Fig. 10.

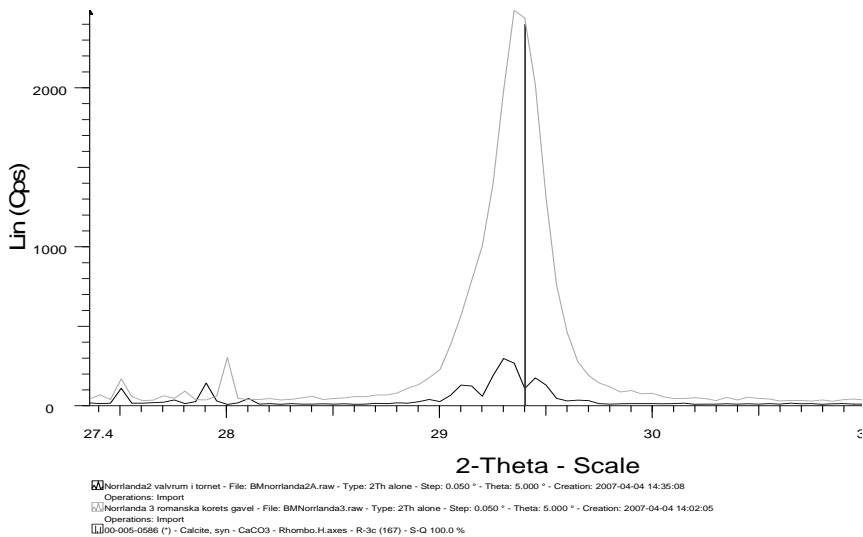
Fig. 11 X-ray diffraction made on two medieval mortar samples from the attic of Norrlanda church on Gotland. The lower black line is from a joint inside the tower while the upper gray line is from a render surface once being an outdoor render on the choir but since the last building phase (around year 1300) it has been indoors on the attic. Because of the low intensity of the sample from the tower, the conclusion can be made that it has transformed and re-crystallized to a less crystalline form.

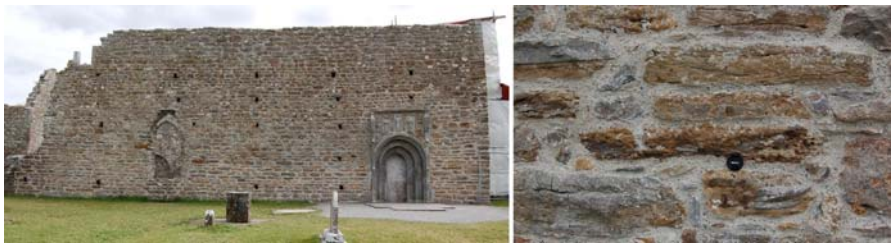
Fig. 1 The north wall of Clonmacnoise Cathedral, Ireland, constructed c. AD 909, with an elaborate perpendicular Gothic doorway inserted at the western end of the wall c. AD 1460. Recent conservation of the cathedral focused on repointing the ruined structure (above right).

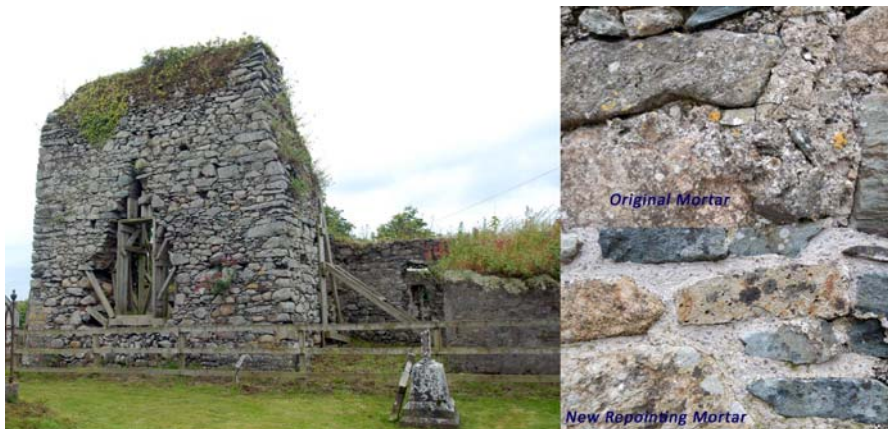
Fig. 2 Comparison of original in mortar (top right) and new replica mortar (bottom right) used for ongoing conservation work at the remains of Stradbally Church, County Waterford.

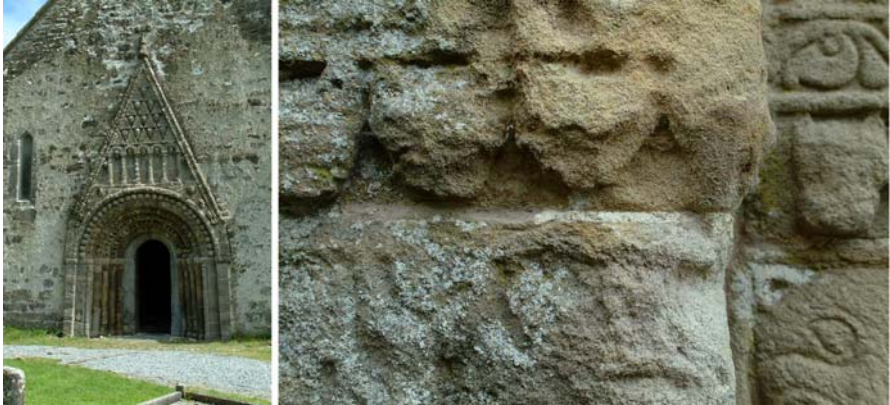
Fig. 4 The Romanesque portal of Clonfert Cathedral, County Galway (AD 1161-1171) showing the original white pointing mortar [19] and the red-coloured lime-based repointing mortar.

While analysis and interpretation of historic materials is an engrossing study in its own regard, using the data to formulate repair solutions adds additional layers of complexity. Ensuring compatibility and safeguarding the original material are key issues. Many (but not all) medieval Irish lime mortars show several sources for hydraulicity, including combinations of intentional pozzolanic additives, the use of reactive aggregate, reactivity from the residues of burnt fossil fuel used for lime production, and mineral impurities naturally occurring in limestones. However, it may not be appropriate to exactly replicate the properties of the original material as changes to the formulation may have to be incorporated to safeguard original material, especially in proximity to carved stonework. In addition, the majority of medieval buildings in Ireland survive today as ruined structures and a ‘fit-for-purpose’ repair mortar must also meet certain aesthetic needs as a poorly-formulated new repair mortar, though materially compatible with the original mortar, can significantly detract from the character of the structure, which also forms an important part of its historic value.

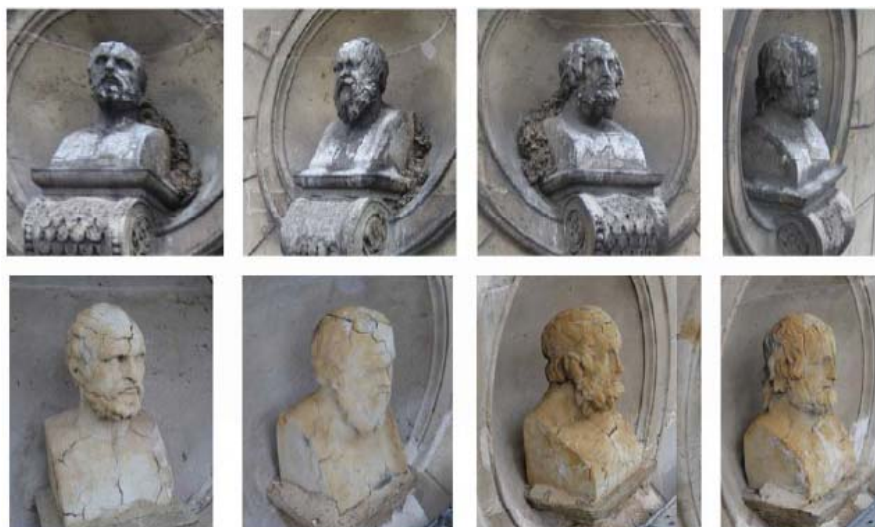
Fig. 2 Cast busts of the four famous men before and after micro-sanding cleaning.

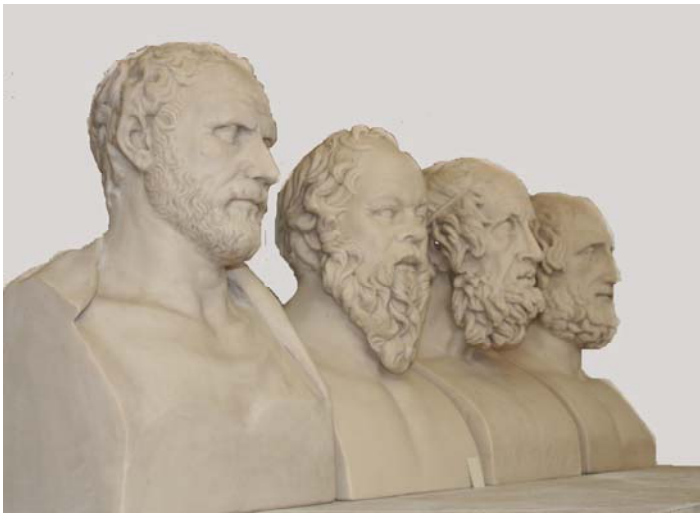
Fig. 8 New cast busts made in resin by the moulding studios of *L'Atelier des Moulages de la R.M.N.*, and replaced in January 2010 on the façade, *rue d'Aboukir N°4th*.

The conservation initiative has been to relocate the busts to the entrance of the building and to install on the façade new busts similar to the original, but cast in resin. They were made by the *Louvre* moulding studio and recently placed in January 2010 (Fig. 8).

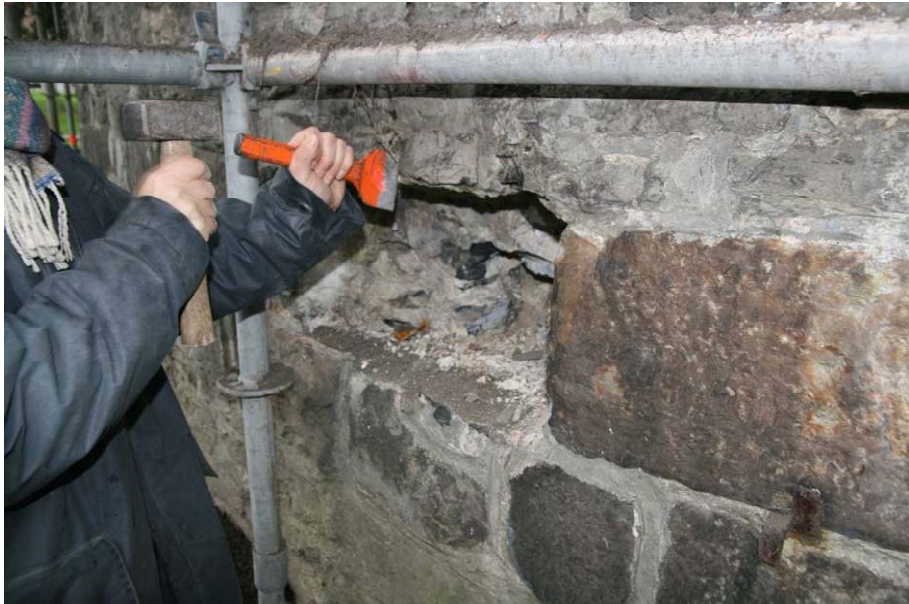
Fig. 4 Sampling in the heart of the wall- Tour Henry VIII- Tournai.

After defining our questions, we take samples in each representative structure. If possible, we base our sampling on the archaeological interpretation. For example, we take samples from each stratigraphic unit (US). Samples are always taken from the heart of the wall (Fig. 4). If possible, we also take samples from joints and coatings to compare the property of each material on the same structure. In a single site, a church for example, we can take 50 samples. The minimum size is 5 cm³.

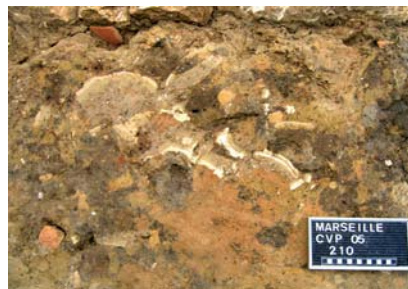
Fig. 1 The archaic painted plaster on the site of *College Vieux-Port* (Photography S Mathie, INRAP)

These archaic plasters had received a fine grey earth finishing layer which contained less sand, or a white lime-based layer, prior to the application of the blue (Egyptian Blue, cuprorivaite mineral) or red (red ochre) paint. The elemental composition of the grey finishing layer and the plaster were close, with calcite as the main phase associated with quartz, dolomite, mica/illite, smectite and kaolinite clay minerals. The materials were probably of a local origin. They had the same composition as the Stampian marls collected on the site. Both contained calcite,

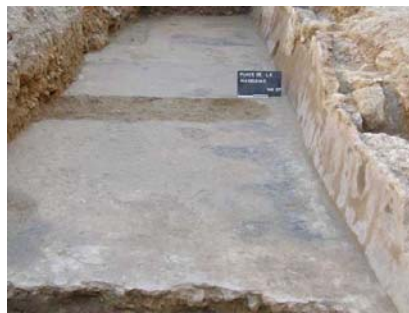
Fig. 2 Place de la Madeleine. Floor and walls in *opus signinum* (Photography LF Gantès)

Plinths covered with a Roman concrete (*opus signinum*) were a common feature within many of the excavated sites. This kind of mortar was recommended by Vitruvius [1] for the bottom of the walls up to a height of three foot, for rooms located on the ground floor, in order to reduce damage caused by moisture. The

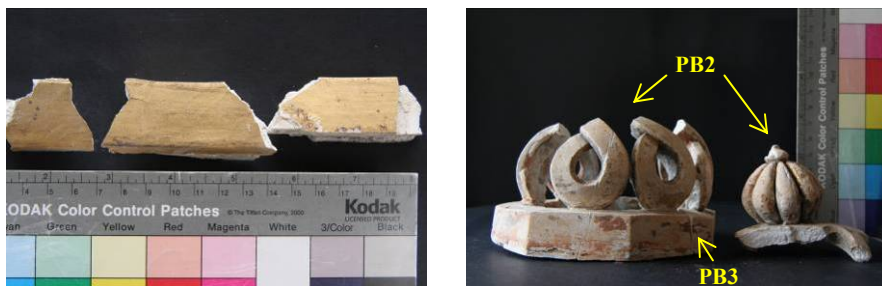
Fig. 2 Sample PB1 (left) and PB2 plus PB3 (right)

Identification	Sample description
PB1	Frame from the ceiling (gilded) (Fig. 2)
PB2	Ornaments from the breathing holes of the ceiling (gilded) (Fig. 2)
PB3	Octagonal base of PB2 (gilded) (Fig. 2)
PB4	White ornaments from the ceiling
PB5*	White ornaments from the coronation of the cove that limits the ceiling (partially gilded)
PB6	Preparation layers and ornament of a wall of the gallery (with polychromes)

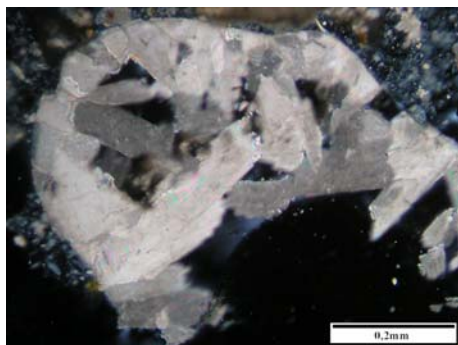
Fig. 6 Sample 8 - photomicrograph of calcite crystals filling a pore

The composition of the examined mortars does not vary considerably, but the mortars display different degrees of micrite recrystallization (Fig. 6). Based on the evaluation of the carbonated lime-based binder recrystallization degree and by comparison with archaeologically dated samples, it was concluded that the mortars belong to three separate periods. Samples 1, 2, 4, 9, and 11 display low micrite recrystallization degree and, thus they are the youngest in the set. A higher recrystallization degree was identified in samples 5 and 6. Samples 7, 8, and 12 are the most recrystallized and, thus the oldest in the set. The estimated speed of recrystallization is given in Table 2.

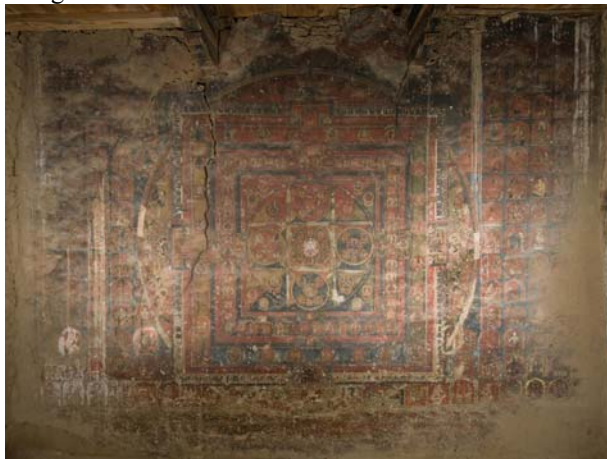
Fig. 3 Translator's temple, South wall, 8 m in length © Conservation Department, University of Applied Arts Vienna

The plasters of the first decoration phase in all the temples were applied in a two-layer system to level the walls and provide support for the paintings which consist of glue-bound paint layers over a ground gypsum support layer. In secondary decoration phases, only one plaster layer was applied to support the paintings. For the first phase's two-layer system, a coarse mortar was applied as a lower plaster, with its thickness (from 1-7cm) being dependent upon the evenness of the adobe walls to which it was applied. The upper plaster layer, without any further anchoring, consists of a finer mortar applied in a much thinner layer from 0.2 to 1 cm thick. The lower plaster layer had a rough surface and was presumably planed with wood whereas the surface of the upper plaster layer was finely smoothed, probably with stone, to prepare a truly perfect ground for the elaborate murals (See Fig. 3).

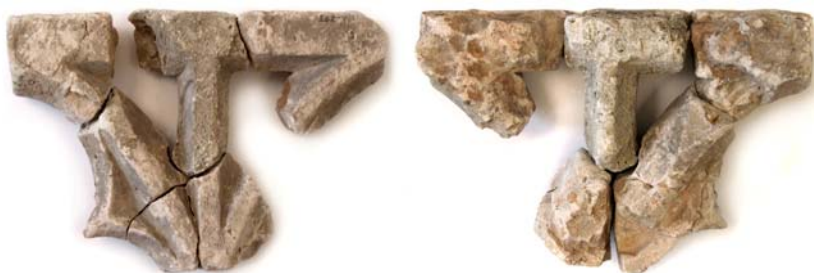
Fig. 2 Balustrade of the gallery, fragment, both sides; ca. 52,5x72,5x19cm; rose-coloured gypsum mortar, central part reconstructed in cement mortar in 1960's, Muzeum Okręgowe w Toruniu, object No. MT/ZK-20

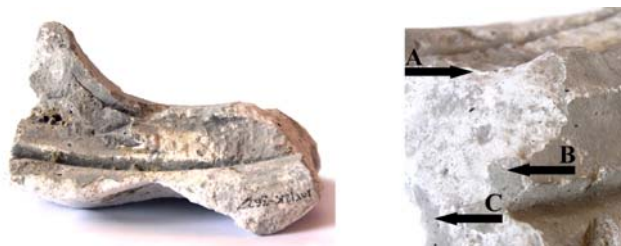
Fig. 4 Window tracery fragment MT/ZK-362. Left – principal view. Right – detail, weathered fracture surface: A – dense material layer of relief surface, B – dense material layer of old fracture surface, C – fresh fracture showing the actual colour of mortar

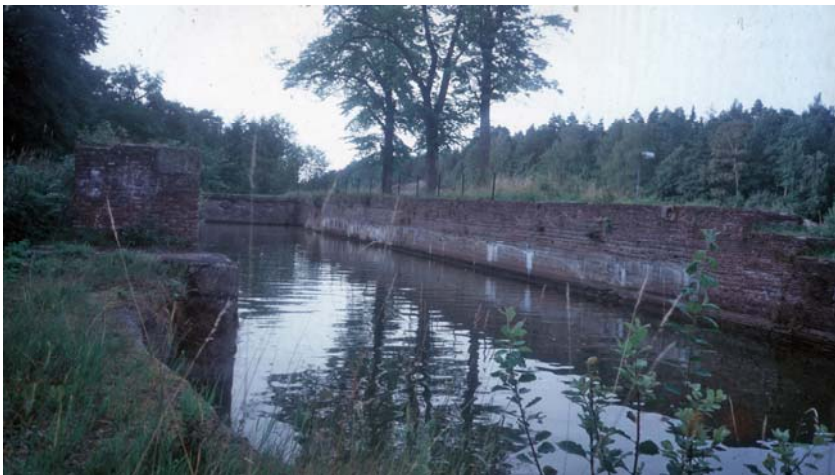
Fig. 1 Gustaf’s Locks at Brinkebergskulle in the Göta river, constructed 1772-78 with an alum shale mortar from the cement factory at Brinkebergskulle. Photo: Sölve Johansson 1989.

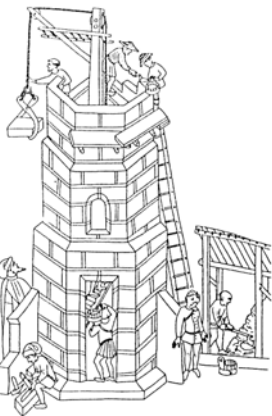
Fig. 3 Mortar prepared in an open hut

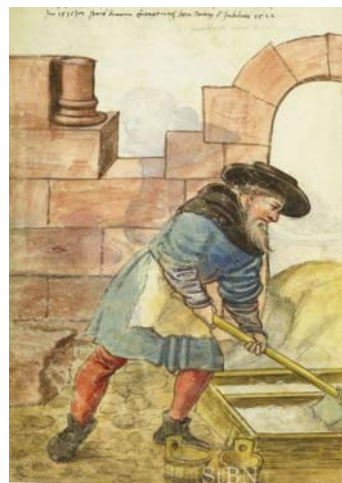
Fig. 6 Preparation of lime mortar in 1522

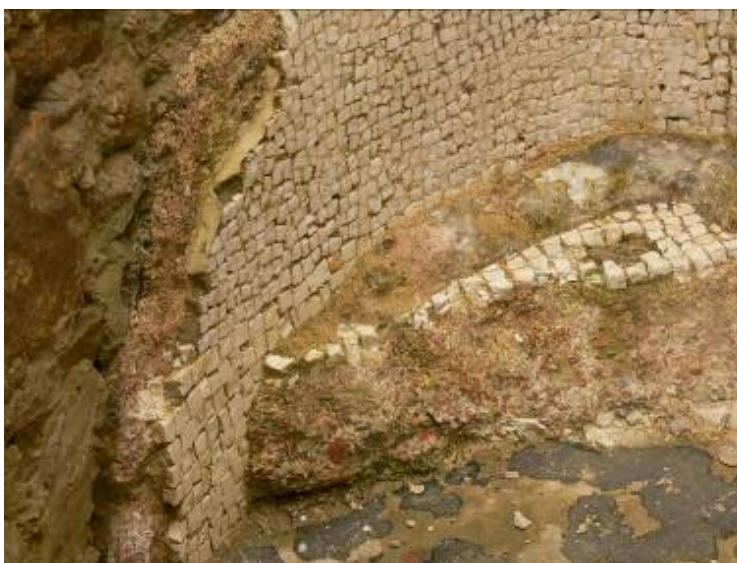
Fig. 1 joint mortar of the internal mosaic lining of the tank at the monumental door

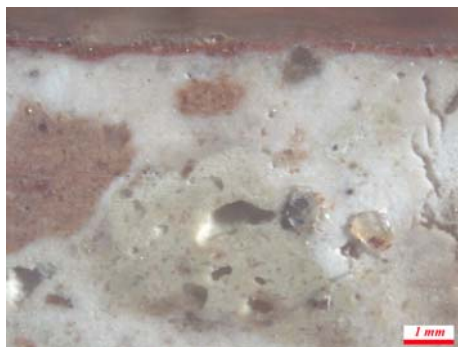
Fig. 3 Polished cross section in reflect light of the crushed brick mortar with a red painted layer coming from the external wall of the octagonal hall

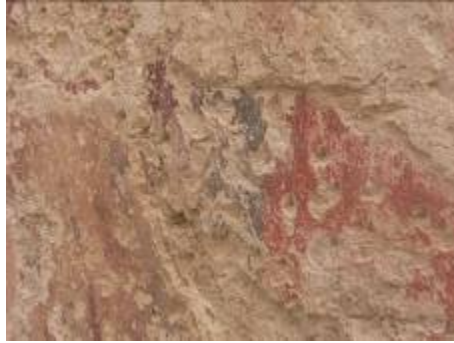
Fig. 5 the two pictorial layers on the four-sided portico wall

The in situ observations on the frescos of the four-sided portico have revealed the overlapping of two pictorial series, as shown in figure 5, applied on substrate mortars, whose characteristics do not essentially differ from the ones already described.

The thickness of the pictorial film goes from 100, sample 09PA24, to 20 micron, sample 09PA23, each pictorial film is applied on a layer of plaster that is almost completely composed by binder superposed on the reinforcing mortar. Yet, it is evident that the reinforcing mortar of the most recent pictorial series is a lot richer in binder, i.e. $I/B=0,2$, than other samples. Also in this case the aggregates are mostly composed by quartz grains and less by carbonate rocks, sparitic and microsparitic, by rare feldspars, even rarer muscovite lamellae and casual bioclasts, this highlights that the material comes from local arenaceous outcrop. The binder has a colophorm texture also in this case.

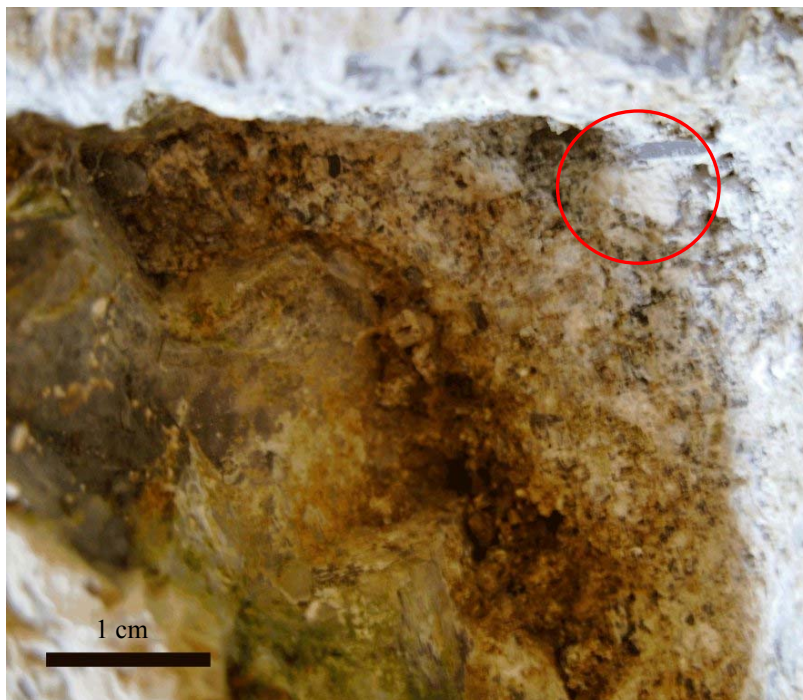
Fig. 1 Mortar joint with lump of lime (upper right corner, inside the red circle)

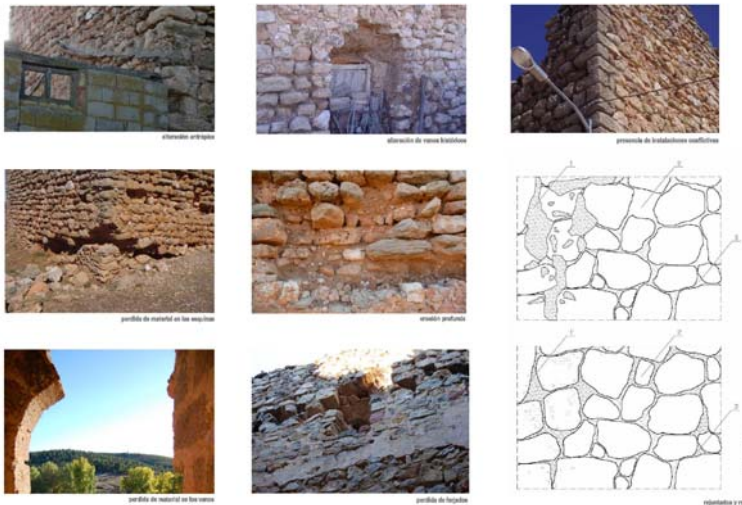
Fig. 4 Masonries study: classification of pathologies (structures and surfaces)

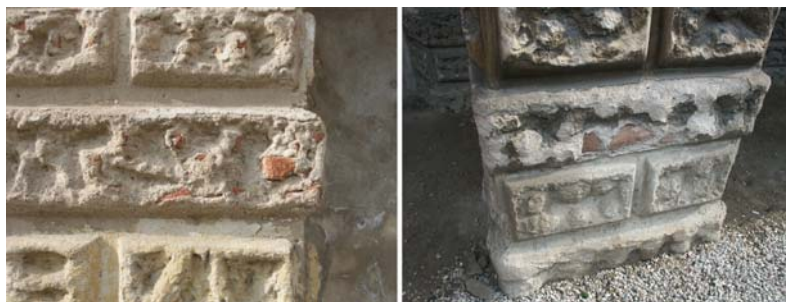
Sample 3, although having relatively low porosity, has the highest percentage of coarse pores among the examined samples (34.3% of pores with $r > 1 \mu\text{m}$, Table 2). The rough compaction of the plaster was necessary to achieve the rustication appearance and is responsible for the high number of macropores. The thickness and coarse placing of such plaster was made possible by the insertion of brick fragments as a reinforcement for supporting the fresh plaster (Fig. 3).

Fig. 3 Brick fragments insertion in the rustication plaster.

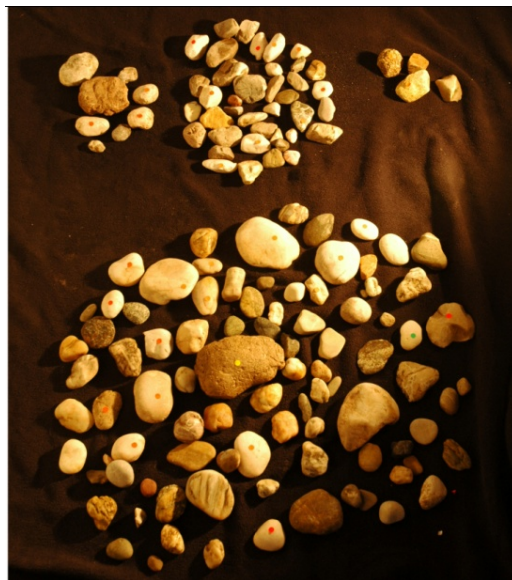
Fig. 2 Different limestone rubble samples from Upper Austria
Below-the pebbles of the gravel plant Brandner at the Danube, *above left*-gravel from the Enns river in the mountains near Großraming, *above middle*-rubble from the Reichraming stream at its estuary in the Enns and *above right*-the material from a headwater of the Steyr near Schmidleithen near Obergrünburg.

A picture of the different rubble samples is provided in Figure 2. Results show that nearly all the material consists of different variations of limestone and marble, namely Wetterstein limestone, shallow water limestone, dolomite, coral rag, marbles, flysch limestone, gravel limestone and shelly limestone.

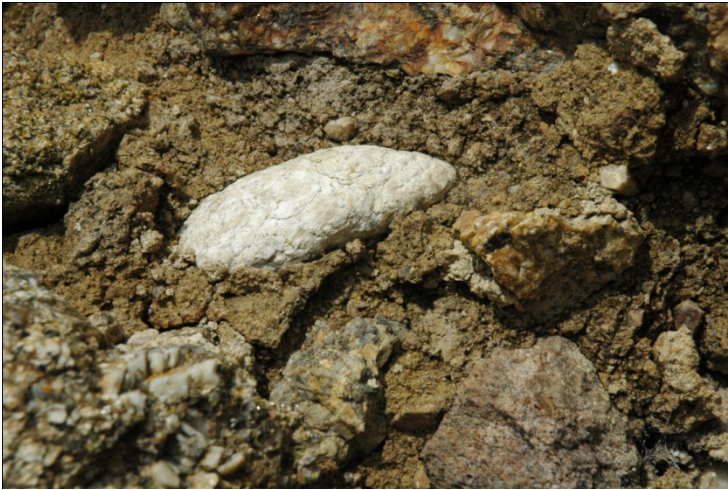
Fig. 4 Partly calcined gravel chip in the core mortar of the tower at Prandegg

Further evidence for the theory of Danube gravel as the source of quicklime showed up recently during various inspections at the ruin itself. Burned Danube pebbles were found directly in the core of the historic walls (fig.4). These pebbles are mostly silica stones which show a glass-like layer on their surface. This was likely caused by the heat of kiln as the silica pebbles were not removed prior to burning and so were burned and slaked with the limestone. Another pebble, found in the mortar of the watchtower, was clearly identifiable as a partly burned limestone river pebble with a rough burned outer shell. As a result all gravel that is seen in the mortar during restoration works or inspections is being kept and documented.

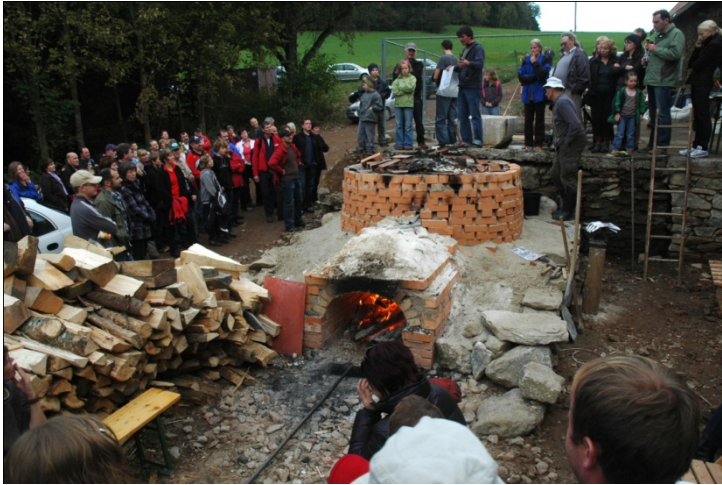
Fig. 5 Burning Danube gravel in 2009 with Dr. Karl Stingl and Mr. Vösenhuber

A total amount of one cubic meter of Danube gravel was taken to Mauerbach, where the Bundesdenkmalamt (office for the preservation of monuments) built a historic field kiln to burn a certain amount of limestone every year (fig.5). This oven was constructed according to historical archetypes and was fired constantly for three days with wood as a sole fuel source to allow the burning temperature and procedure to be as similar to that of the medieval times. Before filling the oven, all the gravel chips were sorted, documented and if possible determined and named by the geologist Karl Stingl from the University of Graz. Here a variety of different burnable limestones, such as Wetterstein lime, black lime, red lime, shallow water lime, grenoide, jura lime and dolomite, along with a few non burnable quartz-pebbles, were identified. The possibility existed for the quartz to cause a hydraulic effect ($2\text{CaO}\cdot\text{SiO}_2$) similar to the silica processes of modern NHL ($3\text{CaO}\cdot\text{SiO}_2$).

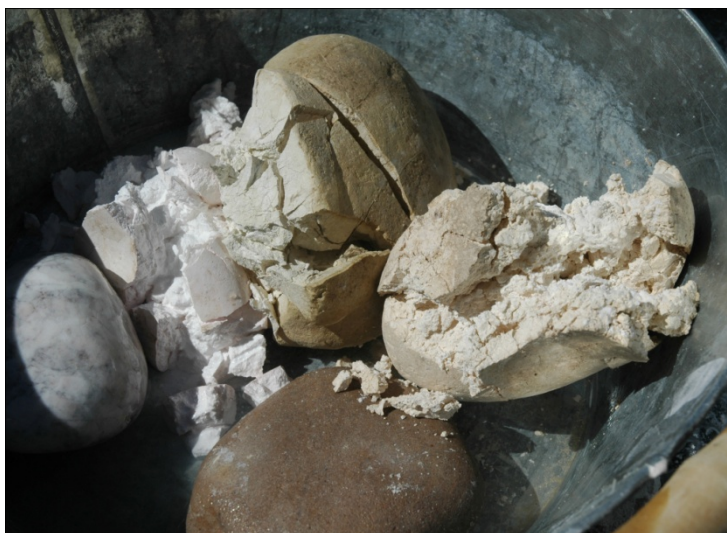
Once sorted about 0.3 m^3 of gravel chips were placed in the oven. Restorer and lime burner Hannes Weissenbach doubted the success of the experiment as he thought the burning process would be too short to completely burn the more dense pebbles and that the amount of non-burnable “deaf” stones would be over 60%. For this reason the examination of the quicklime after the cooling of the kiln was even more exciting, although the much lesser weight of the quicklime-gravel was already very promising. Once cooled, the first slaking of a typical lime pebble was immediately conducted; results showed an instant vigorous exothermic reaction and the transformation of the gravel pebble into very homogeneous lime putty after only a few minutes (fig.6). It must be said, that the slaking reaction differs

Fig. 6 Three burned Danube pebbles starting their slaking reaction. The pebble on the left is a silica quartz and shows a glass-like surface like the one found in the core of the walls. Like the brown silica based sandstone below it will not slake and remain as “deaf” stone in the mortar.

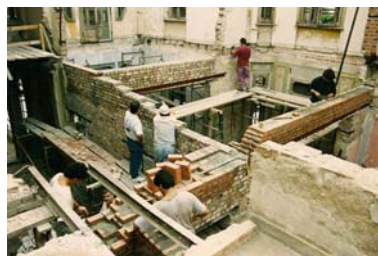
Fig. 5 Internal bearing structure, 1994

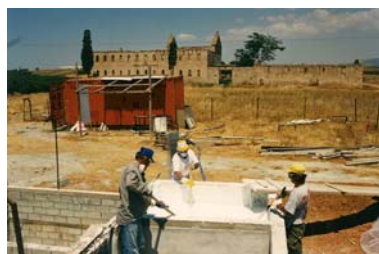
Fig. 7 Wet slaking at the worksite, 2001

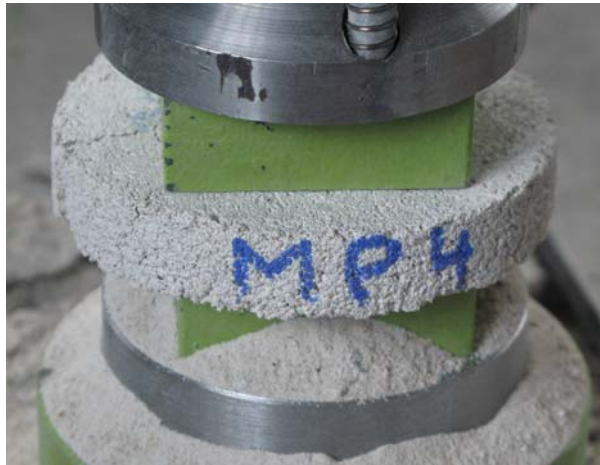
The circular plates with diameter larger than the punching steel plates, Fig. 2, exhibit approximately the same average strength as the square regular shapes, see Fig. 1. Therefore the same reduction corrections are applicable.

Fig. 2 Compression test on circular discs.

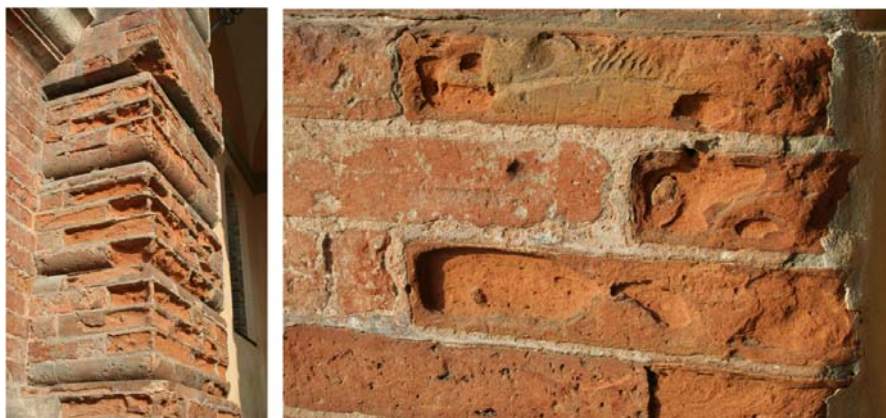
It is noteworthy that a differential alteration between bricks and mortars occurs (Figs. 2 and 3): the brick degradation is several centimetres deep, while the contiguous embedding mortars are in some cases perfectly conserved. In this paper, a possible direct role of embedding mortars (supposedly cement-based, applied during some not-documented 20th century maintenance work) into brick decay is investigated; for this purpose, mortars and brick samples were withdrawn from the portal and characterised.

Fig. 2 Details of the materials' decay in the portal

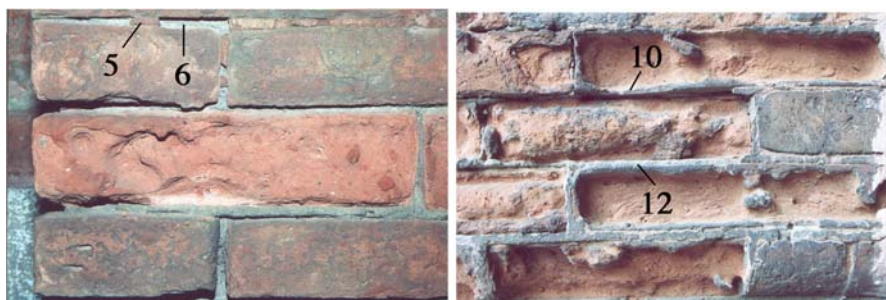
Some significant embedding mortar and brick samples were withdrawn from the portal: the sampling areas are shown in Fig. 3, while a brief description of the samples is given in Table 1.

Fig. 3 Position of sampling points 5-6 (left) and 10-12 (right)

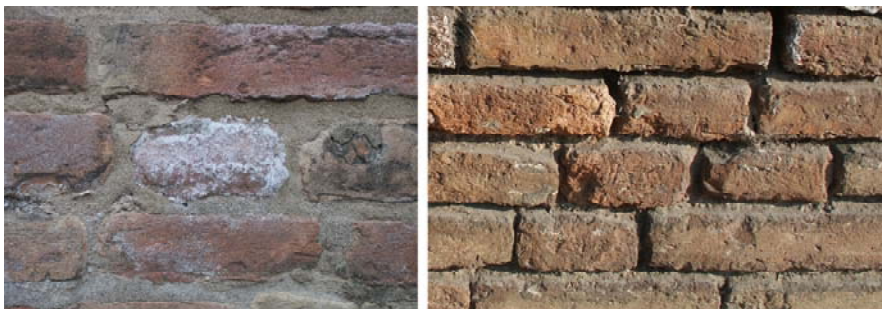
Fig. 6 Differential efflorescence in the bricks (left) and salt decay in correspondence to the mortars (St. Lazarus church in Modena, Italy, XII-XVII cent.)

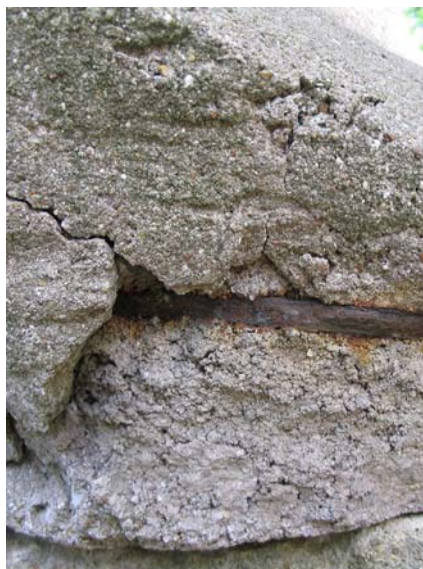
Fig. 2 Many busts have numerous cracks and cavities with visible corroded rods under a thin and porous mortar layer

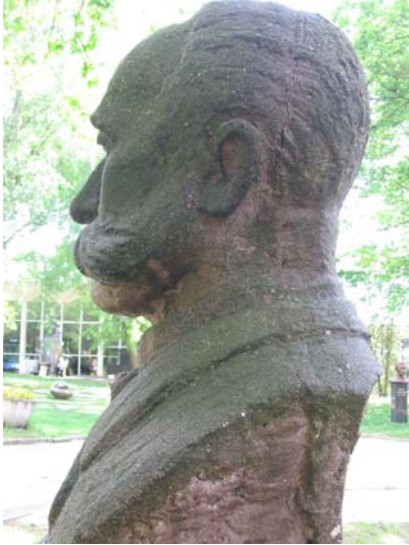
Originally, the busts had an intense purple colour, as shown in Fig. 3. A surface layer of mortar with the pigment has been leached out and currently the busts have a grey colour.

Fig. 3 The original purple colour of busts

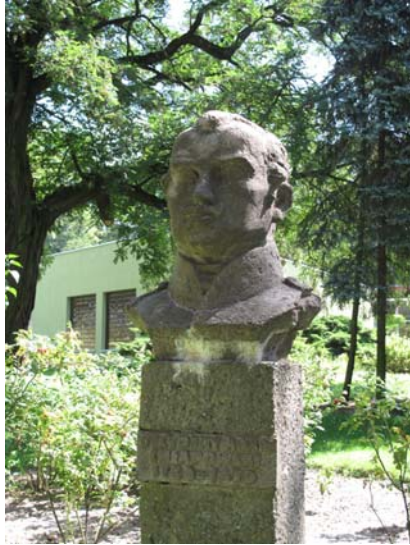
Fig. 4 White calcium carbonate efflorescences leached out from cracks

The concrete surface is very porous, covered with grime, lichens and moss colonies. Some connections between three technological parts are leaky; the width of the crevices varies from 0.1 to 3 mm. There is especially a lot of moss in these places. The soluble components of the concrete, visible as white calcium carbonate efflorescences, were leached out by water, as shown in Fig. 4 [2].

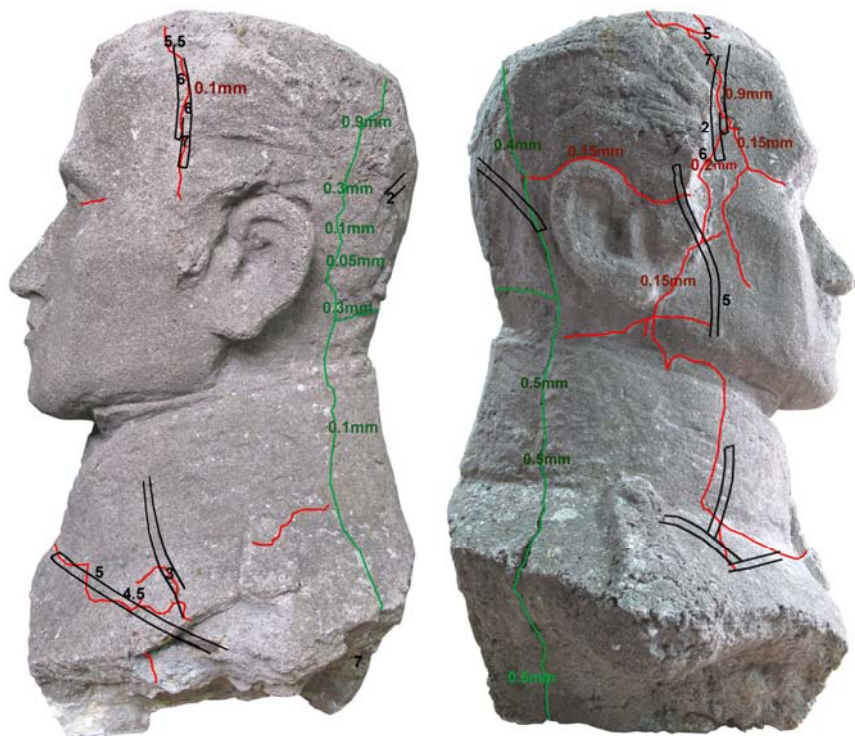
Fig. 5 The bust of Dezydery Chlapowski - view from the left and right side. The location of rods, thickness of lagging, the width of the cracks and crevices

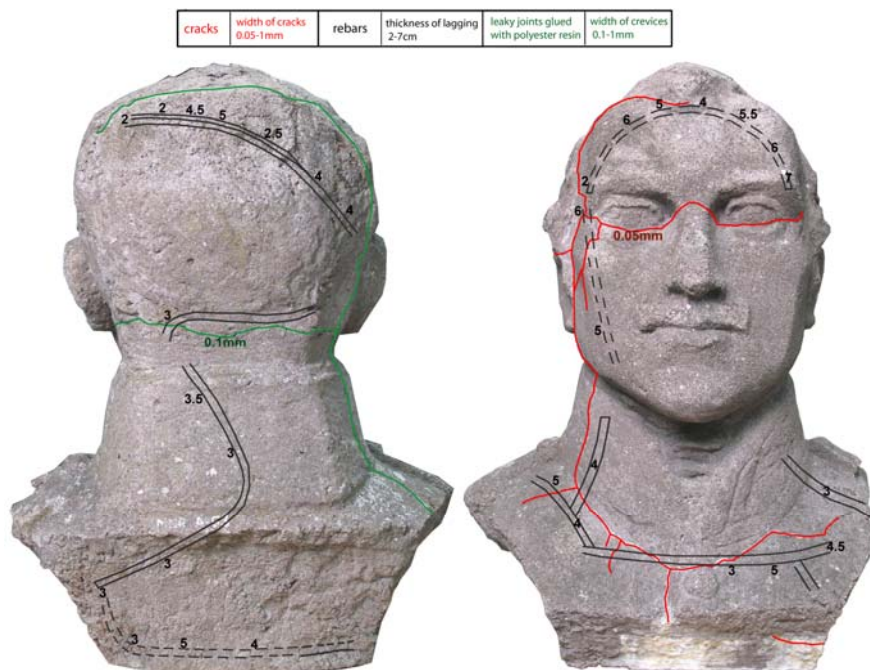
Fig. 6 The bust of Dezydery Chlapowski - view from the front and back. Location of rods, thickness of lagging, the width of the cracks and crevices

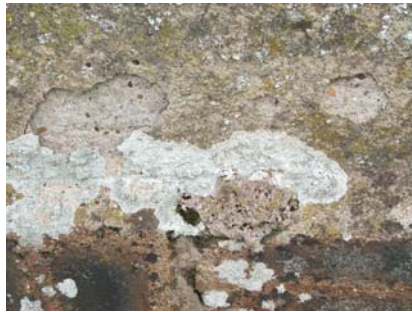
Considering their age and the circumstances of their construction, the buildings are in fair condition. Many still have their original asbestos roofs, still functioning, and most of the cementitious render is original. Only a few of the most severely deteriorated bricks have been replaced. However, some deterioration has occurred, due to a combination of the way the buildings were designed and constructed, and the environmental conditions at the site. The deterioration includes breaking and crumbling of the unrendered bricks just above the ground; salt efflorescences forming on the inside walls of the buildings; cracking and delamination of the render; and blistering and flaking of the render. This paper will focus upon the work that has been undertaken to investigate the blistering render and identify possible causes for it.

Fig. 2 The blistering render on Building 47 (Spare Parts Store)

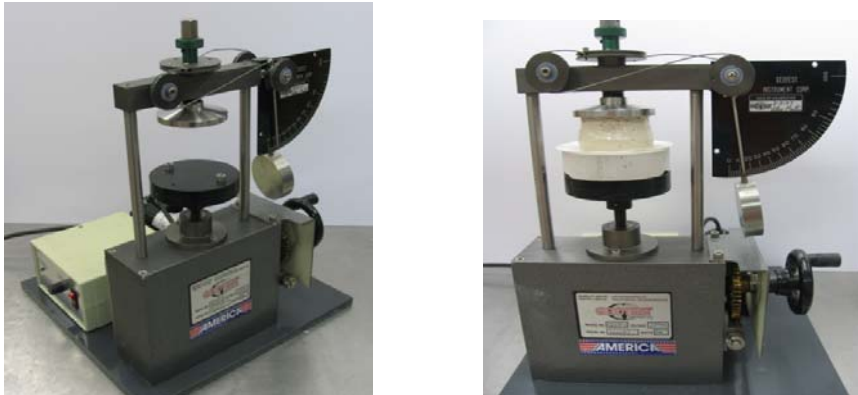
The Emley Test method for plasticity takes into account the force required to lift a weight due to friction of lime putty against a platen. At the same time the puttywater is being suctioned into a gypsum base plate and the time it takes to reach failure is being recorded. The starting materials for Emley plasticity measurement are lime putties of the same consistency slaked directly from quick lime or from putty made from dry hydrated lime [1, 2].

Fig. 1 Emley plasticimeter

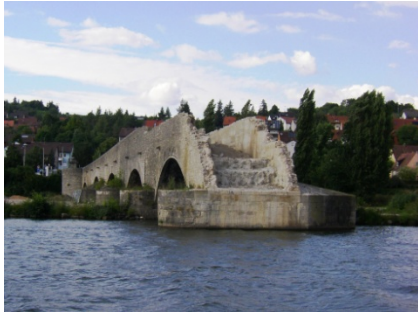
On the northern side of the river two vaults from the baroque period and three arches from the 19th century are preserved (Fig. 1). The baroque arches were built with small rubble material (25x15x30 cm³) and were in a poor condition. Similar

Fig. 1 Northern vaults of the bridge

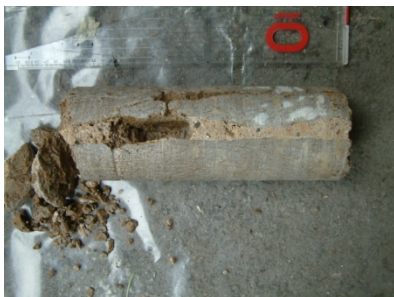
The vaults erected in the 19th century consist of massive limestone ashlar (30x48x60-80 cm³) with thin bed joints. Some of the cores presented a very hard mortar up to a depth of 5-10 centimetres while the material behind was completely frozen (Fig. 3). The loose mortar material was washed out during drilling. Mortar deterioration here was induced by a dense repointing mortar (20th century repair) which retained water in the inner section. Cutting mortar prisms or cubes was not possible in this case but the regular shape of the ashlars allowed the assessment of masonry strength by the bed joint drill core method (Fig.4).

Fig. 3 Drill core with various mortar types

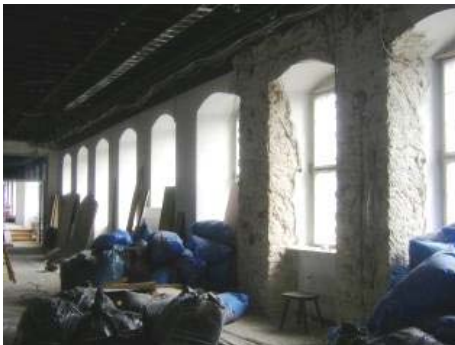
Fig. 8 Baroque masonry pillars

The stone and masonry bond differed throughout the different pillars; tests on stone and mortar lead to an estimation of the masonry strength between 1.1 and 2.3 N/mm², depending on the bond. The elastic modulus calculated from stone and mortar properties and the geometric relations again exceeded the first estimations with values between 8000 and 9500 N/mm² being determined.

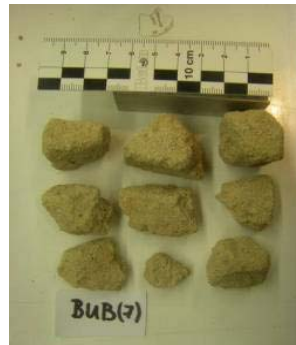
Fig. 9 Mortar samples–inner section

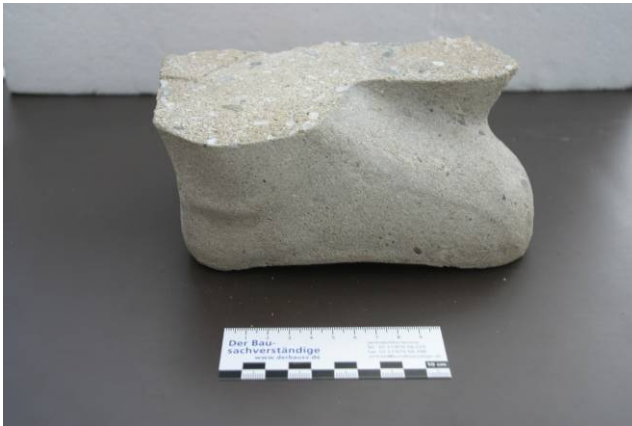
The concrete samples were taken from a separated foot of the cavalier sculpture 12 in row 4. Fig. 1 shows the tamped concrete foot. Investigations with phenolphthalein show a complete carbonated concrete-texture. To describe the binder-aggregate-ratio concrete analyses were performed by acid dissolution and binder separation from aggregates [10]. The chemical composition of the acid-soluble binder was determined for soluble silica. Wet chemical analyses were performed on the acid filtrate for the characterisation of soluble Me_2O_3 , CaO, MgO and SO_3 -ions. The carbonate amount was determined volumetrically.

Fig. 1 Separated foot of the cavalier sculpture 12 in row 4 (VD_M_4_12)

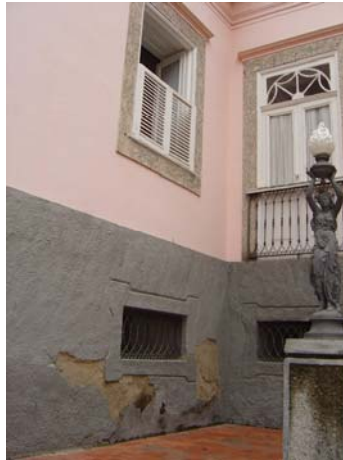
Fig. 2 The deterioration of cement plaster at Casa de Rui Barbosa Museum

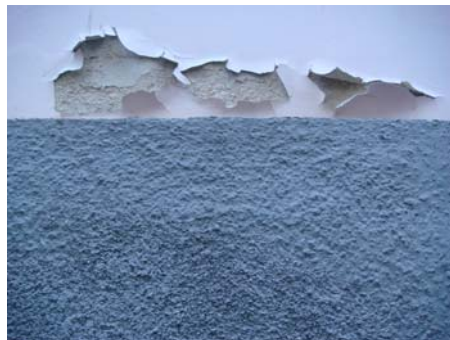
Fig. 3 The deterioration of cement plaster at Rui Barbosa's House

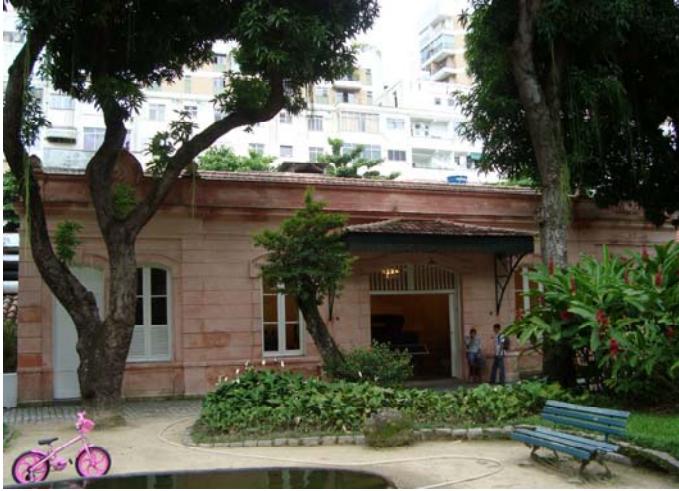
Fig. 4 Stable façade restored with lime plaster two years after the intervention.

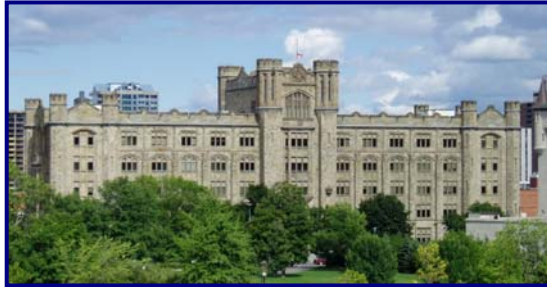
dominated by the lumber industry into "The Washington of the North". The heritage character of this property is defined by the exterior elevations which were designed in the modified Tudor Gothic style. The symmetry of the massing reflects an underlying Beaux Arts layout. Various elements of its architectural design contribute to define the heritage value such as; articulated stonework, buttresses, corbelling, niches, carved embellishments and elaborate window and door surrounds. The wall finish is primarily of sandstone with granite plinth detailing.

Fig. 1 Front façade of the Connaught Building

The building is a seven storey steel structure with a mechanical penthouse above. The steel is encased in concrete with concrete floor and roof slabs. The exterior walls consist of stone cladding, with multiple wythes of brick backup, and terra cotta with plaster on the interior. The stone cladding is of varying thickness keyed into brick backup in various locations. Below the third floor level, the stone exterior is Ashlar Granite, while above this level consists of Nepean and Wallace Sandstones. The scotch work is Nepean Sandstone. The quoins, window surrounds, ledge stones, buttress capstones, and all stone above the roof ledge, such as parapet and turrets, are Ashlar Wallace Sandstone.

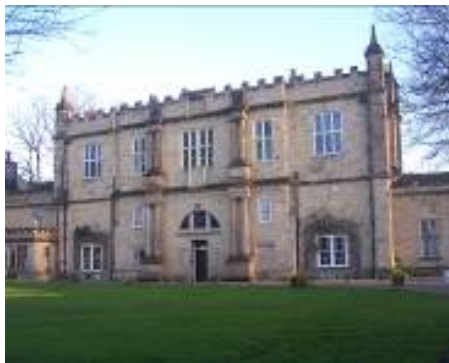
Fig. 2 Subsequently extended 1604 gatehouse of Eure mansion, Malton, constructed using calcareous sandstone, earth mortars and plasters

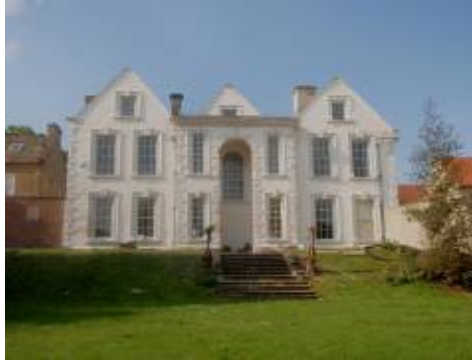
York House (see Figs. 3 and 7) is a high status gentry house set on a wide burgage plot just within the line of the former town wall. Probably built by the Gilbertine Priory, it later fell to the Eure family and was then the Malton residence of Sir William Strickland, who owned much of the town at the turn of the 17th and 18th centuries, among other East and North Yorkshire estates. The current appearance of the house is mostly a result of improvements made by Strickland

Fig. 3 S elevation, York House, Malton. Central range and windows introduced around 1690, using earth and 5% quicklime mortars and hay-rich earth plasters with limestone dust, quicklime and oxhair finish coats over.

Our own burning of local limestones, producing authentic limes for use upon York House (Figs. 3 and 7), confirms this. Both Hildenley and local oolitic limestones generate feebly hydraulic limes of appropriate impurity.

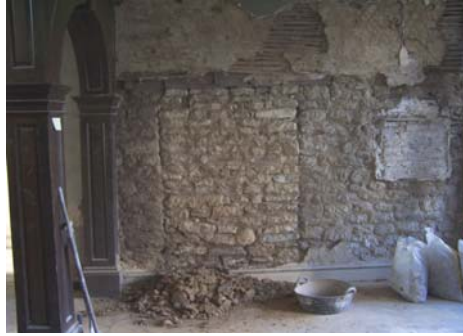
Fig. 4 York House interior, mud-mortared limestone to original wall and late 17thC blocking of original doorway.
