Proceedings
PRO 78

Historic Mortars and RILEM TC 203-RHM Final Workshop HMC2010

Proceedings of the
2nd Conference and of the
Final Workshop of RILEM TC 203-RHM

**2nd Historic Mortars Conference and
RILEM TC 203-RHM Final Workshop
HMC2010**

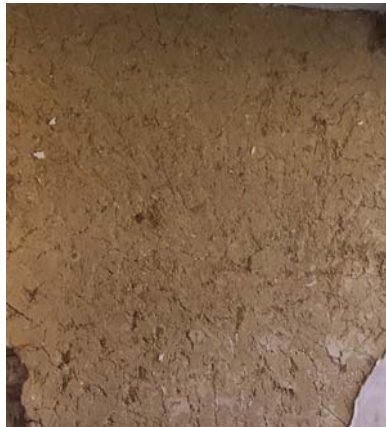
Internally, buildings locally were then plastered with earth plaster, usually in a single coat up to 40 mm thick; a thinner, but typically 4-6mm thick, haired lime finish coat applied over, and limewashed. Earth plaster was always left ‘off the float’, with a smooth finish, rich in fines, even when it was intended as a scratch coat. Whilst a harder, lime rich surface is undesirable in a lime mortar, too much lime migrating, or having migrated to the outer face of the mortar, this is not such an issue with earth mortar, which does not ‘set’ as such, but dries, hardening as it does so. This said, the surface was commonly finished by ‘opening up’ the float for a final pass, leaving characteristic drag lines impressed by any hay or grit taken up by this motion.. The only key that earth mortars seem to have offered were small shrinkage cracks and ‘drag marks’. Although not evidenced on all historic earth mortars locally, initial shrinkage cracking of plaster (of both earth and lime) seems to have been common and of little concern to the masons, so long as this represented a release of surface tension only, and did not announce detachment of the plaster from the substrate.

Fig. 5 York House interior, earth plaster, surface as produced by opening up of float before limestone dust and lime-rich finish coat applied over

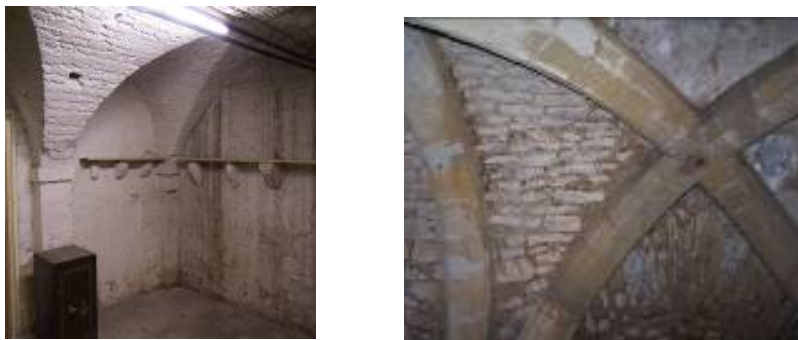
Fig. 6 Cross vault with earth mortared walls and lime mortared vault; 12thC ribbed vault with lime mortared ribs and earth mortared fill illustrating informed and deliberate mortar selections by stonemasons

At least 8 different 'recipes' of earth mortar have been visually identified within York House, and whilst earth mortars throughout town are generally similar, they vary significantly from one building to another, suggestive of there being no consistent 'recipe'. Most buildings in town that have earth mortar also have undercrofts or cellars and the floors of these are usually of or upon the bedrock. It would seem likely, therefore, that much of the mortar used within each building was generated either from pits around the town or else during the excavation of the overburden on site. Within these undercrofts, the mortar of the walls is earth; that of the segmental vaults above, lime mortar the aggregate of which is limestone, with no added siliceous material.

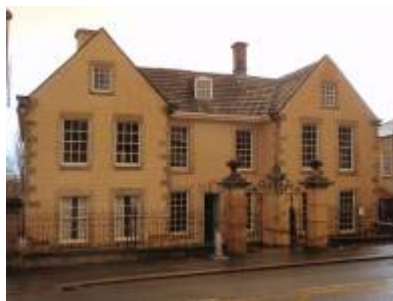
Fig. 7 North elevation, York House, copperas pigmented limewash

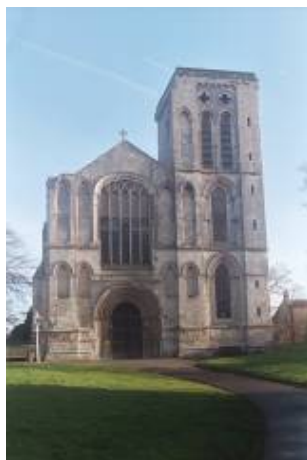
Fig. 8 Old Malton Priory 12thC ashlar bedded in limestone dust/lime mortar;
wall core in earth mortar

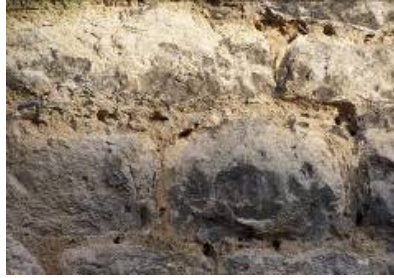
Fig. 9 Mud-mortared limestone exterior, Malton.
 To be limewashed rather than repointed with lime to avoid loss of earth mortar

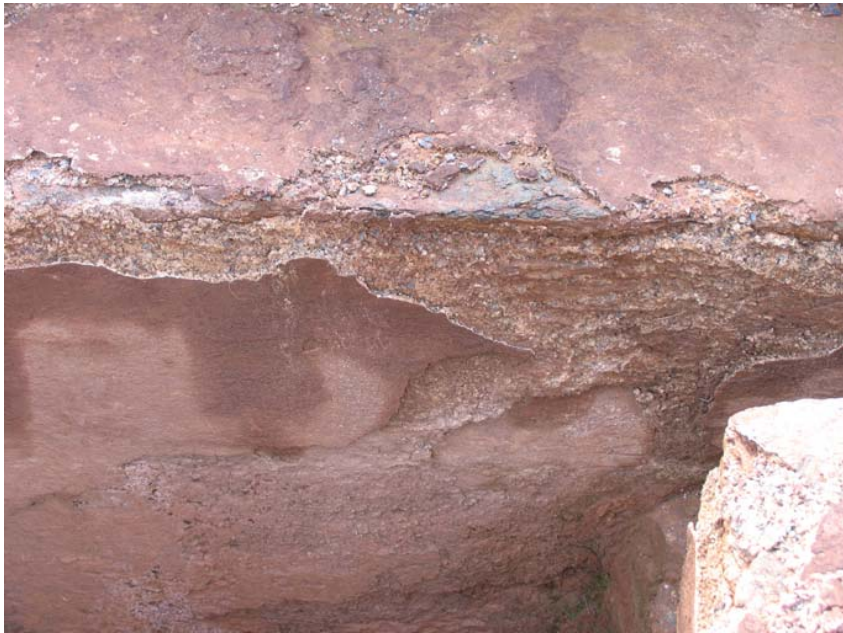
Fig. 1 Plaster at the edges of the floors is most prone to deterioration caused by water ingress.

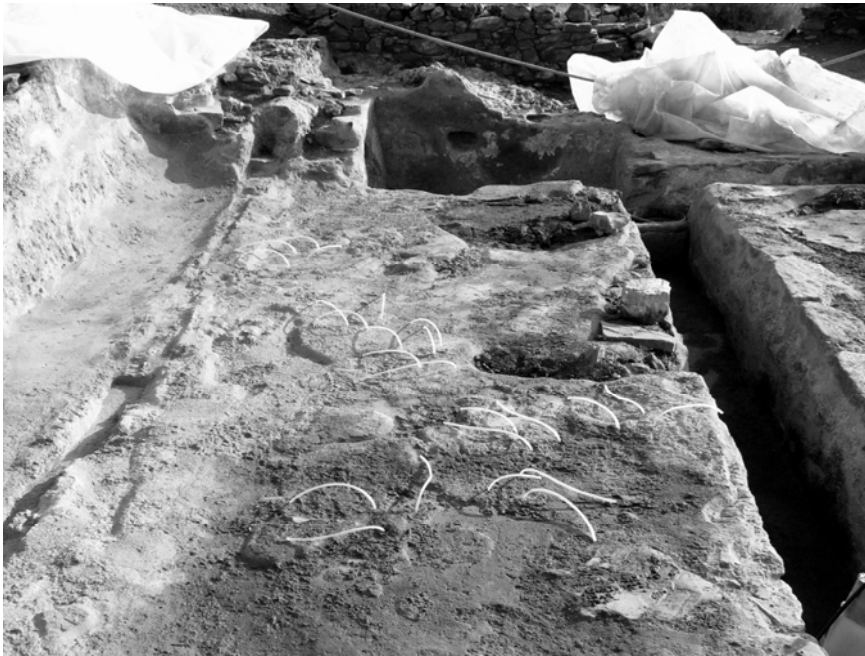
Fig. 2. Washery working floor with remnants of plaster and tailings during grouting

Grouting of internal voids and reattachment of delaminations also required diligent cleaning. A gauze facing was applied to the cleaned plaster surface with a 5-8% solution of Paraloid B72 in acetone in order to avoid cracking and/or bulging. Soil accumulation and debris were removed by aspiration and brushing followed by water spray. Flexible tubes of \varnothing 2-4mm and needles were inserted into cracks or into the sides at different depths and were attached in place with the

pointing mortar (Fig. 2). Grouting was performed manually using plastic syringes which proceeded from the bottom upwards; it was monitored through the tubes, some of which acted as exit holes. A metal strut with revolving head was used over separation layers (rubber, foam and polyester film) in order to apply pressure to the injected area. The grout was mixed in a 5Lt ultrasonic mixer to increase injectability and stability. The tubes were removed 3-4 days after grouting, and the entry/exit holes were filled with mortar.

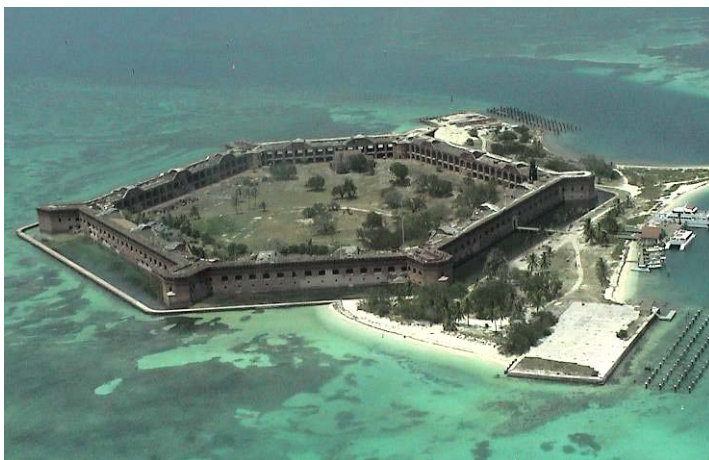
Fig. 1 1994 aerial photograph of Fort Jefferson, Garden Key, Florida. Demonstration phase installation of natural cement-lime mortar was in progress at that time.

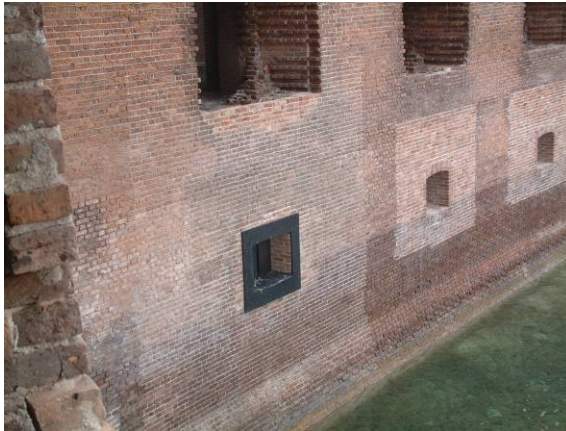
Fig. 2 High lime content, Phase 1 mortars (embrasure openings, at right) were a poor visual match to original materials, which contained no lime. Demonstration phase mortars (left), containing more natural cement, performed and matched better.

laboratory hence erroneously concluded that the binder was a form of lime with clinkered impurities. The project conservator subsequently designed a mortar mix based on high calcium lime putty and beach sand, mixed and ground in a roller pan mill. Natural cement was added as a minor constituent only. Phase 1 construction proceeded with this mixture in 2005. The high lime mortar proved a poor visual match to original materials (Fig. 2) and it performed poorly in the salt-contaminated masonry structure. It was soon damaged by severe exposures that included direct hits by two hurricanes in 2006.

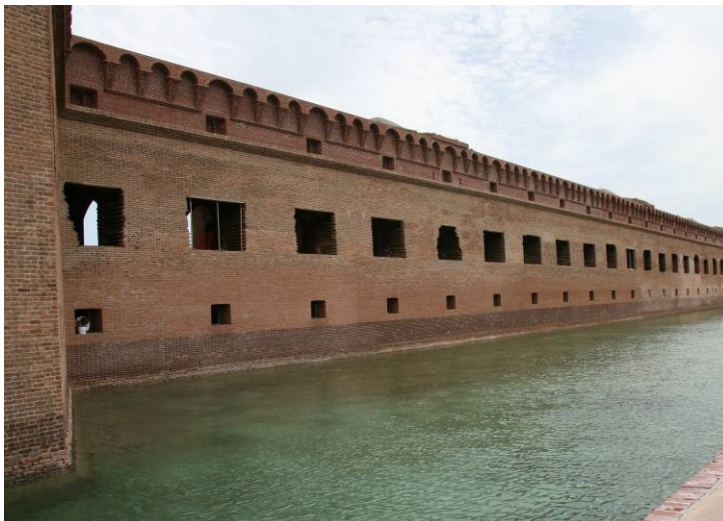
Fig. 3 Phase 2 work fully implemented use of natural cement, providing a "remarkable improvement in the overall aesthetics and virtual seamlessness of the new work abutting to existing work" [8].

Early in Phase 2, new mortar analyses were performed. Utilizing ASTM C1324 petrographic procedures, ASTM C457 Procedure B Modified Point Count method, and ASTM C114 Chemical Analysis, the geologist/petrographer concluded that mortars and coral concrete at Fort Jefferson contained no lime, the binder being composed entirely of natural cement [7]. After protracted conflict, the restoration mortar binder was changed to natural cement. Repairs now blend seamlessly with original materials (Fig. 3).

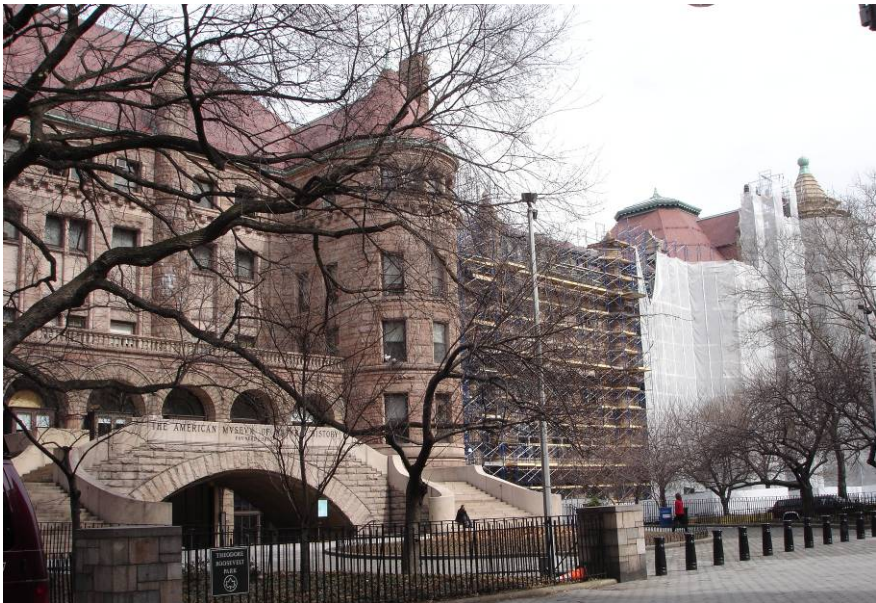
Fig. 4 In 2007, the first phase of masonry repointing was begun at the American Museum of Natural History in New York. The decision to use natural cement mortar was not reached until shortly before work commenced.

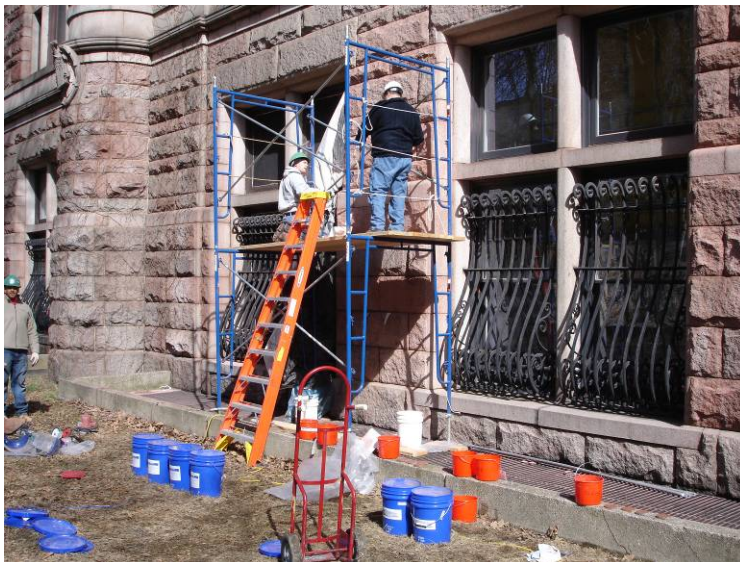
Fig. 6 Masons preferred the workability of natural cement mortars to portland-lime, when both types were installed in mock-up areas.

The final testing was a workability evaluation, performed on site in the Spring of 2007 (Fig. 6). Candidate mortars in several colours, including both portland-lime and natural cement formulations, were installed on the building in a mock-up area. The masons installing the various mortars agreed that they found the natural cement mortar to be more workable. The Museum accepted the subsequent recommendations from the project consultants and reaffirmed its commitment to preserving the building's integrity by using historically accurate materials. Some 20 tons of natural cement mortar were installed over the course of the next 2 years.

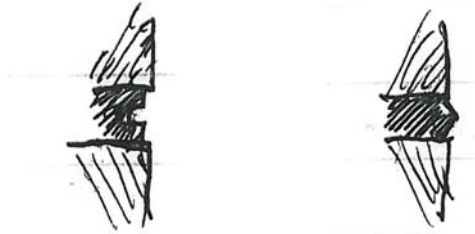
Fig. 2 Tooled/scribed pointing circa 1740(left) Struck pointing circa 1810 (right) (Drawings R.Marks)

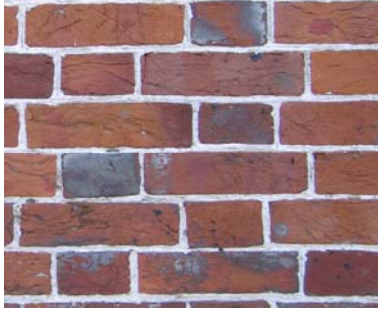
Fig. 3 Mortar joint in situ

Each sample was first inspected visually to look for similarities or anomalies, and then photographed on site before being removed. Care was taken to only remove loose or damaged samples. After samples were taken on site, they were catalogued into the time line matrix to help place them in context. Next, a basic visual analysis was performed in the lab for each mortar sample under magnification with an American Optical Micro Star stereo zoom microscope using a 40x lens. Representative parts of each sample were postured in resin cubes, then cut and polished flat to reveal the mortar in cross section. Observations were recorded in regard to aggregate particles, binder and the visual ratio of the composition, enabling a better understanding of the mortar composition before a more destructive analysis was performed. Most samples were observed to have pieces of quartz, sharp angular red aggregate and long angular gray and white aggregate. The binder matrix was predominately a whitish yellow substance which profusely coated the gray/white aggregate. This aggregate was potentially identified as oyster or clam shells which would have been manually crushed to become aggregate for the tuck mortar. Samples from bedding mortar did not have

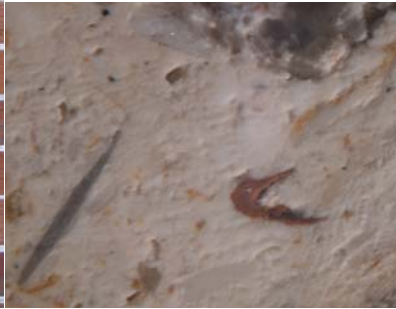
Fig. 4 Mortar in cross section

After completion of this visual analysis and a few tests using 31.45% hydrochloric acid, it was observed that most of the sample was digested, leaving little or no aggregate. It was felt at this point that the shell was present in large enough quantities to be essential to the final replication mortar. It was determined that standard acid digestion procedures would have to be altered to best uncover the original mortar mixture. Attempts were made with some samples to gently crush the mortar and clean the aggregate of its lime binder. This proved difficult without some re-agent to dissolve the lime. Finally, an attempt was made to stir the sample in a beaker which held a mild vinegar solution (5% acidity). The entire procedure was monitored under magnification to determine the level of attack by the vinegar on the aggregate. When the aggregate was suitably clean, the vinegar was filtered and the aggregate rinsed with water. The shell aggregate could then be weighed free of most of its lime binder.

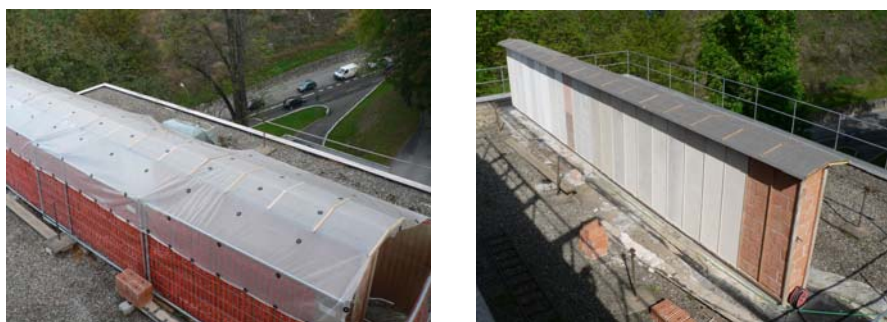
Fig. 2 External masonry brick wall showing the protective covering (left side) and the different coatings (right side)

An external masonry brick wall, 12 m long, 2 m high and about 0.43 m large, with a little roof, was constructed on top of one the buildings of the campus (Fig. 2). The 9 mixes were applied by casting with the trowel, covering a surface of 2 m² facing south and the same surface facing north. After dampening down the wall, a thin first coat of about 5 mm, and two other coats of about 6-8 mm each were applied either after one or two weeks or after the “right” maturing time. The surface was finished by floating on and pressing back the coating, using a wood

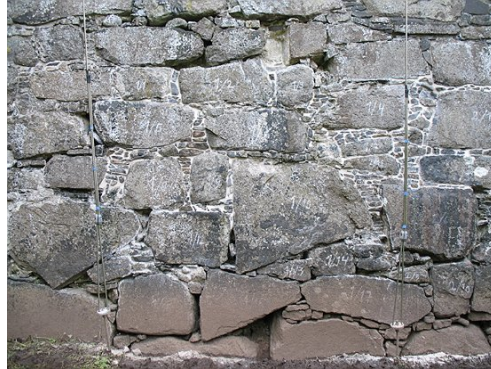
Fig. 2 The walls of the cathedral are made of irregular basalt boulders. The cavities in between are filled with smaller pieces of rock held in place by the mortar. Test area for restoration on the north side of the north wall

In the summer 2007 three test areas were established on the north side of the north wall (Fig. 2). Each area is approximately 2.0 x 2.0 m, located 1 m above ground level. The facade is little exposed to wind and sun, so this part of the monument is protected against the natural drying and wetting cycles. Two types of premixed lime mortar were used for the joints, one with lime putty matured for

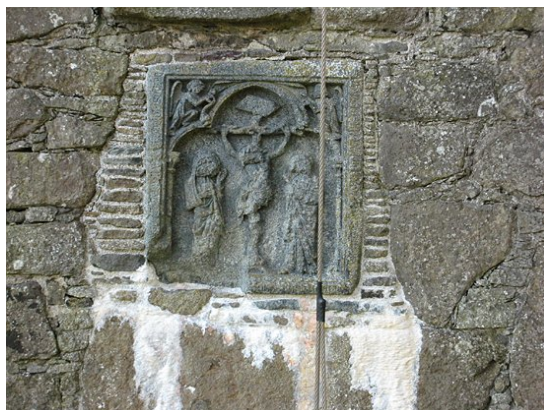
Fig. 5 The lime deposit below the relief on the east wall has leached from the lime mortar used for the joints.

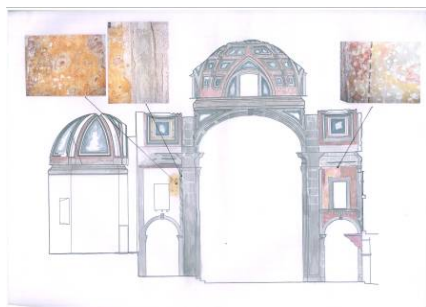
Fig. 7 Mapping of the polychrome studies conducted on various vertical projections and the main dome.

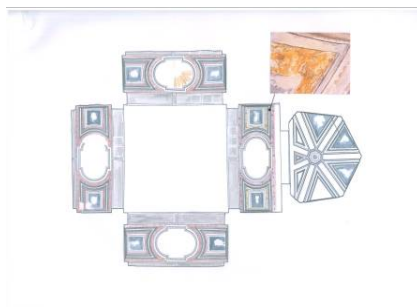
Fig. 8 Mapping of the polychromatic gamut on the lateral dome vaults.

The principal cause of deterioration was an excessive accumulation of water coming from various sources and in various forms, most notably as rain-water infiltration, excessive humidity and condensation (Fig. 8).

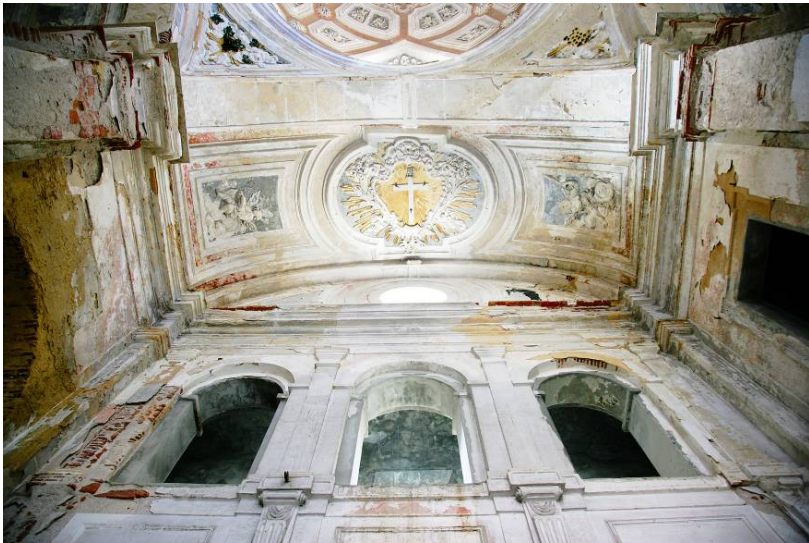
Fig. 9 Degradation observed on the decorative layers.

Beyond these, a number of other problems were identified, the greatest among them being the presence of oxidized metallic elements used in the fixation and support of the decorative elements in plaster; deterioration of these had resulted in fissures and fractures in, and the breakdown and detachment of the plasters. The presence of early restoration mortar containing Portland cement, was equally detected in various regions of the church, as were multiple paint-over's covering most of the decorative renderings, thus hiding the beauty and form of the original decorative work and contributing to their aesthetic degradation and deterioration. In this way, the principal anomalies observed in the renderings were: saline efflorescence, loss of cohesion, loss of adherence, detachment, open gaps, generalized dirtiness, painting over and previous interventions (Fig. 9, 10, 12).

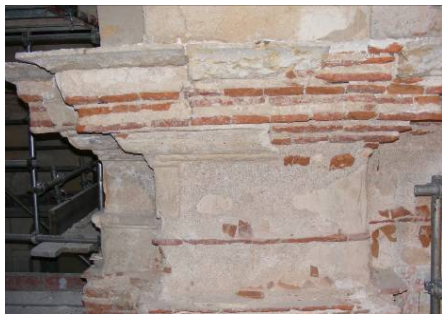
Fig. 10 Detachment of the mortars, showing the brick structure.

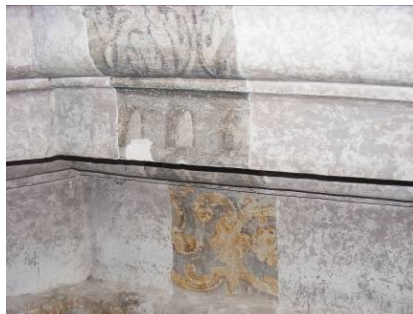
Fig. 11 Juxtaposition of finishing, mural painting and whitewash over the original render.

Removal of the juxtaposition of inadequate layers of whitewash and mortar – through mechanical means (chisels and mallets, scalpels, fibreglass pens and precision equipment in the areas with the most adherence, such as micro drills and vibrating pens).

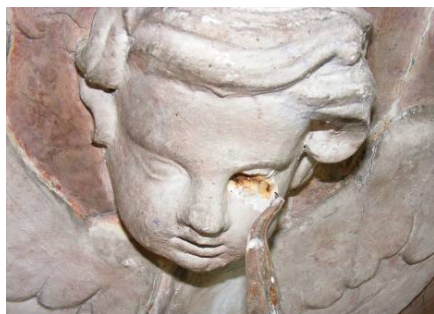
Fig.12 Oxidation of the metallic structural elements

Treatments of oxidized elements – Elements destined to be restored rather than replaced were treated with a rust converter; elements that could not perform their function were removed due to excessive deterioration, and those that retained a function were replaced by fibreglass.

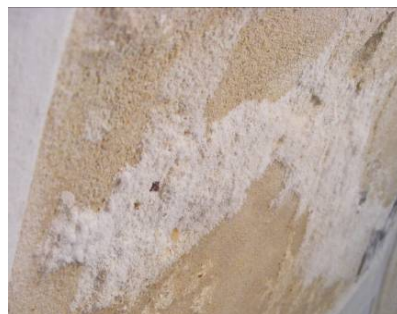
Fig. 13 Presence of salt and concretions

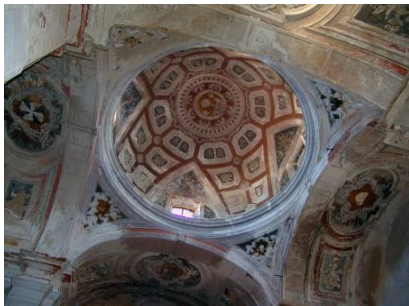
Fig. 14 Before restoration

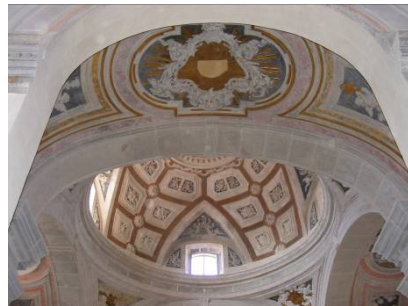
Fig. 15 After restoration

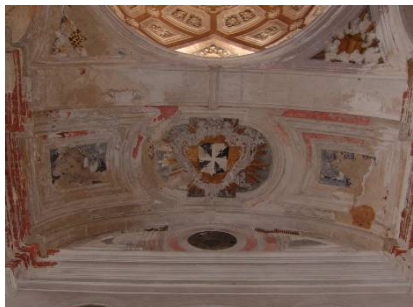
Fig. 16 Stuccoes before restoration.

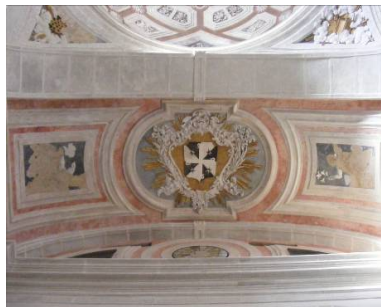
Fig. 17 Stuccoes after restoration.

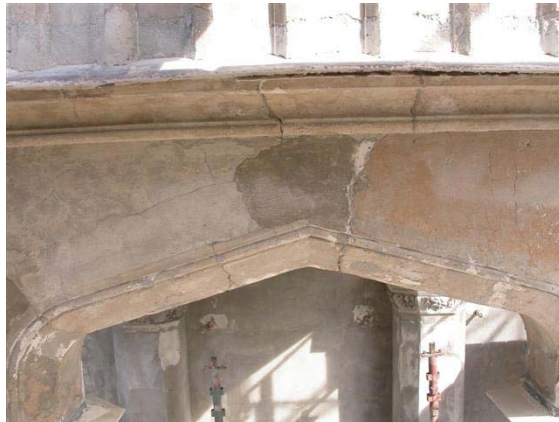
Fig. 1 Several different old cements with variable colours

Further more there are indications in the archives and on the walls that PC was not proving an easy material to work with [3, 4]. Imperfectly smoothed render can be seen as well as ongoing repairs performed whilst the building was still under construction (the PC binder matches but the colour varies). This situation was not helped when the Royal Bursar managed to take control of the project [5]. He ordered the use of a cheaper and lower quality PC and forced the work to continue into winter to reduce the cost [6]. Consequently deep cracks appeared in the render as a result of poor application, low quality materials and failure due to the harsh weather and exposed position of Oscarshall.

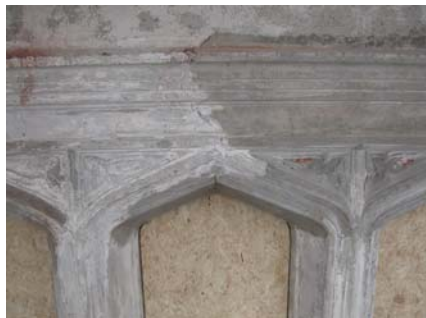
Fig. 2 The lime/cement repair seen on the left side and the original grey cement seen on the right.

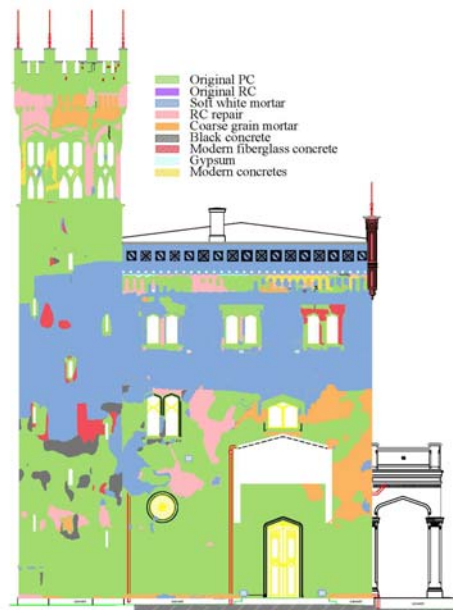
Fig. 3 All render above the 2nd floor and parts of the tower was probably exchanged in 1909-1913. Large parts of the corbel table had recently been exchanged with copies made of gypsum. The mapping is based on a visual investigation without analyses of the different repair mortars.

As soon as the walls were cleaned the mapping of materials and damage could start. The repair materials range from: hard, dark and grey to soft, light and white, often done without clearing off the old paint or addressing any underlying problems. The cleaned facade was mapped out by visual inspection, scientific analysis of removed sections and physical investigation using a hammer to sound walls and open up specific spots. This process also allowed for better forecasting of the extent of repair.

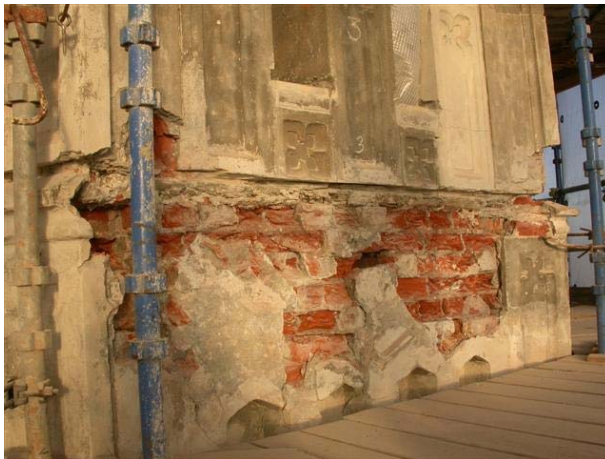
Fig. 4 The damage on the bricks underneath the open walkway in the tower

There is little sign of salt damage to the brick core but massive areas of spalling behind and below damaged or cracked render do occur.

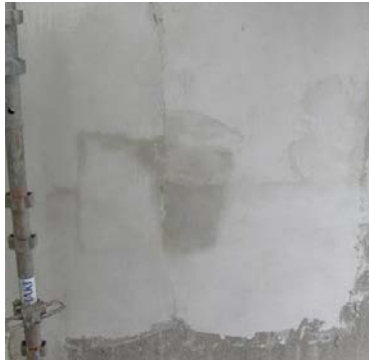
Fig. 5 The challenge is to hide the "ghosts". Here trying out different finishes.

Another problem was ghosting, caused by the difference in hygroscopicity between the mortars. This was and still is, highly visible after rain. Solution of this problem could either come from within the application of the fine coat or the paint systems over it.

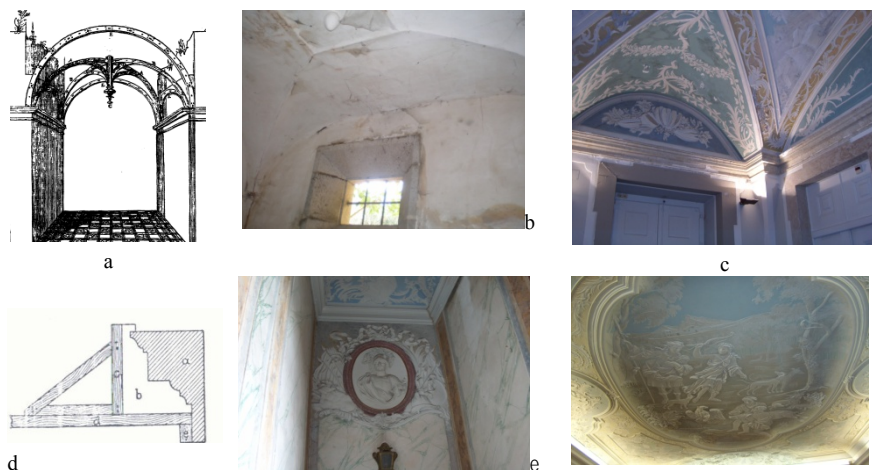
Fig. 1 a) Wooden vault structure of support of a plastered ceiling (De l'Orme, 1561); b) Ceiling of Chapel Sacristy, 16th c., Aveleiras House, Torre de Moncorvo (2008); c), e), f): Plasters of Pombal Palace, Oeiras, 18th c. d) Running mould for the execution of interior cornice (SEGURADO, J, 1949).

was to use plastered lathwork (Fig. 1a). The lathwork was fixed in a wooden structure composed from a double stave of wood tied with wooden pins to form the skeleton of a vault formed from the intersection of ogival (gothic) arches [1].

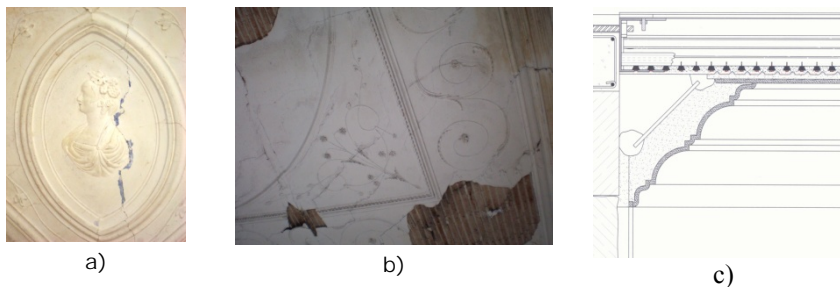
Fig. 2 a) Decorative plasters, in the “Adam Style”, of English influence; b) cracking and unfastening of parts of the plaster; c) repair suggestion of plastered ceiling (CAVALHEIRO Photos; 2007)

The anomalies presented in this chapter were identified in a case study of the early 19th century decorative ceilings of the main floor of Guerra’s House (of Aveleiras), in Torre de Moncorvo [5] (Fig. 2).

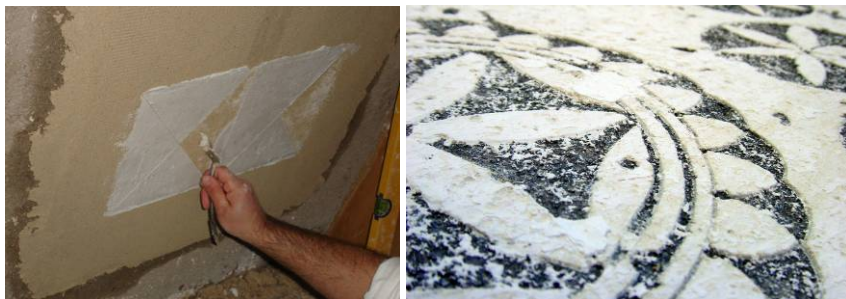
Figs 6 and 7 Doing a sgraffito in Mértola, a black and white sgraffito in Sabugueiro (Arraiolos)

The colour of sgraffito stands out, especially, due the effects of light-dark obtained by different textures and shadows. The result is an expressive plastic game of “*chiaroscuro*”. This technique links both drawing and painting skills, and also requires a deep knowledge of plasters.

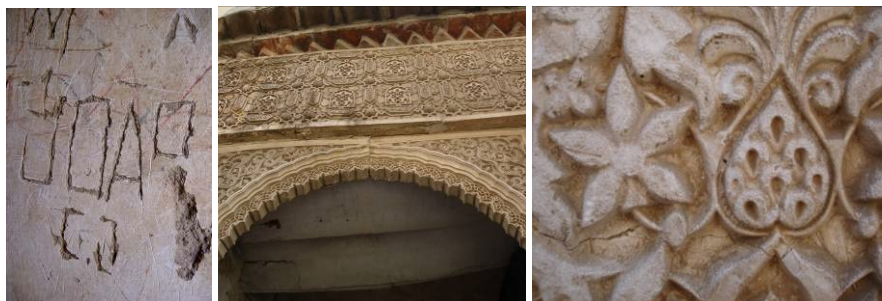
Fig. 8 An example of graffito technique produce by vandalism; **Figs 9 and 10** Yeserias in Alhambra, Granada, Spain.

Since the sharp tool used in graffito's technique (Fig. 8), when pressed against the surface causes a furrow with a certain depth and, consequently, produces waste material that is removed, makes this technique resembled to sgraffito. If the wasted material resultant from both processes is valued as the predominant feature, both techniques turn out to be very similar, namely when its origins is in question.

Leopoldo Torres Baldás [8] relates the Moorish “*yeserias*” (gypsum plasterwork) work with the concept developed in Sassanid Persia. In both cases the works made from gypsum, when not produced by moulding, were manufactured with fresco technique. In this sense, the gypsum was cut with a bevel or chisel in order to carve a relief decoration. The similarities between this technique and sgraffito are clear although “*yeserias*” allow a more complex decoration (Figs. 9 and 10).

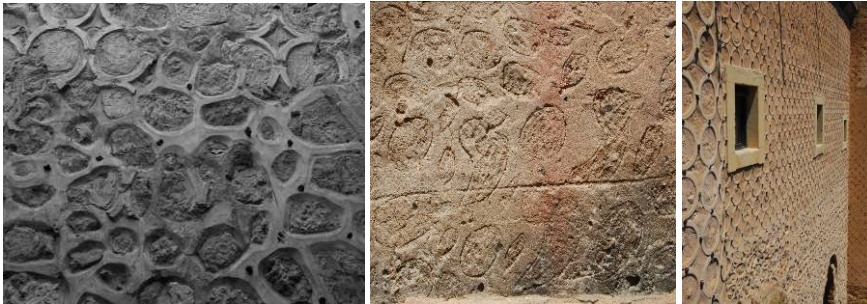
Fig. 11 The effects of the plaster work on joints in a non-plaster masonry walls. This could evolved towards sgraffito; **Figs. 12 and 13** Sgraffito in Segovia, Spain

Another hypothesis, traditionally formulated by Segovian scholars, is that sgraffito is the result of the evolution of plaster work on joints on masonry walls. This joint work (with distinct aspects whether it was salient, plain or re-entrant) is named in Castilian as “*rejuntado ou encitado*”, meaning the effects of joints in non-plastered masonry - jointed or seamed (Fig. 10). Such definition is used for the portion of mortar which seals and fills spaces in brickwork or masonry joints. This mortar has functional purposes; however, it can also be ornamental, for instance, when it is modelled in high-relief.

Another aspect that led us to the same conclusion is the fact that, in many joints, a bit of mineral slag is applied on the mortar while it is still fresh (Figs. 11 and 13). Such operation diminishes the risk of cracked mortar in these joints. Visually, there are many resemblances between this technique and those found in primitive Segovian sgraffiti, where the use of a slag can be seen today.

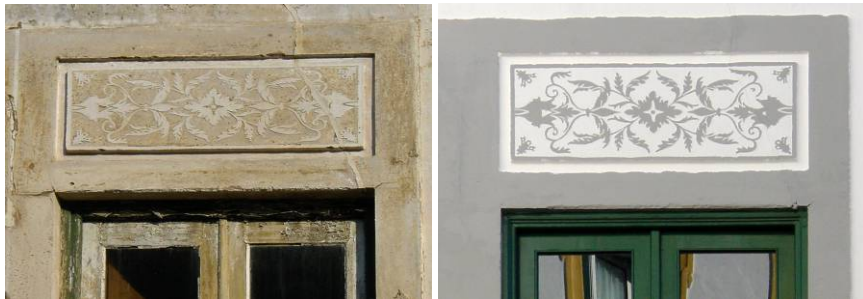
Figs.17 and 18 Évora, before and after the intervention (it was applied a painting layer that inverted the syntax's)

to cultural heritage values, to the undervaluation of sgraffiti and to the insensibility of players. The application of (re)painting layers invert the syntax's (what was dark becomes whitish, what was whitish becomes a new and often stronger coloured) causing loss of the building aesthetical and historical values and, ultimately, loss of authenticity (Figs. 17 and 18).

For example in Évora if the building is in bad conditions of conservation with the risk of collapsing, regulations may allow demolition and rebuilding of the whole façade. Moreover, in case of intervention on the protective layer of a facade, painting is often proposed as a solution, instead of a lime wash. This solution is also applied to sgraffito and other decoration plasters (Figs. 17 and 18).

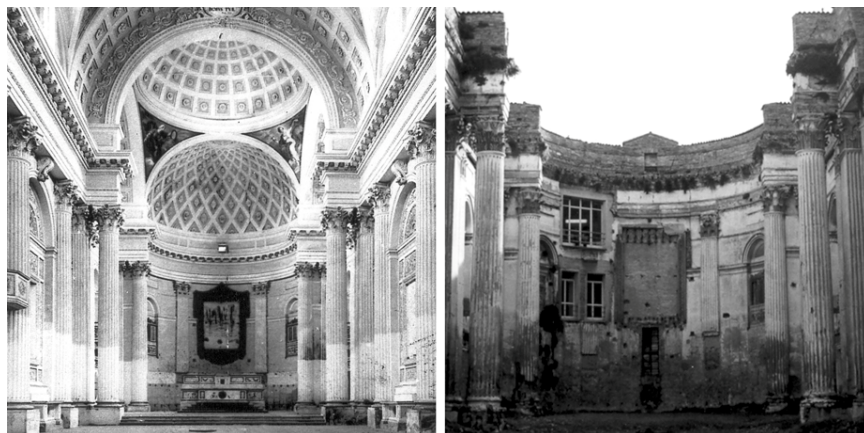
Fig. 1 The church before the roof demolition (left) and in 2002 (right).

The church of San Francesco in Fano, completed around 1323, was originally covered with trusses. In 1840 a restoration campaign was undertaken to repair the structural and aesthetic degradation effects on the church. New masonries were erected over the medieval ones, a new barrel vault was built and a completely new, neoclassical decorative apparatus was added to the interior of the church (Fig. 1, left). In 1930, as a consequence of several seismic events, the roof and the masonries erected in the 19th century over the medieval walls were demolished [9] and, since then, the church has been permanently exposed to meteorological and environmental agents (Fig. 1, right).

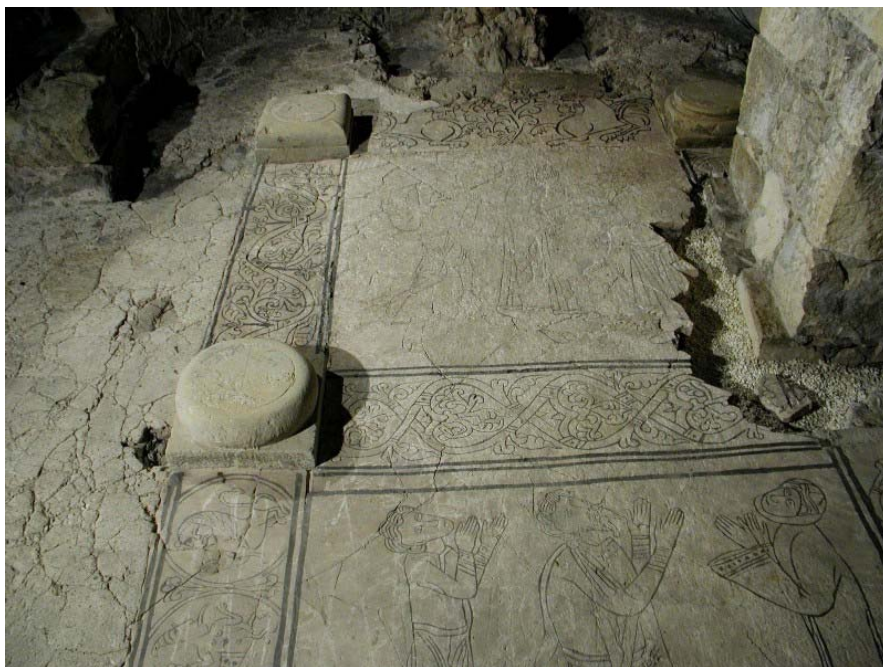
Fig. 1 Estrich gypsum floor in the crypt of first Romanesque church.

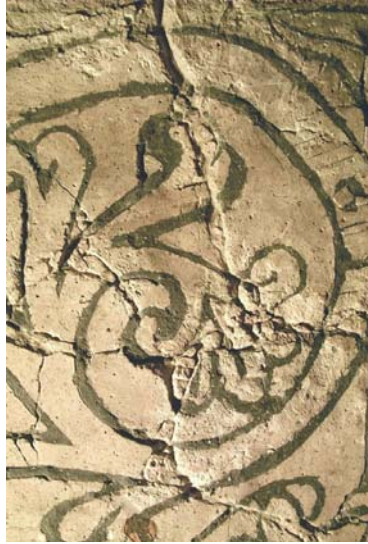
Fig. 2 Fragment of the engraved gypsum floor.

As noted above, cleaning the small chips was problematic. In order to prevent their replacement or loss, the cleaning procedure was combined with the procedure of fixing these chips to their original location. One after another, the chips were cleaned and immediately set in their places.

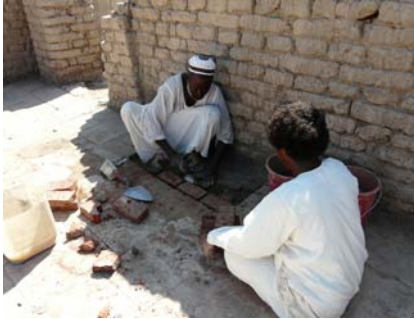
Fig. 3 Laying bricks in a missing area of floor

With a small team of workmen to train, a missing section of sandstone floor was the first area selected. The intention was to fill the missing area with fired bricks. Sand and soil were removed and the area levelled to allow for a bedding mix and a brick depth to be laid. The area was well-damped and the bricks soaked to avoid rapid drying of the bedding mortar. It was imperative to plan the activities of the day. When possible, work was carried out in shady areas and in the coolness of the early morning. It was important to avoid working in areas directly under the midday sun and it was essential to keep the lime mortar work covered with tarpaulins. This allowed the mortar to cure slowly and in a controlled way. Retaining the moisture in the bricks and mortar assisted the pointing (Figs. 3, 4). Other trial areas followed a similar practice and approach; bedding with combinations of lime mortars; raking out and removal of excess soil; pointing. For the wall capping and brick column, a render was applied to cover the top of the new bricks (Figs. 5, 6).

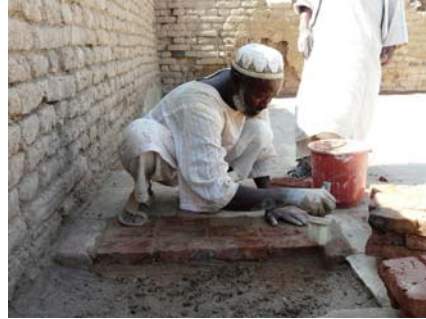
Fig. 4 Pointing the bedded bricks

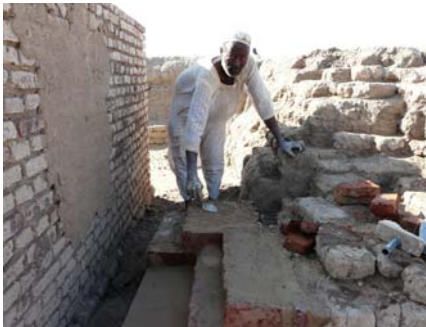
Fig. 5 Applying lime render to brick capping

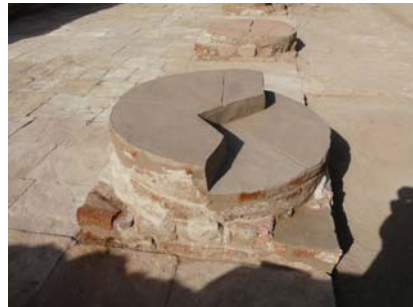
Fig. 6 Finished lime render on column

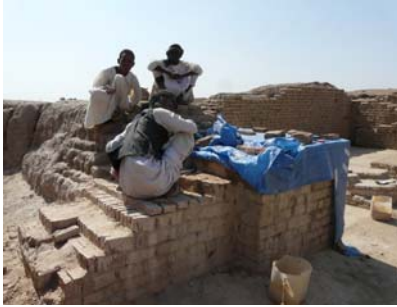
Fig. 7 Failed render to lower area of wall

In November 2009, a two-week visit allowed for the evaluation of the previous year's work, to continue the trial areas and to adjust, if necessary, the methods and treatments. Regrettably, there had been some failure of the previous year's trial areas. The lime renders to the brick wall capping and the brick column had been washed away by seasonal rains (Figs. 7, 8).

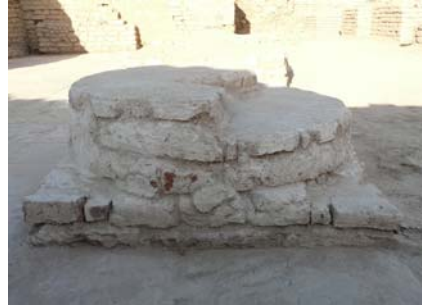
Fig. 8 Failed lime render to brick column

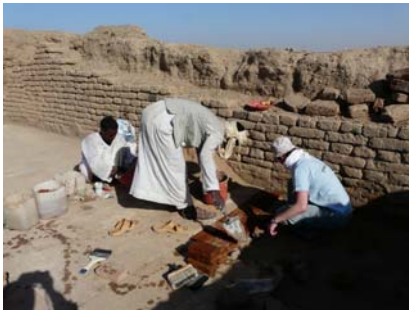
Fig. 9 Brick infill of sandstone floor, 2009

The two areas of brick infill to the temple floor were successful and had withstood the rain of the previous season. Perplexed by the failure of the lime mortar, a sample from each of the various limes purchased in 2009 was retained to be analysed on return to the British Museum. It was hoped these analyses would give an indication of the lime content in the mortars being used. As in the preceding season, purchasing lime appeared to be a lottery, when one bag transpired to be a casting plaster. Three further areas were chosen to continue the work of the previous season; a larger, missing area of the temple's sandstone floor; a staircase; and another area of wall capping (Figs. 9-12).

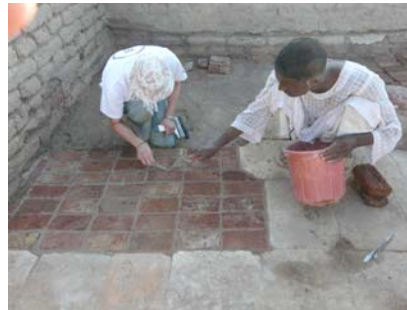
Fig. 10 Pointing brick infill to floor, 2009

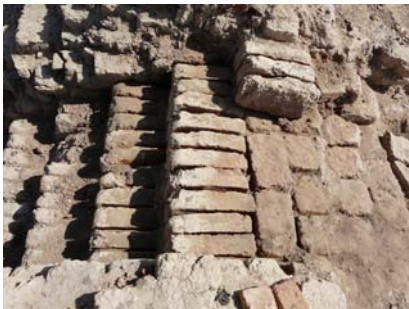
Fig. 11 Top of staircase, 2009

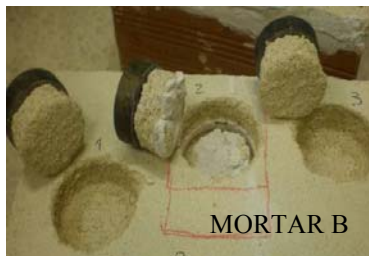
Fig. 5 Specimens after pull-off test, showing grout mortar B in the central section

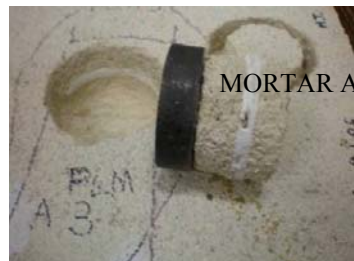
Fig. 6 Grout mortar A in the core removed from the pull-off test.

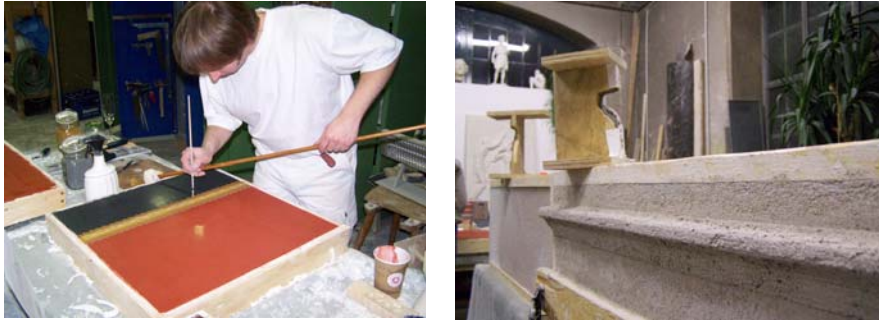
Fig. 1 Workshops for the experimental reconstruction of antique roman plaster-techniques at the studio for stucco-works at the Akademie der Bildenden Künste in Munich (Photo: Kilian)

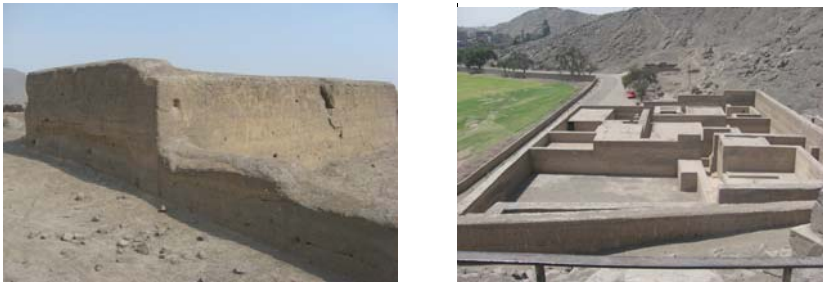
Fig. 6 a) Mud wall in Cajamarquilla, Lima. b) Mud wall and adobe construction, Lima.

At this stage the mortars start to use in mass to form large masses, these casts were forming the large brick adobe or mud wall. The use of mud walls were reported in the construction of the great cities and ceremonial centers, its use was widespread in the last stage before the Spanish conquest and his technique is still in force in the Peruvian Andes. We know that building with adobe blocks involved the manufacture of molds and *brick mold* [3]. To shape in the same building site, compacted clay was carried out with blows of a wooden hammer, getting a good height walls, and straight and sufficiently earthquake resistant stability. The walls apparently had a relationship width: height to 1:3, and generally trapezoidal section which gave it good stability. You can verify that at this stage is a more technical use of clay mortar as a building material.

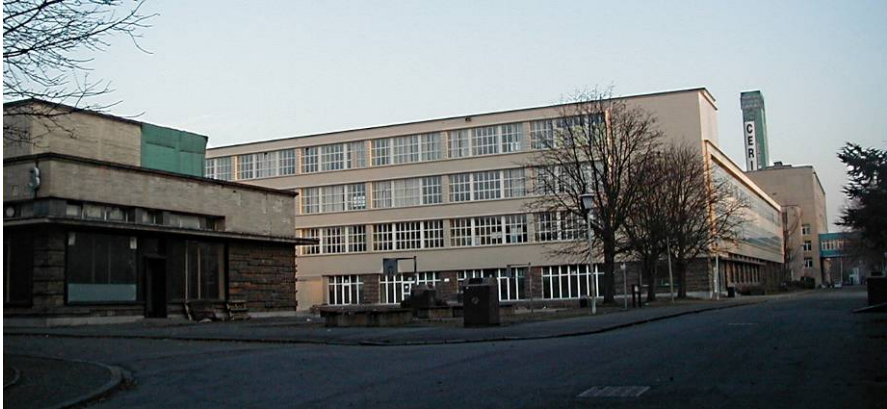
Fig. 1 View on some buildings of the COOVI/CERIA complex

The name of the study object in this paper is COOVI/CERIA. These are the Dutch and French abbreviations of the full name of the complex, namely the Centre for Education and Research of the Food Industry. It consists of many buildings, grouped in a green area. The buildings are characterized by horizontal lines (Fig. 1), with one main exception, the tower.

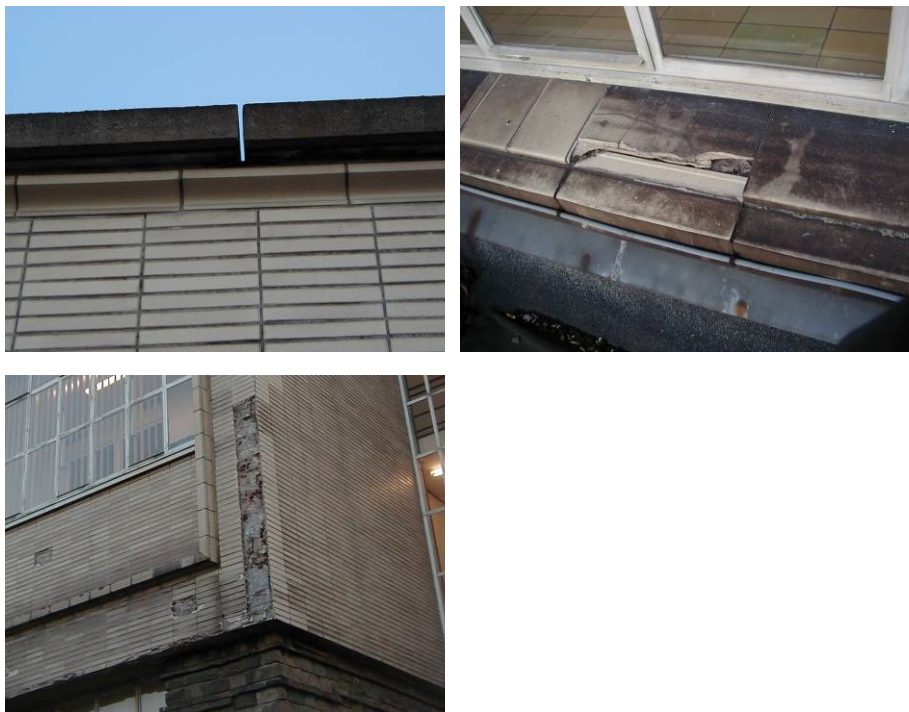
Fig. 2 Different risks for water infiltration: missing joints between covering stones (top left), defects in window sills (top right), missing tiles (bottom left).

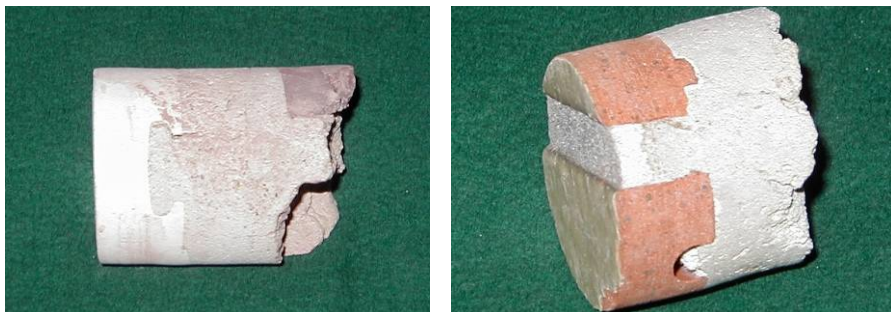
- The tiles exist in two versions. One version is a tile that is coloured in the mass (Fig. 3, left). These tiles have a kind of ‘hook’ on their back, which serves as an anchor in the bedding mortar. On later buildings on the site, the tiles seem to be red on the inside (Fig. 3, right), with a thin coloured glaze on top of the tiles. Both type of tiles seem to have a good resistance to degradation, the tiles are in very good condition.

Fig. 3 Two drilling cores from the facades. On the left a drilling core with tiles that are coloured in the mass, on the right a core from a façade with tiles with a superficial colouring. Note the mechanical ‘hooks’ on the back of the tile (left photo) that ensure a good mechanical adherence. Also note structure of the façade on the left photo, with from right to left the structural masonry (a part of a brick is visible), the bedding mortar, the tile. On the right photo also the pointing mortar between the two tiles is visible.

From the technical point of view, an adaptation of the repair mortars was even more necessary. Because of the lack of the anchor at the back of the new tiles, the adherence of the tiles to the façade might come somewhat problematic with the original bedding mortar. Moreover, we know that water infiltrations inside the façade can be reduced seriously, but it cannot be stopped (because of the lack of dilatation joints, causing cracks between tiles and pointing mortar). And we know that the presence of the cement-bound pointing mortar was one of the causes of

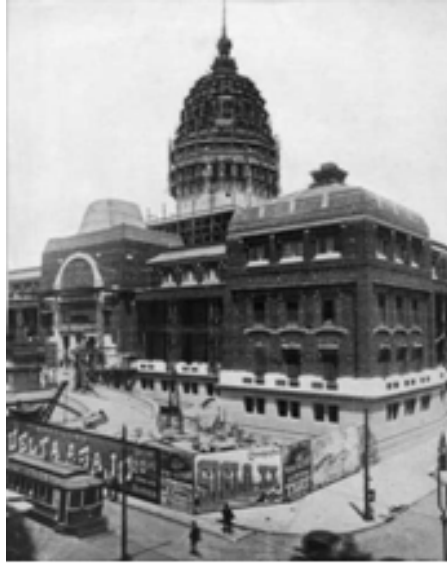
This building of the palace of the congress was declared Historical and Artistic National Monument in 1993. The building possesses a socle of 6 meters in height composed by granite from Uruguay. The rest of the components are about 75.000 limestone tooled stones from the province of Cordoba (centre of Argentina). Fig. 2 shows the facades of the National Congress without the stone cladding.

Fig. 2 Façades of the National Congress without stone cladding

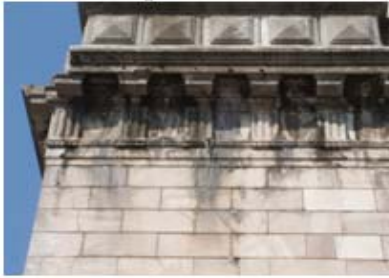
Fig. 3 Black crusts on stone

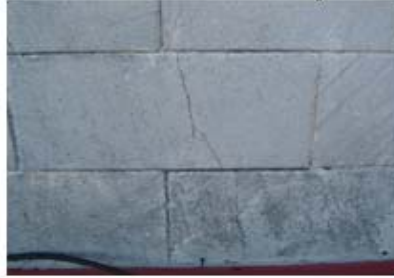
Fig. 4 Fissures in stone cladding

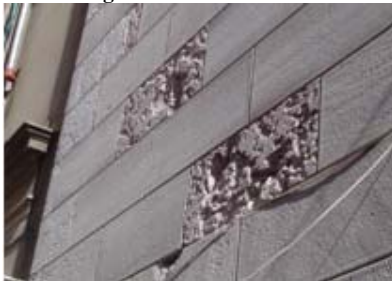
Fig. 5 Superficial deterioration

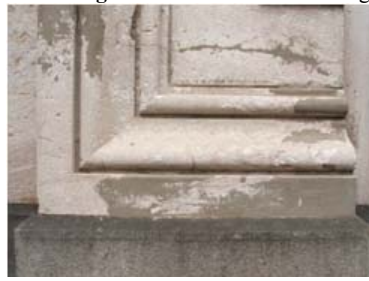
Fig. 6 Previous repair mortars

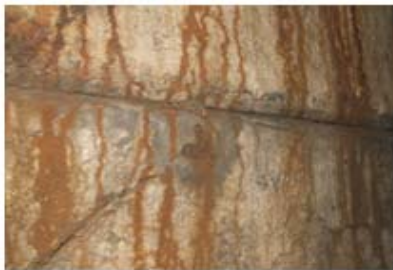
Fig. 7 Stains of oxide

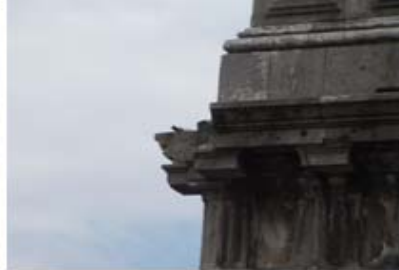
Fig. 8 Missing elements of decoration

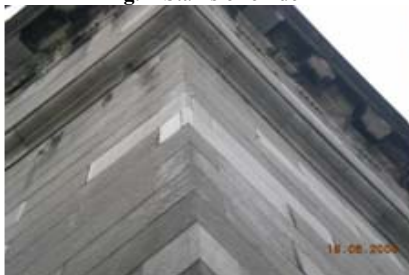
Fig. 9 Replaced stones

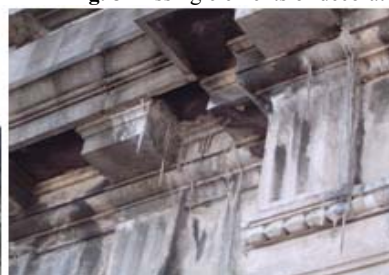
Fig. 10 Deposit of salt

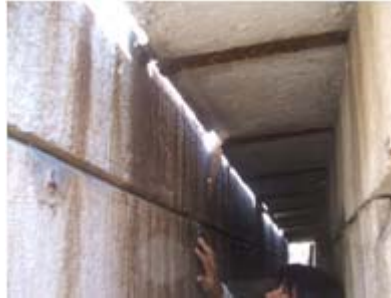
Fig. 12 Equidistant metallic elements
