Proceedings
PRO 78

Historic Mortars and RILEM TC 203-RHM Final Workshop HMC2010

Proceedings of the
2nd Conference and of the
Final Workshop of RILEM TC 203-RHM

**2nd Historic Mortars Conference and
RILEM TC 203-RHM Final Workshop
HMC2010**

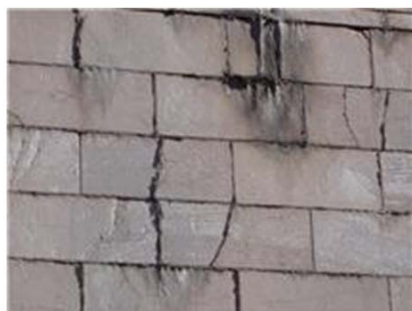
Fissures in stone cladding are of two types. Small slabs present vertical central fissures due to constructive problems (Fig. 16). On the other hand, big slabs, located in the upper rectangles and ornamentation, show fissures that follow the original rock structure (Fig. 17).

Fig. 16 Fissures due to constructive problems.

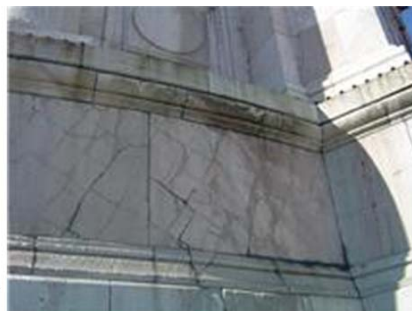
Fig. 17 Fissures that follow the original rock Structure.

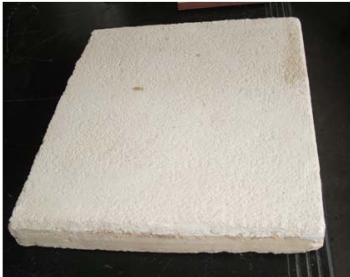
- 1) Repair Mortar (company: Tarquini), Figs. 18 and 19. Composition detailed in point 6.

Fig. 18 Specimen with substratum for adherence, resistance to the impact and permeability to rain water.

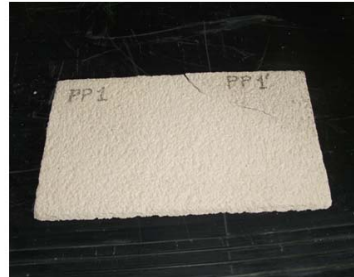
Fig. 19 Specimen without substratum for absorption test.

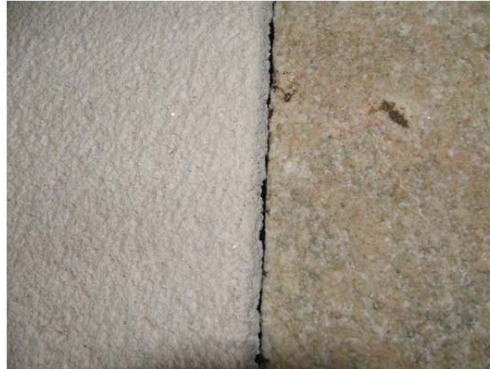
According to the laboratory test programs, compatible texture and colour of stone and mortar was achieved (Fig. 21).

Fig. 21 Repair mortar (left) versus original stone (right).

An important difference of absorption and superficial hardness between mortar/stone exists. We have suggested to the producer of the mortar to modify the capacity of the water absorption.

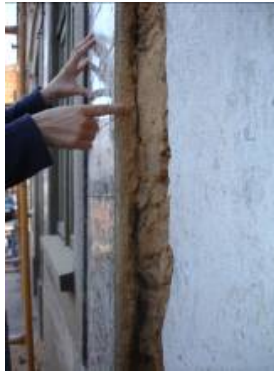
Many glazed tile panels suffer from detachment, as shown in Fig. 3. This may happen in the tile/mortar interface, in the mortar/wall interface, or between different mortar layers. Often this type of degradation is associated with areas exposed to water (capillarity, tubes), and its main cause is the differential behaviour of the materials that compose this system, in terms of hygric expansion. The lack of joints and the crystallization of soluble salts also contribute to this occurrence.

Fig. 3 Detachment of ceramic tiles and mortar

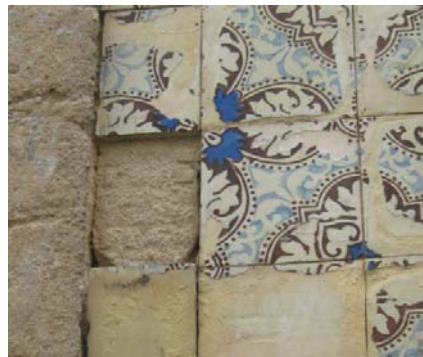
Often a façade only lacks a few ceramic elements (Fig. 4) due to differential behaviour of wall components, as explained in the above section. However, this is a starting point for quick degradation caused by increased water uptake at these locations and the impermeability of the tile cladding.

Fig. 4 Lack of ceramic tiles

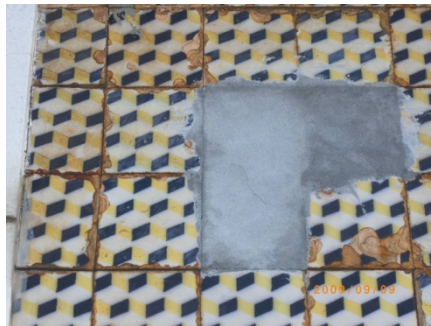
Due to the frequent loss of ceramic elements from façades, there is a need to fill the empty spaces, and often there are no similar ceramic pieces readily available. It is quite common to find these spaces filled with cement mortars, which behave differently than the rest of the panel (Fig. 6) and contain soluble salts that may cause further damage to the façade.

Fig. 6 Filling in of space left by tiles with a cement mortar

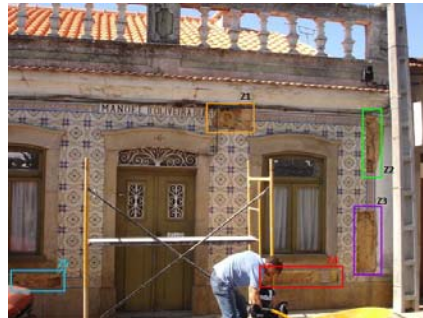
Because of their specific function, mortars applied in this system have particular requirements that must be taken into account and encompassed in the general requirements for conservation mortars [5]. However, this may only occur after thorough investigation of the applied materials (Fig. 7) and the adjustment of existent testing procedures [6, 7], such as water vapour permeability test, as seen in Fig. 8.

Fig. 7 Sampling of tiles from façade – sampling areas

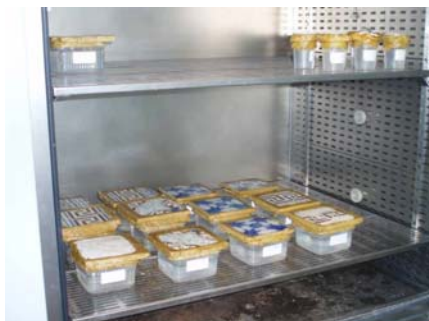
Fig. 8 Water vapour permeability tests (LNEC)

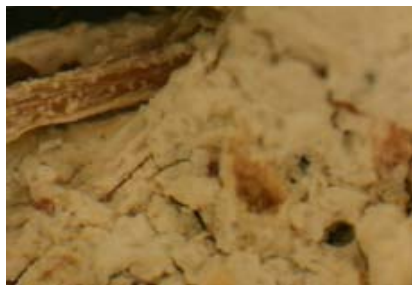
All the samples are fresco paintings composed of two layers. The mortars are whitish, fine and friable and most of them contain organic additives (fibrous plant materials - straw, Fig.7). Occasionally, where the straw isn't present anymore (due to advanced decay, decomposition or fire) there are visible imprints of where the straw used to be. All samples are very porous with numerous micro cracks (Fig.7). On some samples there is visible salt efflorescence above the color layer (Fig.8).

Fig. 7 SN-9 (x 120)

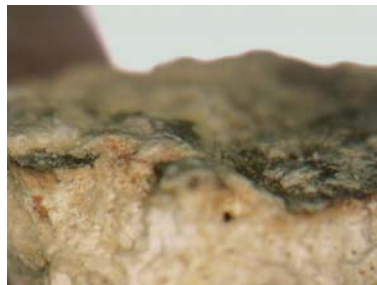
Fig. 8 ST-5 (x 120)

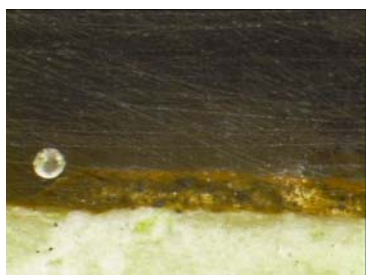
By fiber optic microscopy it can be observed that even though, all the colour layers seemed generally in moderate preservation state, they displayed some localised flaking and detachments. Furthermore, on some samples there is visible salt efflorescence above the color layer. Moreover microscopic observation of the red-brown color indicates that the width of the red - brown color layer is 150µm whereas a thin red layer of 40µm. In addition, microscopic observation of the bright red color showed that the width of the color layer ranges between 30µm to 100µm whereas a thin top reddish layer of 20µm width is presented.

Fig. 9 FOM - Sample BA: red -brown colour

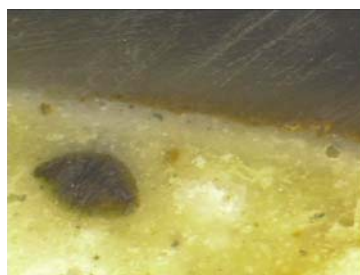
Fig. 10 FOM – Sample BA/D-4: bright red

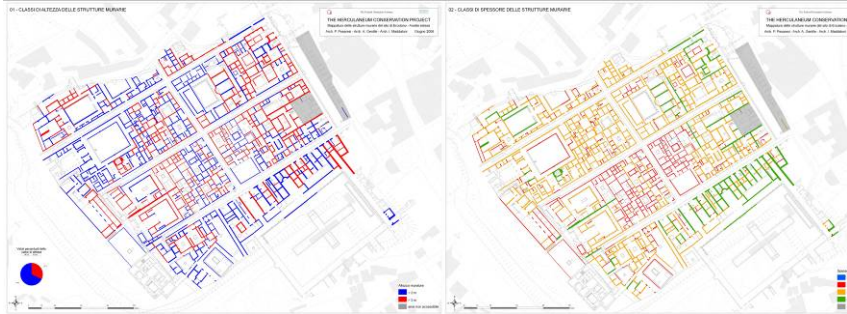
For the internal samples a diamond-tipped core drill was used with a diameter of 2 cm, while pieces of the joint mortars were often easier to extract using a small hammer and chisel. The bored hole was also investigated using an endoscope. The location of the samples is recorded on a geo-referenced map and all the relevant data are entered into HCP's GIS database (Fig. 1) [7].

Fig. 1 Examples of HCP mapping of walls using the GIS data base (Image: Paola Pesaresi/Ascanio D'Andrea/HCP)

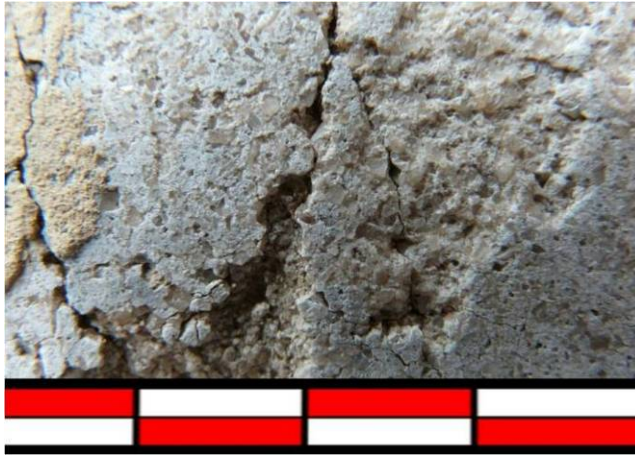
Fig. 3 Detail of plaster in the peristyle of the House of Argos where the primary aggregate can be seen. Scale marker: units of 1 cm. (Image: Alessandra De Vita/HCP)

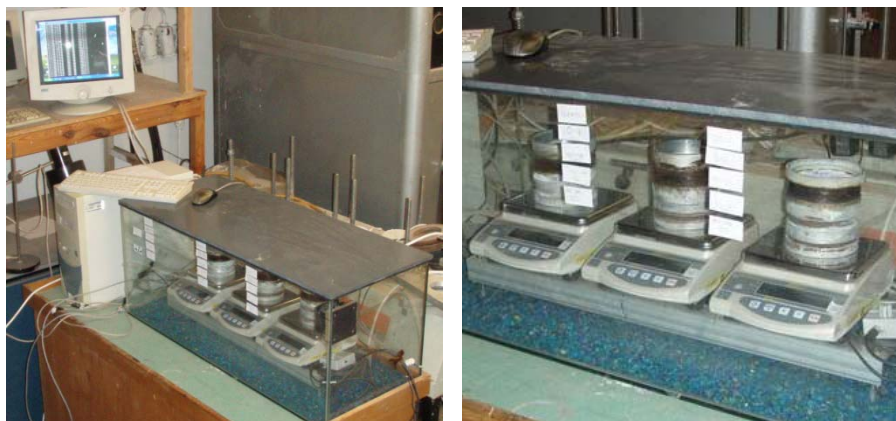
Fig. 1 Measuring chamber with three sets of sample, scales and connection with PC. Internal chamber parameters (temperature, relative humidity, barometric pressure) are scanned by the internal data logger connected with the PC.

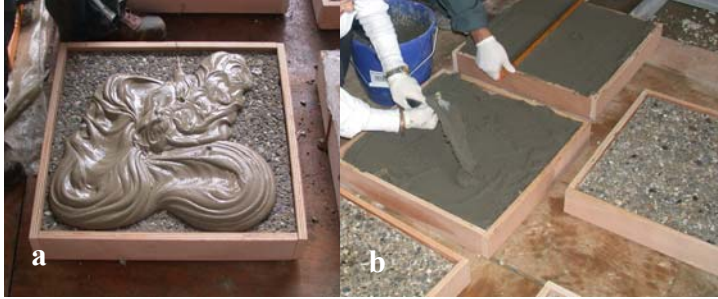
Fig. 2 Application of mortars 1 (a) and 4 (b).

The four selected mortars were applied to the slabs (four slabs per mortar). In terms of workability, mortar 1 was very fluid, mortars 2 and 3 were easy to apply, and mortar 4 was sticking to the tools and therefore was quite hard to apply (Fig. 2).

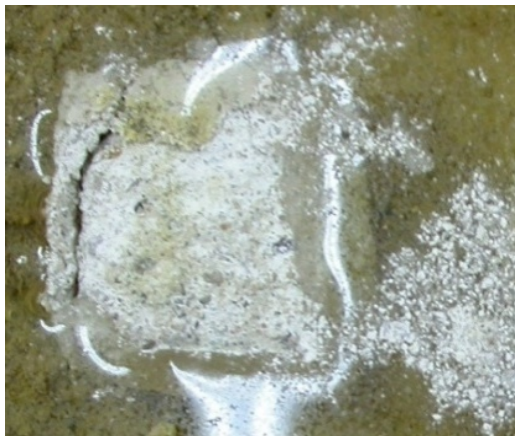
Fig. 3 The photograph shows an example of a specimen with a 3% addition of oil (code BO3) in salt solution – the material is hydrophobic and weak, it loses its powdered surface layer

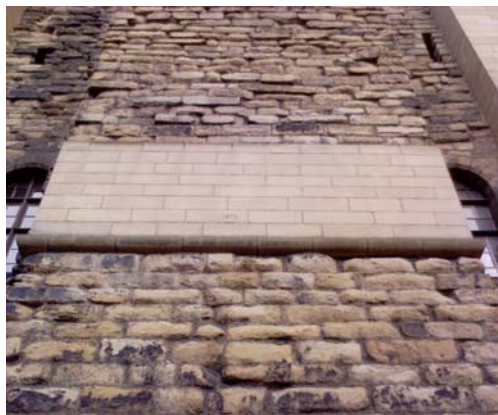
Fig. 1 Overzealous masonry replacement, Newcastle Upon Tyne

Stones that have eroded to the point that the structural integrity is questionable could warrant replacement. That being said, wholesale replacement of masonry (Fig. 1) should be avoided as this is not minimal intervention, resulting in unnecessary loss of historic material and debasement of authenticity. Conversely, the replacement of isolated stones leads to the retention of a higher degree of original fabric with additional benefits for the authenticity of the fabric.

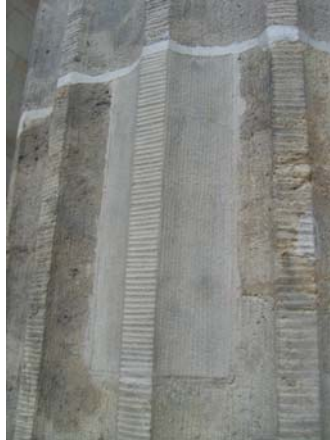
Fig. 2 Stone indent to column, Brandenburg Gate, Berlin

Indenting masonry is the process of replacing an isolated section of stone and piecing it into the existing (Fig. 2). A good indent should be almost seamless and attached using a suitable mortar. These repairs can be undertaken to carved stone sections or flat faces, and can be considered as being relatively minimal intervention in nature as they are localised. They do however require the removal of a certain amount of stone forming a pocket to house the new material. Stone indenting would initially be honest as the existing and new works would be distinguishable. However, as the stone weathers, and soiling occurs the ability to do so is diminished. The reversibility of stone indenting interventions is questionable as the only real approach is to ‘cut out’ the repair. Clearly, if a minimal intervention approach was paramount, then plastic (mortar) repairs may achieved better results.

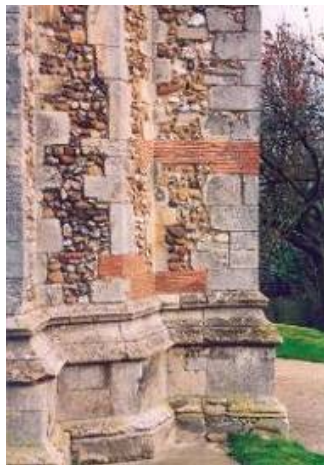
Fig. 3 Honest repair in plain clay tiles to limestone and flint substrate

Tile repairs are undertaken using clay plain tiles (Fig. 3) or natural stone slips. These are built up in bonded layers and accommodate voids left behind by deteriorated masonry.

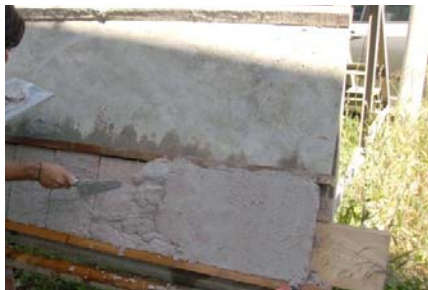
Fig. 1 Sample preparation

The samples were carefully executed to reduce workmanship problems (fig.1). They were cured in a conditioned environment at 20°C and 65% relative humidity (RH) and were wetted twice a day during the first 7 days, with the exception of specimens of pure lime putty, which were cured in dry conditions (23°C and 50% RH). Table 2 describes the sample compositions and curing conditions.

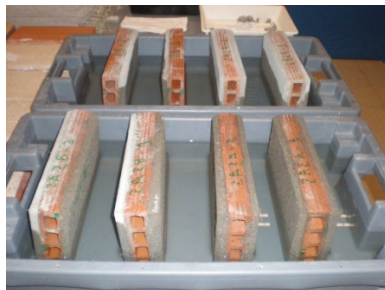
Fig. 2 Partial immersion in NaCl solution

After curing, the samples were partially immersed in NaCl solution (fig. 2).

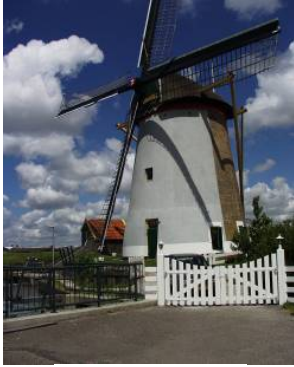
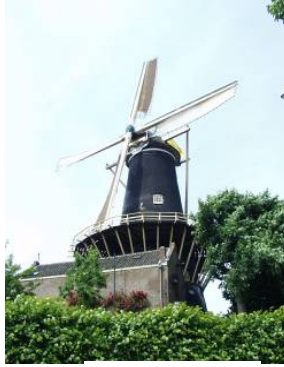
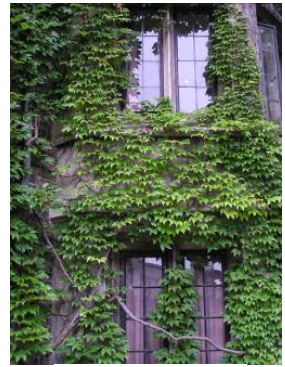
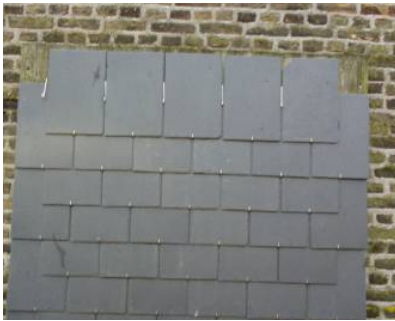
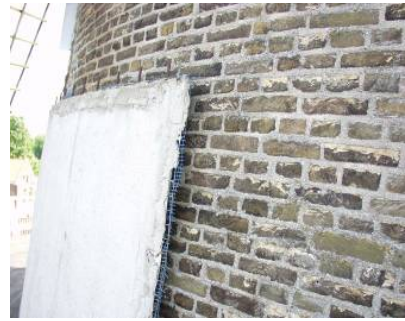
Fig. 1 Examples of protection measures against rain water leakage

In case of leakage the most logical and promising way to solve this problem seems to be, the protection of the masonry from the penetration of rain (rain coat solution). In practice a number of solutions are applied in which this approach is chosen, such as the application of:

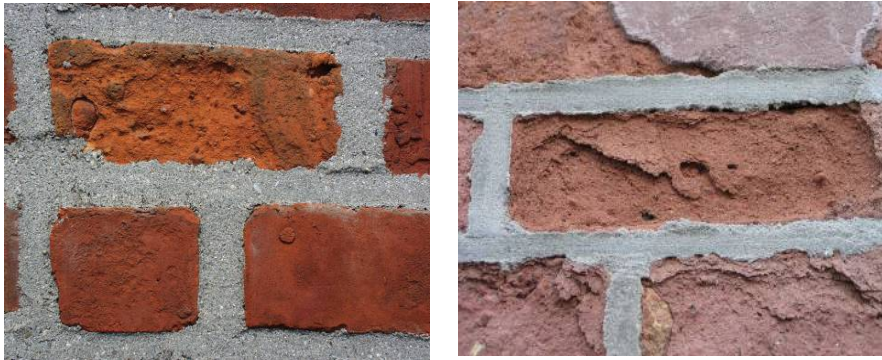
Fig. 4 Salt damage as a result of the application of a water repellent

There is as well another strong motive to refrain from the application of water repellents in the case of historic masonry. The reason is that very often historic masonry contains salts. Drying leading to salt crystallization just under the repellent layer may cause substantial damage (see Fig. 4)

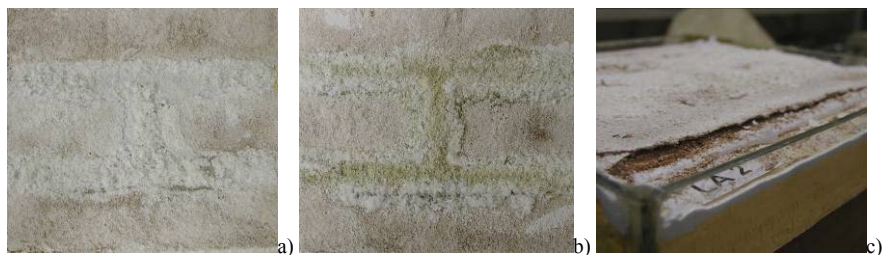
Fig. 3 Distribution of efflorescences on different wallettes during the first cycles

Visual inspection continuously made during the tests revealed some common behaviour of the mortar joints. Since the first days soft efflorescences in the shape of needles appeared on the surface of MA, MD (Fig. 3a). In other cases efflorescence appeared at the interface brick-mortar joint (Fig. 3b). Later on, one month after the test beginning some bricks suffered delamination (Fig. 3c).

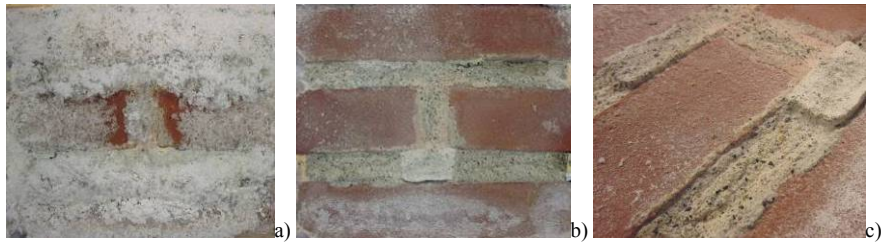
Fig. 4 Surface of MA wallette after 4 weekly cycles: before (a) and after (b) brushing (c) detail of MA wallette after 4 weekly cycles: severe scaling of the mortar can be observed.

The most critical situation is represented by the MA specimen, on which the spalling appears to be the most evident even at visual inspection (Fig. 4). This

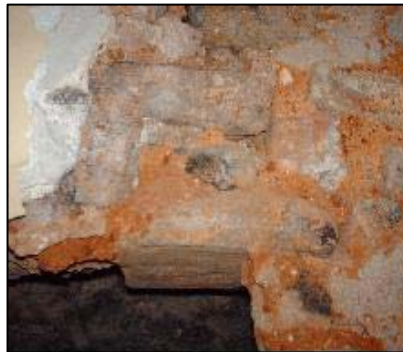
Fig. 2 Construction system of brick with lime mortar

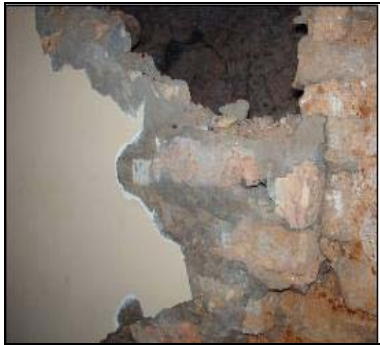
Fig. 3 Use of cement mortar

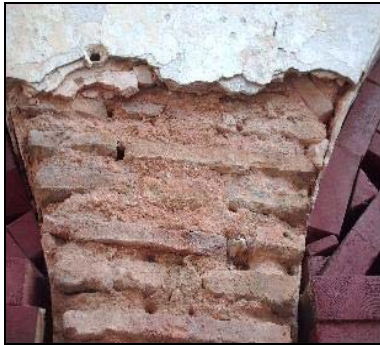
Fig. 4 Detachment of cement mortar

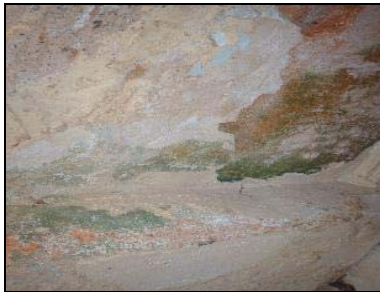
Fig. 5 Lichen on the external wall

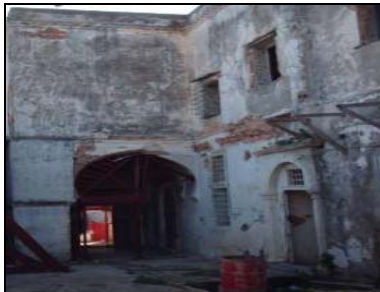
Fig. 6 Moisture in the external wall

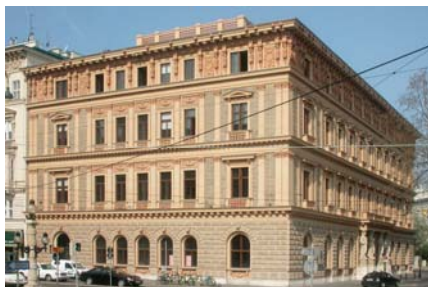
Fig. 1 Palais Epstein, Vienna (1868-72)
Unpainted facades combine Roman cement renders & ornaments with terracotta elements

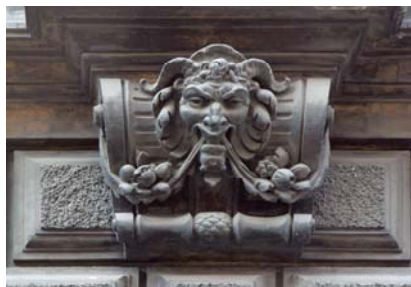
Fig. 2 Original cast decoration and rusticated ashlar blocks: private house, Vienna

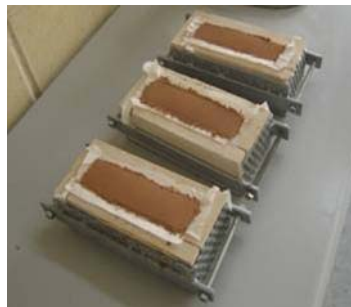
Fig. 1 Prismatic moulds fabricated from limestone

The mortars cast in the limestone moulds (see sample 11 in Table 1) exhibited significantly higher compressive strengths than those cast in the steel moulds. This is clearly because the former had sufficient water abstracted in the wet state to lower their water/binder ratio and therefore increase their strength. It is worth noting that, while mortars placed in steel moulds remained soft for several days, similar mixtures placed in limestone moulds had set within 24 hours. This is consistent with the behaviour of the mortar mixture used in the plastering of the brick and stone wallets (Fig. 4).

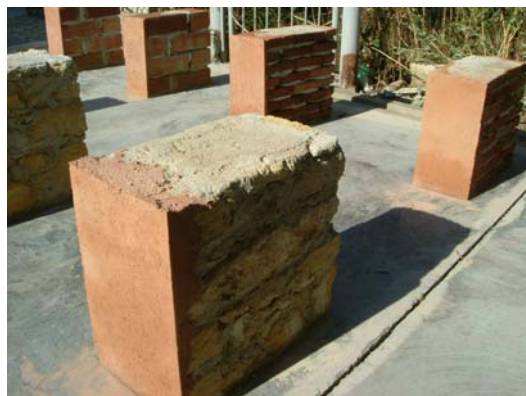
Fig. 4 Pilot applications of repair mortars on wallets constructed of stone (front row) and fired clay brick (back row).

The latter showed absolutely no evidence of cracking or efflorescence (salt growth on their surface) 12 months after their construction. Pull-out tests resulted in adhesion strengths exceeding the minimum requirement of Eurocode 6 (i.e. 0.2 MPa) and well over 1/30th of the compressive strengths of mortars. Adhesion strengths were significantly improved along joints.

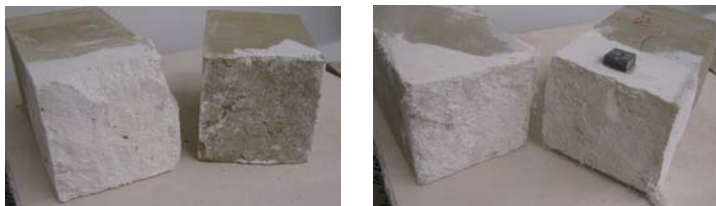
a) Failure at the Block-Mortar Interface b) Failure through the Mortar

Fig. 8 Modes of Failure in Masonry Units: a) Quasi-Static Loading (All Specimens) and b) Dynamic Loading (Fibre Reinforced HLM)

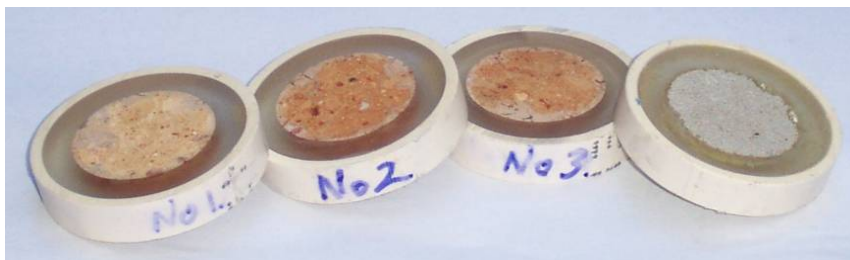
Fig. 4 The one mortar and three brick samples set within their respective resin and PVC tubing sleeves.

To determine permeability matching, samples of bricks were cored to produce 38 mm x 13 mm discs and mortar samples were made up to the same dimensions. The samples were mounted using resin in PVC tube and tested with water using a controlled pressure differential of 20 kPa: permeability (in m²) was then determined from the volumetric flow rate using a form of Darcy's law (see Figs. 4 and 5).

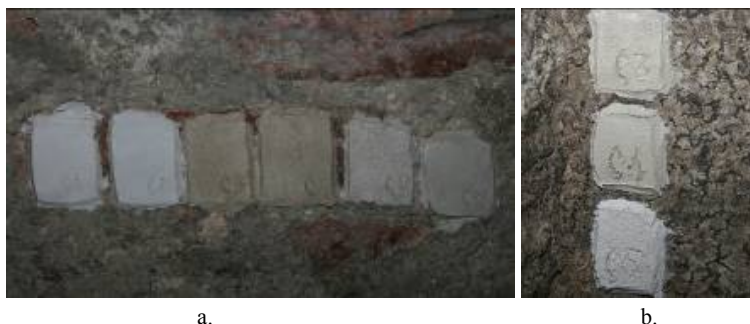
Fig. 1 Mortars applied on iconostasis (a) and on sandstone wall (b)

From the evaluation of the mortars in fresh state it can be said that they have presented a good behavior, assuring a sufficient working time for application. Also, they have presented a good modeling capacity, and also a good adherence at support. From point of view of the mural aspect, the mortars which contain sandstone as aggregate (C3, C4) are closer as chromatic tonality of the iconostasis or altar's wall. The mortars with limestone (C1 and C2) are closer as chromatic tonality of the lime mortar of mural painting support. Below (Fig. 1 a, b) presents the areas with applied mortars.

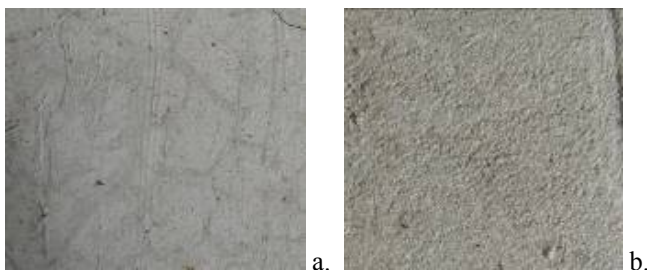
The mortars C1 and C2 which contain fine calcareous aggregate, present on their surface micro-cracks of contraction (Fig. 2a). In case of the mortars C3 to C6 which contain aggregate with 0 -1 mm granulation not presented cracks of contraction (Fig. 2b).

Fig. 2 Images where micro-cracks of contraction on mortar surface C1 are remarked (a) and their lack on the mortar C4 (b) applied on iconostasis

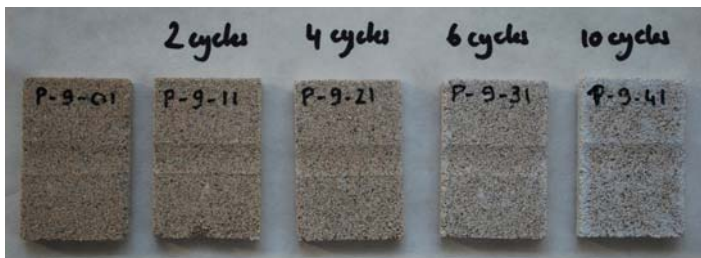
A whitening of the surface is visible on all type of mortars, increasing with the number of cycles, as can be seen on the Fig. 4. It is also visible, on sample P-9-41, after 10 cycles of application, that there is a whiter part on the edges of the plate, probably due to the concentration of particles.

Fig. 4 Change of colour of the specimens (mortar 1:9) after treatment.

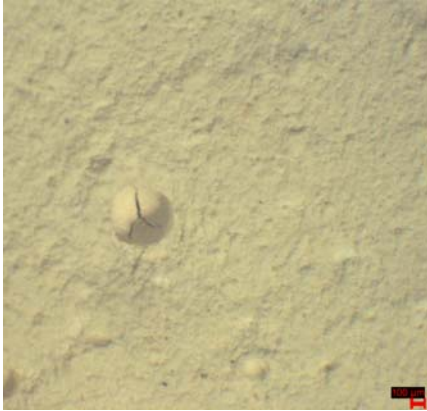
Fig. 7a Stereoscopic images of grout with cement without nanoparticles. Composition 4a

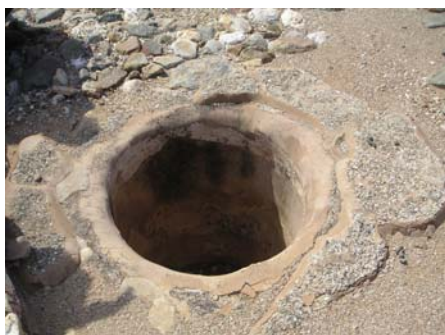
During the classical and Roman period, renderings were the only way to seal cisterns (Fig. 2).

Fig. 2 Render in cistern at Olynthos 4th century B.C.

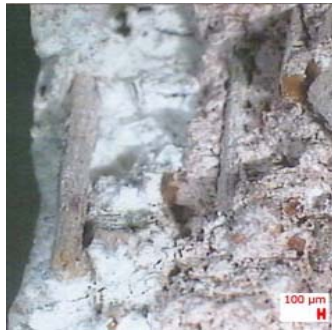
Specific materials and techniques were often used for renders and plasters in order to fulfil their functional and aesthetic requirements. The analysis of a large number of old renders (more than 500 samples) based on the recording of the chemical, microstructure, mechanical and physical properties showed that they were rich in fines, the binder/aggregate content ranges from 1:1 to 1:2 while the aggregates could be classified as sand of different maximum size (2mm, 4mm or even 8mm) [2, 3]. Additionally, inclusions such as straw and chips of wood were often added in order to increase their stability and durability and minimize their cracking tendency (Fig. 4) [4].

Fig.4 Chips of wood in a render of the Byzantine period.

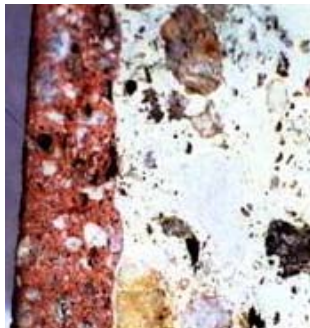
In some cases pigments were added in order to give a colourful result (Fig. 5) [5].

Fig. 5 Red render from the Roman period.

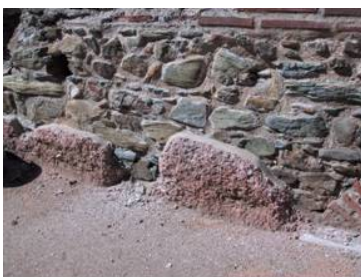
The thickness of historical renders ranged from 3-7cm (Fig. 6) to less than a centimetre. The different layers generally showed very good adhesion with the masonry substrate. The usual practice was to apply renders in three layers. The first one was used to cover the rough wall and coarse sand was used for that purpose while the second had a thickness of 5mm and was applied after the first layer was dry. The sand used for the second layer was fine. In order to ensure the

Fig. 6 Thick render in a wall during the Roman period (Olynthos 4th century B.C.).

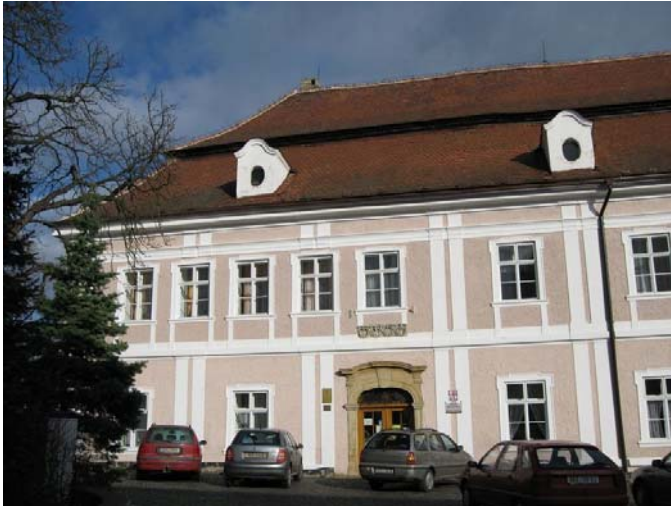
Fig. 1 Castle in Jevíčko – the facade is not covered by renovation plaster

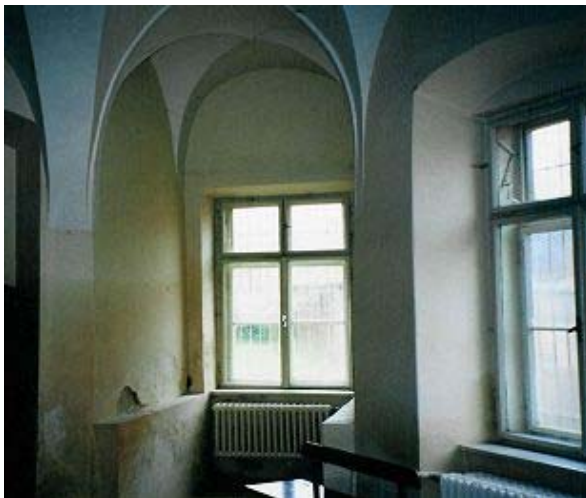
Fig. 2 The original condition of the wall in the interior of the library before renovation actions in 2001

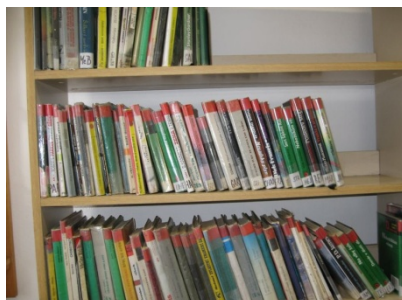
Fig. 6 Current status – suitable open shelves without a closed back are used in library

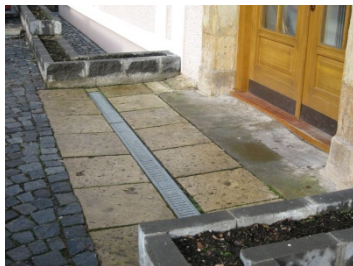
Fig. 7 System for the reduction of surface water and rain water with drainage to a rain water sewer

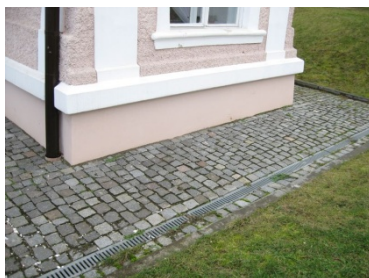
Fig. 8 System for the reduction of surface water and rain water to a rain water sewer

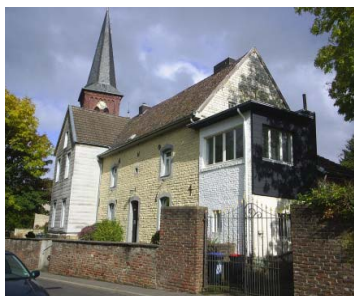
The gable of the rectory of St. Peter in Aachen-Orsbach (1764) (fig. 3) was built of marl stones. Pointing was carried out using a mortar consisting of lime and extremely fine marl. During a previous restoration, some stones were replaced and the facade was partially re-pointed with cement based mortars which has contributed to the destruction of the remaining original materials (fig. 4). Conservation work performed in 2009 was based on the following steps: At first the mortar was structurally consolidated with CaLoSiL E-25 (fig. 5); after which flakes and shells were adhered to the surface by an injection mass based on a CaLoSiL paste. In the final conservation step, voids were filled with a mortar containing CaLoSiL paste as the binder.

Fig. 3 Rectory of St. Peter in Aachen - gable before the conservation

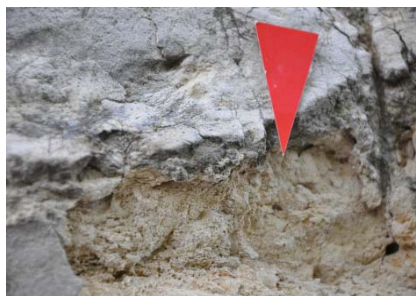
Fig. 4 St. Peter's in Aachen-Orsbach - original mortar underneath the flaking cement mortar

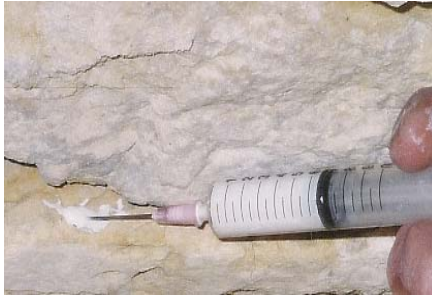
Fig. 5 St. Peter in Aachen-Orsbach, - residues of mortar were stabilised using injection masses

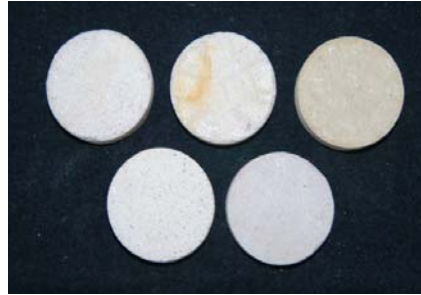
Fig. 6 Artificial samples of mortars developed using CaLoSiL paste for the conservation of mortar

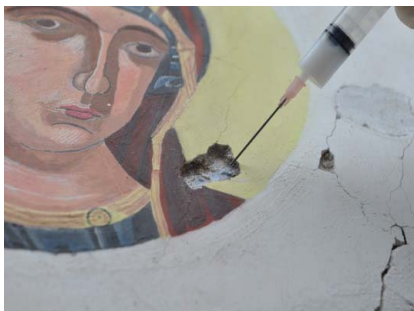
The conservation of the wall paintings in Mersch was realised in several stages. First, unstable mortar underneath the paintings was stabilised through the injection of the nano-lime CaLoSiL E-25 (fig. 7); defects were then filled with a nano-lime-based repair mortar. Following this, voids, fissures and cracks were filled with an injection grout based on a CaLoSiL paste (fig. 8) and coloured lime was applied in the final retouching. Thus, the conservation was achieved with lime based materials which were fully compatible to each other.

Fig. 7 Consolidation and stabilisation of the plaster (fresco) with CaLoSiL E-25

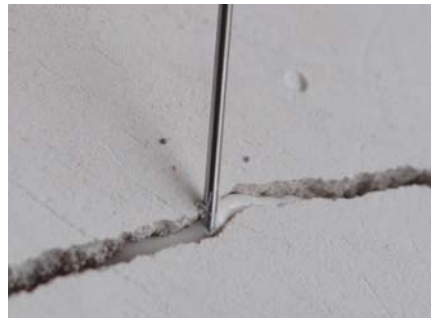
Fig. 8 Filling of cracks with the developed injection grout

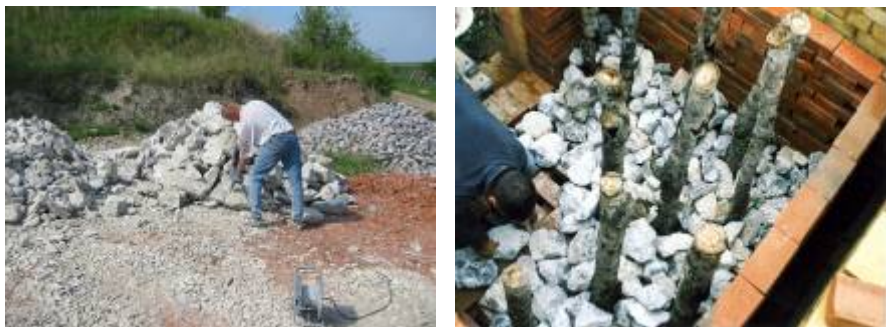
Care is taken to minimize contaminated deposit horizons as raw material. After crushing and separating by size, the gypsum stones are stacked by hand (Fig. 2). The bigger stones (20-25 cm diameter) are located in the lower part of the chamber, and the smaller ones (5-10 cm diameter) are located on the top. A sufficient space between the stones has to be kept for the removal of the flue gases. Tree trunks are placed vertically between the stones for the same purpose.

Fig. 2 Left: Crushing the bigger stones of the gypsum raw material; Right: Filling gypsum stones into the kiln above the combustion chamber. Tree trunks are placed vertically between the stones to obtain additional channels for removal of the exhaust gases.

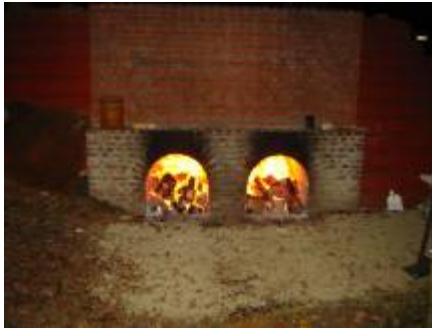
The firing time is 12-13 hours. Monitoring is done by measuring the firing temperature in the middle of the kiln (Fig. 3). Stacking and a continuous firing procedure are essential for the properties of the resulting material.

Fig. 3 Left: View at the combustion chamber of the kiln during firing. The gypsum stones (located behind the brick wall) are separated from the combustion chamber by a grate; Right: Typical firing curve of high fired gypsum

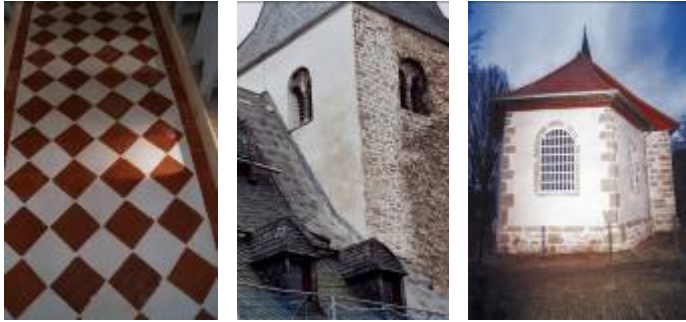
Typical examples for the use of high fired gypsum in restoration work are shown in Fig. 9. The floor of the church in Eschenbergen was reconstructed based on historical findings. The white areas between the ceramic tiles are renewed screed made of high fired gypsum. On the steeple of a church in Wernigerode consolidation of joint mortars and plasters has been done; again, in accordance with the historical findings high fired gypsum was used. At the church of Kehmstedt the outer walls have been plastered using this material.

Fig. 9 Left: Floor in the church of Eschenbergen. The white areas are screed, made of high fired gypsum (photo: Rothe); Middle: Church tower in Wernigerode (photo: Srocke); Right: Church in Kehmstadt. The renewed plaster and joints consist of high fired gypsum (photo: Srocke)

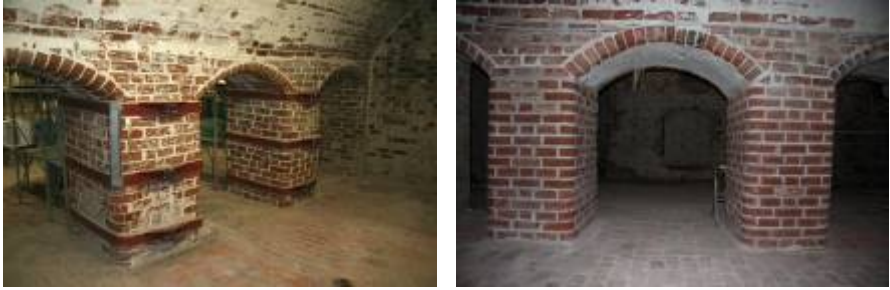
The medieval city hall of Lüneburg was built using gypsum as a masonry mortar (Fig. 10). For structural reasons, in the basement of the building several supporting pillars had to be rebuilt [12]. Preliminary studies have shown that a moderate humidity and salt stress in the pillars allowed the use of gypsum mortar [13]. With a view of the compressive strength required, high fired gypsum was chosen not only because it matched the historical material but because it ensured an optimum material compatibility. Due the relevance of static, it was necessary to ensure that the gypsum mortar, even in contact with moisture, achieved the strength required by regulations. [13]. Table 2 shows that proof of this could be provided successfully; even in water-saturated conditions and after 7 days stored underwater, the high fired gypsum mortar maintained more than 50% of its strength (Fig. 11). Gypsum mortars based on hemi-hydrate show a much greater loss in strength under these conditions.

Fig. 10 Pillars in the basement of the city hall Lüneburg. Left: Situation before start of repair work. The masonry consists of brick and gypsum mortar. The pillars are safeguarded by steel profiles; Right; Pillars in final state, rebuilt using high fired gypsum mortar

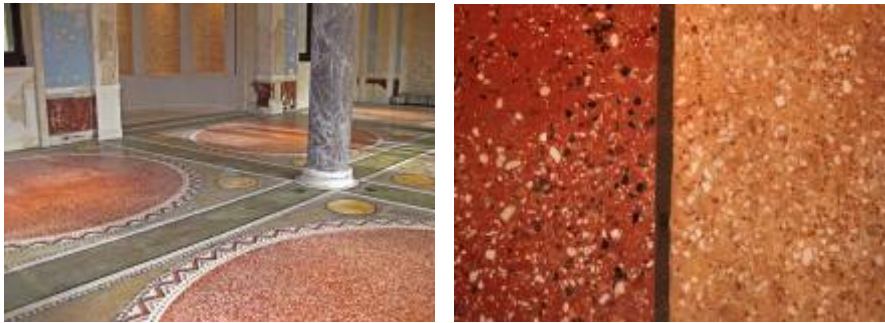
The building of the new museum in Berlin was heavily damaged by the effects of WWII. Since the 1990s, extensive restoration work has been carried out [14]. The splendid terrazzo floors were reconstructed according to historical findings using high fired gypsum from Hundisburg (Fig. 12). For the very elaborate production of the floors in the New Museum, pigments and crushed stone were added as decorative elements, and the floor surface was ground in several steps, polished and sealed.

Fig. 12 New Museum in Berlin: Overview and detail of the terrazzo floors made using high fired gypsum as a binder material (photos: Kaiser)

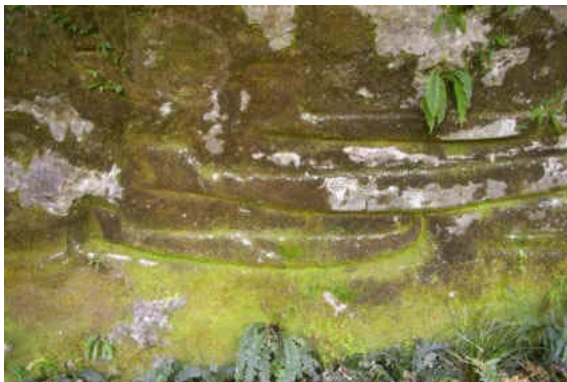
Lithium silicate is the most recent iteration of the water miscible silicates. It has the clear advantage of not releasing cations and has found application in the traditional use of water soluble silicates for the stabilization of concrete. Its high alkalinity (pH 10.8) is a desirable condition for reinforced concrete but presents some issues when used as a consolidant or grout on siliceous rocks. Lithium silicate has clear advantages when consolidating or grouting permanently wet rock (Fig. 1). The formula for lithium silicate is shown in Fig. 2.

Fig. 1 Detail of a permanently water saturated ignimbrite wall containing carved canoes. The water flow and plant roots are causing delamination in many places.

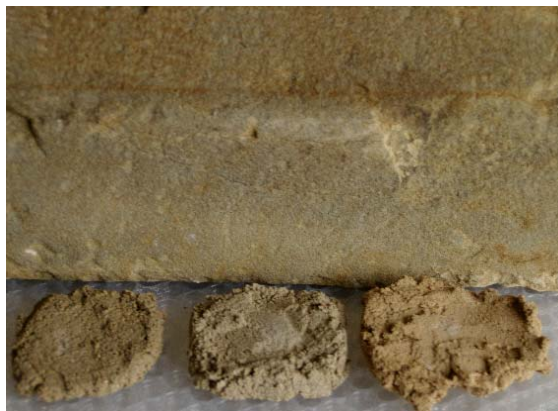
Fig. 3 Three ethyl silicate grouts attempting to match the stone above

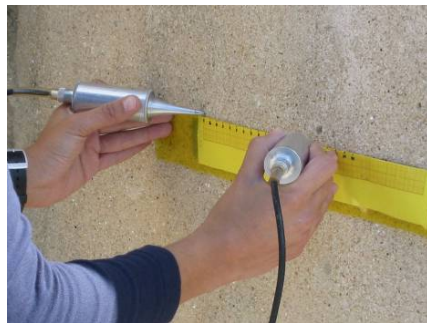
Fig. 2 Modulus of elasticity by ultra-sound measurements

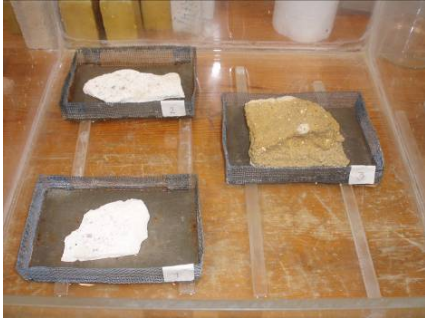
Fig. 3 Water absorption by capillarity of irregular samples

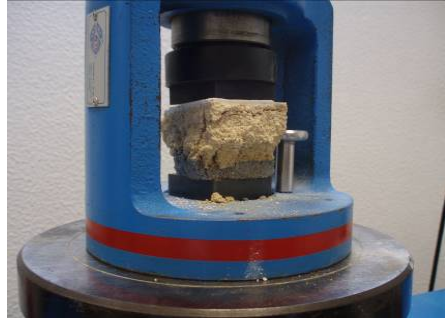
Fig. 4 Compressive strength of irregular samples

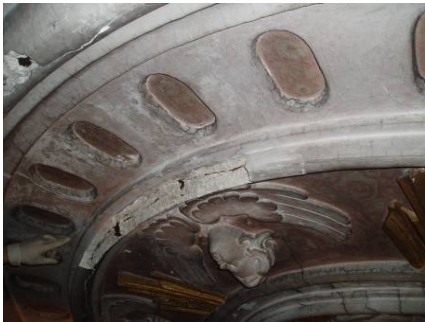
Fig. 5 Corrosion of metallic elements may require partial removing of the plaster

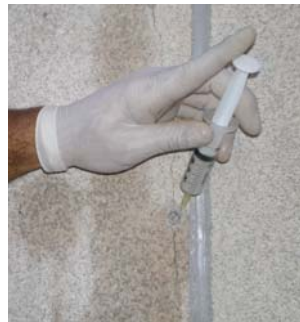
Fig. 6 Repair of render detachment using grouts is a delicate, complex technique

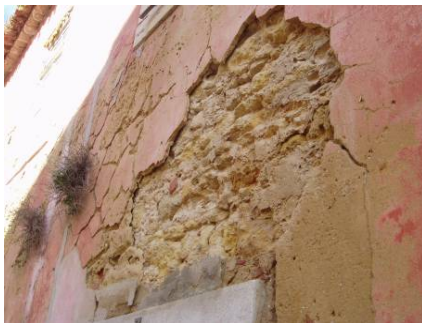
Fig. 7 Mechanical damage due to incompatible new render

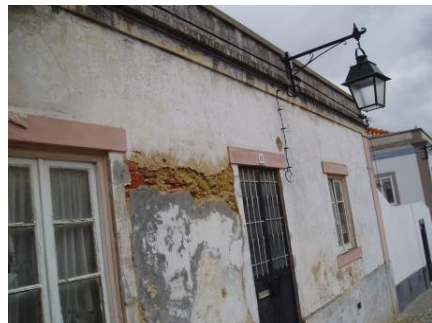
Fig. 8 Damage due to reduction of water permeability of the walls

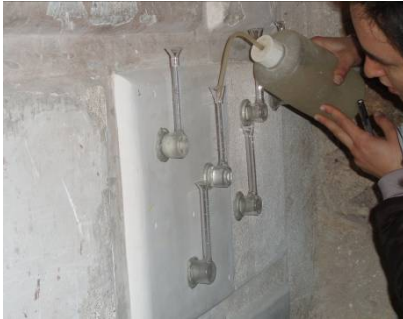
Fig. 9 Evaluation of water permeability with Karsten tubes

Moisture measurement	Pendular Schmidt hammer	Durometer	Ultrasound	Karsten tubes	Salt colorimetric stripes or salt kits
Mechanical Strength	-	X	X	X	-	-
Dynamic modulus of elasticity	-	X	-	X	-	-
Water permeability	-	-	-	-	X	-
Presence of salts on the surface	-	-	-	-	-	X

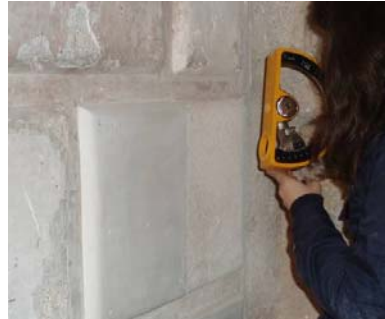
Fig. 10 Evaluation of Mechanical strength with Pendular Schmidt Hammer

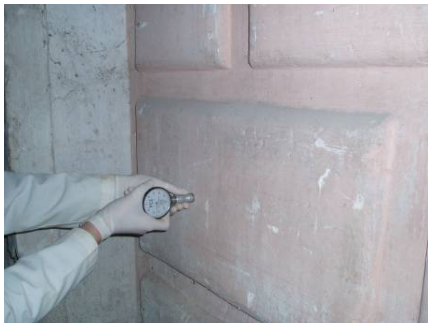
Fig. 11 Evaluation of surface hardness with a durometer

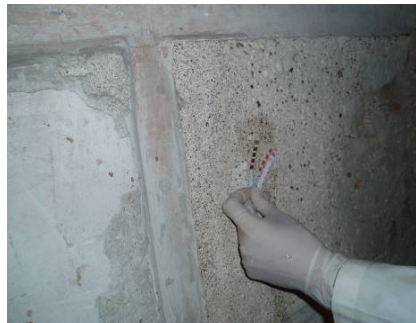
Fig. 12 Identification of presence of some salts with colorimetric strips

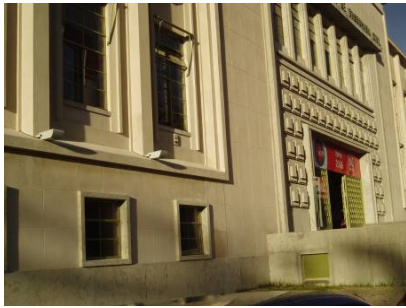
Fig. 13 Main LNEC building: repair with air lime mortar

Some case studies of historic buildings' renders and plasters repaired with compatible mortars are represented in Figs. 13-16 [1, 6, 7, 14].

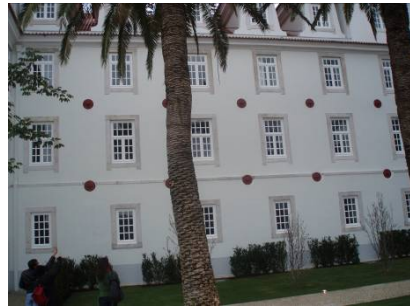
Fig. 14 Inglesinhos Convent: substitution air lime render

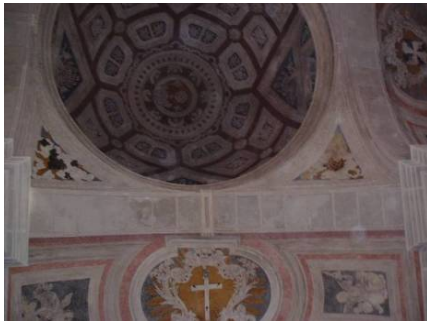
Fig. 15 Sacramento church: repair and partial substitution of plasters using air lime plus hydraulic lime mortars and gypsum and air lime mixes

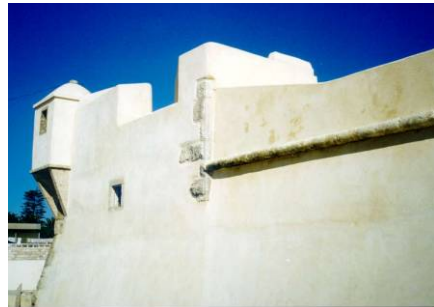
Fig. 16 S. Bruno Fortress: substitution air lime plus cement render

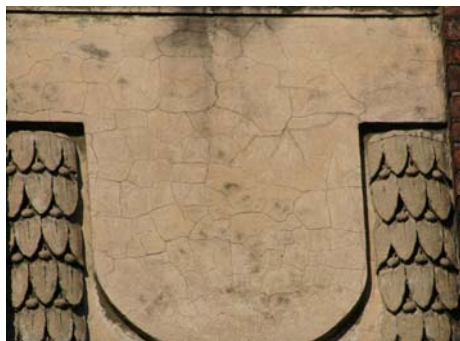
Fig. 1 Typical irregular network of fine shrinkage cracks characteristic of Roman cement stucco.

Fine surface cracks, forming an irregular network not related to building features, are a distinct characteristic of all Roman cement renders and architectural castings (Fig. 1). Usually they do not lead to damage. Only rarely can they widen

The fine cracking of historic Roman cement mortars was caused by their restrained shrinkage during the drying process. It is common to describe shrinkage values in microstrain, i.e. $\mu\text{m}/\text{m}$. Values of long-term concrete shrinkage are typically 200 and 800 $\mu\text{m}/\text{m}$, mortar shrinkage between 800 and 2000 $\mu\text{m}/\text{m}$, and cement paste shrinkage between 2000 and 6000 $\mu\text{m}/\text{m}$ [11]. Shrinkage is primarily affected by the relative humidity in the environment of the drying mortar. Therefore, relationships between the two parameters need to be established by testing and then described by the mathematical formulae or models [12]. The total volume of aggregate in a mixture is another important factor affecting the shrinkage of mortar as only the cementitious matrix shrinks, whereas aggregate generally remains insensitive to drying. However, even the mortar shrinkage normalized to the cementitious matrix volume is considerably lower than that of the cement paste, as the aggregate grains act as rigid inclusions restraining the shrinkage of the matrix. Finally, an increase in the w/c ratio leads to an increase in the drying shrinkage because the additional water increases the porosity of the matrix.

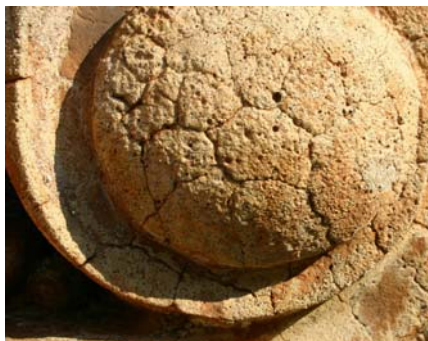
Fig. 2 Heavily eroded surface of a decorative element exposed to rain water; the shrinkage cracks are widened.

if the stucco is exposed to the severe impact of rain water, especially at the top of buildings (Fig. 2).

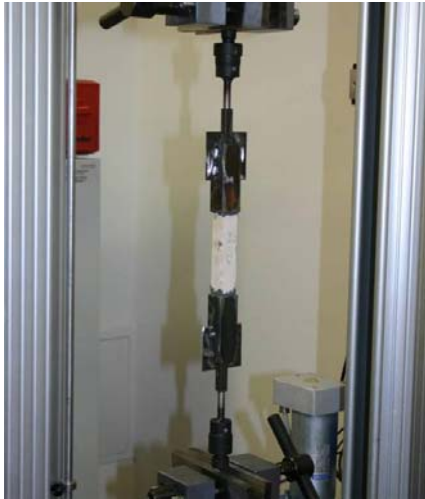
Fig. 3 Experimental set up for the measurement of the tensile properties.

Tensile properties were determined using the Universal Testing Machine from Hegewald & Peschke, Germany. The specimens were fixed with epoxy resin into metal clamps in the machine as shown in Fig. 3 and subjected to tensile strain through ball joints to ensure a linear configuration of the test. The rate of the tensile loading was 10 $\mu\text{m}/\text{m}/\text{s}$. Four specimens were tested. Tensile strength was determined according to a historic test procedure using mortar briquettes in the shape of a number eight (Fig. 4) to be able to compare directly the results with the strength specifications for Roman cement mortars given in an Austrian standard of 1880, modified in 1890 [14,15]. Six specimens were tested, and the mean value of the tensile strength was calculated.

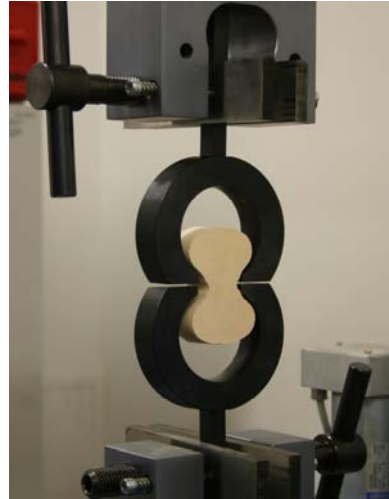
Fig. 4 Experimental set up for the measurement of the tensile strength.

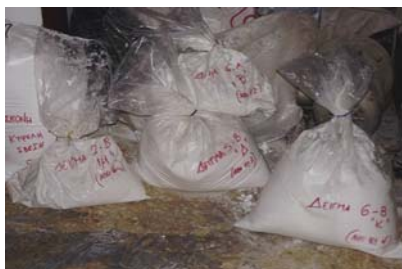
Fig. 1 Lime putty samples

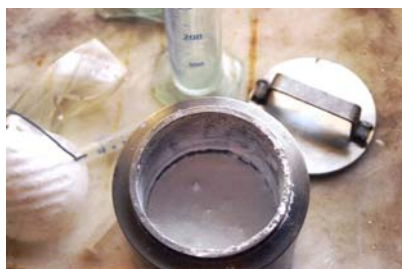
Fig. 2 Slaking vessel (EN 459-2, 5.9)

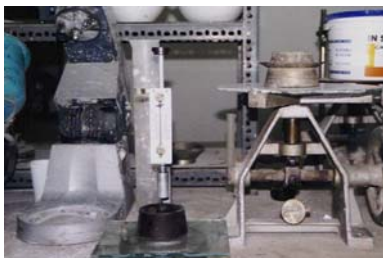
Fig. 5 Vicat apparatus and flow table

Consistency of lime putty (or binder water demand w/l^{binder}) Measurements of lime consistency were carried out using a modified Vicat apparatus (ASTM C110: plunger No. 52, diameter 19 mm, weight 32 g, optimum depth of penetration 10 mm). The initial position of the plunger was 100 ± 1 mm. The additional water required for acceptable lime putty consistency was recorded as w/l^{binder} .

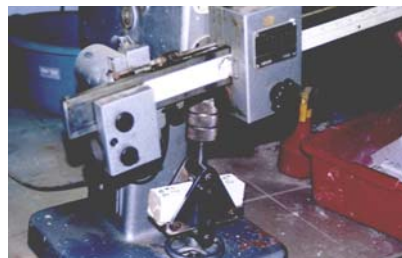
Fig. 6 Testing of flexural strength

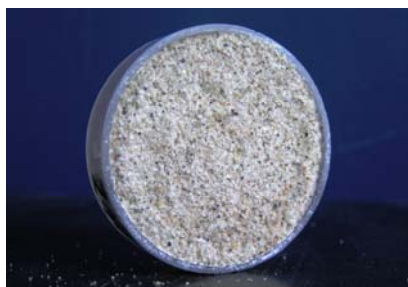
Fig. 5 Sea sand consolidated by CaLoSiL E-25 and the silicic acid ester Funcosil 300 from Remmers

The treatment with CaLoSiL produced a first consolidation. Loose sand particles were bridged together and a solid, non powdering surface was formed. The penetration behaviour of all of the silicic acid esters tested was not disturbed by the pre-treatment with CaLoSiL. The sand was fully penetrated, both by Funcosil 300 and Wacker Silres BS-100 OH. As Fig. 5 shows, the loose sand particles were converted into a solid mass.

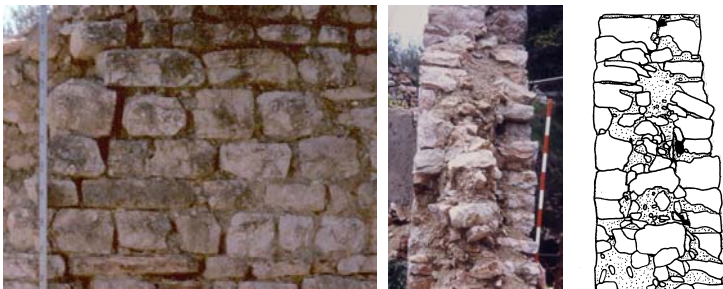
Fig. 1 Apparent regularity of a wall and real morphology within the wall

It is also worth remarking that an apparently regular masonry surface texture often does not correspond to a regular morphology within the wall and vice versa (Fig. 1). This knowledge is not only important for modelling the mechanical behaviour of the walls, but also to make appropriate mortar choices when repairing, rebuilding or injecting damaged masonry.
