Proceedings
PRO 78

Historic Mortars and RILEM TC 203-RHM Final Workshop HMC2010

Proceedings of the
2nd Conference and of the
Final Workshop of RILEM TC 203-RHM

**2nd Historic Mortars Conference and
RILEM TC 203-RHM Final Workshop
HMC2010**

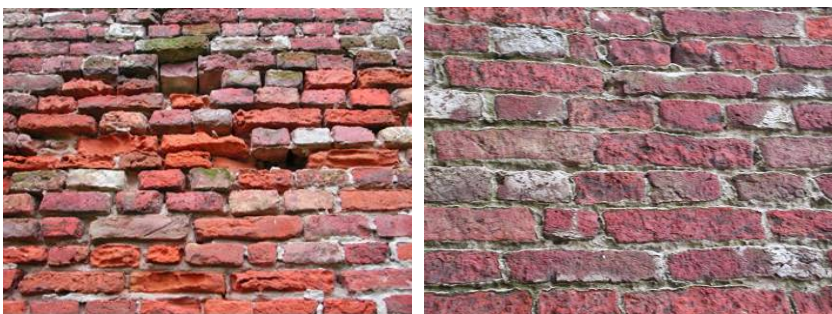
Fig. 2 Examples of the damaging effects of sea salts on respectively masonry and in lime mortar joints (pitting in the pointing mortar).

Damage to mortars (pointing, plaster or render) due to sea salts generally shows up as sanding or powdering or as a kind of pitting.

In lime pointing the damage (pitting) concentrates in the centre of the joints; re-pointing either with lime or cement mortars leads to the formation of voids at the brick (stone) mortar interface, where the salt present in the masonry units may quickly and in considerable amounts contaminate the mortar. In plasters or renders, pitting may occur, but also phenomena such as exfoliation and loss of adhesion between plaster and substrate.

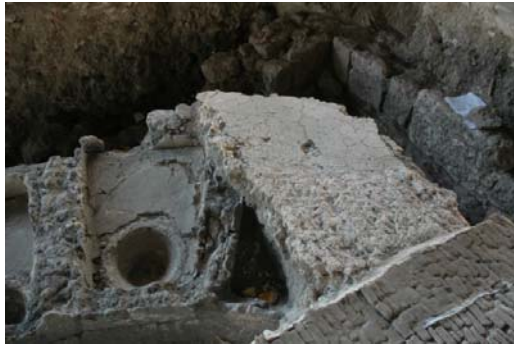
Fig. 2 Hellenistic substrate of a floor mosaic in Pella, Greece (4th cent BC)

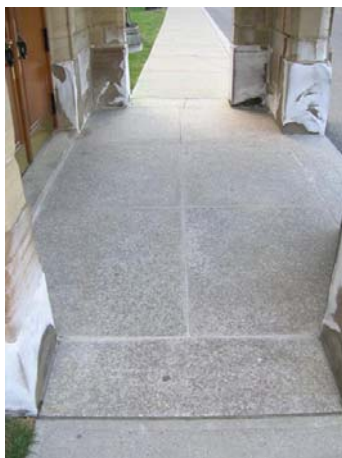
Fig. 6 Floor paving subject to severe exposure. Note salt saturation from de-icing salts at the bottom of the columns (side entrance Parliament buildings, Ottawa, Canada)

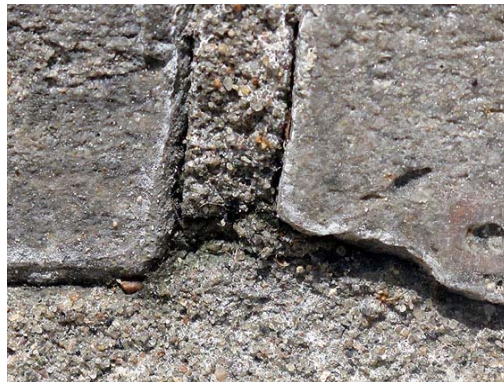
Fig. 9 Condition of joint mortar in Spring (Canada)

- For horizontal surfaces, drainage away from the adjacent walls should be ensured by having a minimum slope of 2%.
- It is important to understand how the components of the pavement (units and joint mortars) behave and interact.
- The severity of climatic conditions should be taken into account for the selection of a suitable mortar. Use of movement joints or sand joints is a possibility where needed. Expect cyclical maintenance every two or three years (Fig. 9).

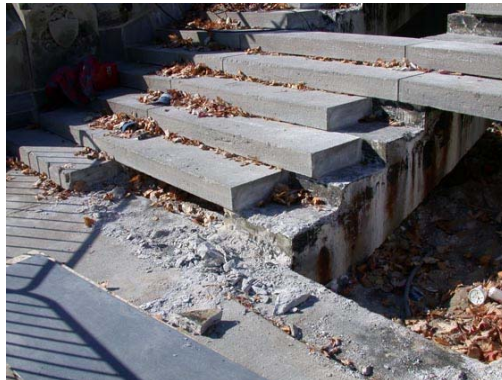
Fig. 10 Salt damage on mortar, stones and concrete base of stairs. Partial dismantling (Canada)

The most crucial requirements for mortars used in repairing joints of pavements and stairs are those related to frost and salt damage (Fig. 10). To avoid such damage, the moisture content of the mortar must be kept low by taking care to have a proper slope on horizontal surfaces to avoid water stagnation. To eliminate efflorescence and salt crystallization within mortars, the salt content of all ingredients of the mortars and surrounding materials should be kept at low as possible.

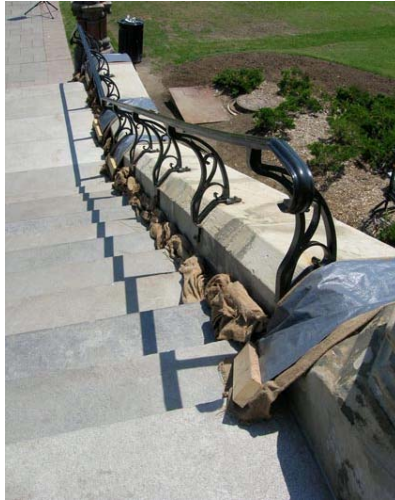
Fig. 11 Curing with wet burlap and plastic for a minimum of three days

Fresh mortar joints should be protected from rain, wind and sun by keeping them damp for three to seven days to avoid shrinkage cracks or obscuring the natural colour of the mortar (Fig. 11). Mortar should also be protected against early freezing in cold weather.

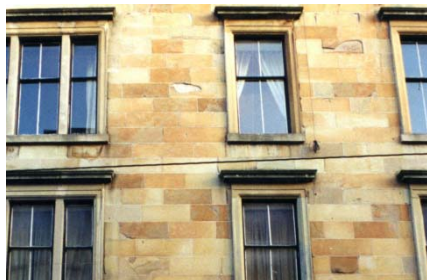
Fig. 1 Advanced deterioration of the 19th century sandstone ashlar masonry façade.

Mortar repairs used to replace deteriorated stone units have been in common use for some time and many historic stone buildings contain such repairs. Figs. 1 and 2 show an example of the application of surface repair.

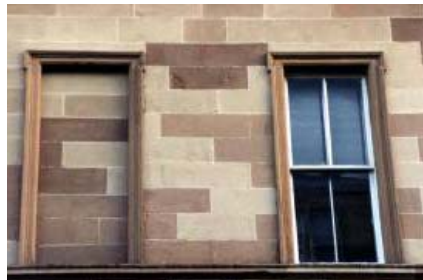
Fig. 2 Example of mortar application as a surface repair of deteriorated stone units.

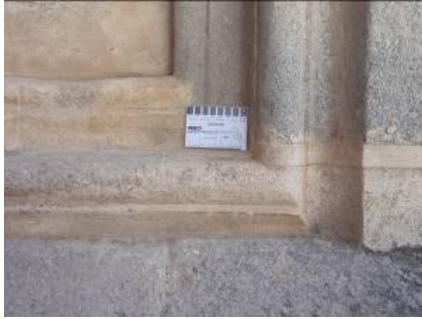
Fig. 3 Mortar was used to repair deteriorated stone parts and detailing of the main entrance portal of the cathedral in Évora.

The performance of surface repairs carried out in the past can, after some time of exposure, be evaluated. Fig. 3 demonstrates a repair which can be regarded as successful and Fig. 4 shows a surface repair which in a complex view is not performing satisfactorily any more. There exist also cases where the properties of the new mortar repair caused, along with the specific exposure conditions, accelerated deterioration of original material, which is not acceptable from a cultural heritage preservation point of view.

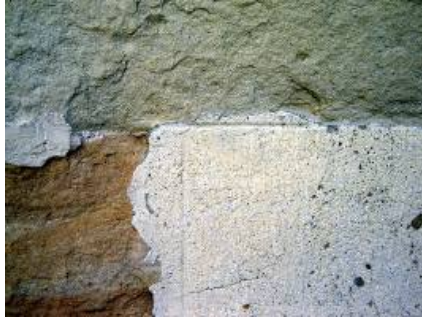
Fig. 4 Surface repair of a stone masonry. The repaired surface is durable but stone continues to decay. Aesthetically it is not functioning very well and it could accelerate decay of the adjacent stone.
