THE HARBOUR STRUCTURES OF CYPRUS

A REPORT ON AMATHUS, NEA PAPHOS & KOURION

BY JUDITH GATT

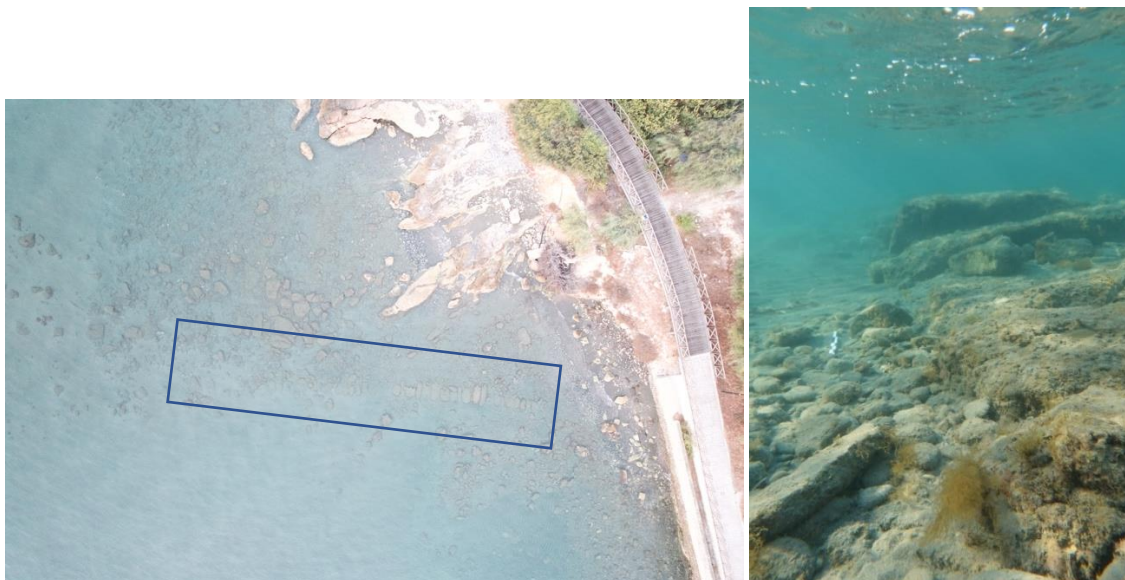
The structure has an N-SE orientation (**Fig.2**). The total visible and documented length is 15.6m (**Fig. 6**). It consists of a single row of headers (whose maximum width is 1.20m) and two courses are visible today. The foundation level is not visible, as the area is silted. Ashlar blocks with lifting bosses² are preserved. They have similar dimensions to those of the ashlar blocks located along the south breakwater-mole and the southern extremities of the east and west mole (Empereur et al. 2017: 67-78). No evidence of fastening or other type of joining material between the blocks has been observed so far. The single row of ashlar blocks continues further to the south towards the direction of Sondage 8 which confirms a construction with core and facings³. However, it remains unclear whether a breakwater was built on the west side of the west mole. The northern extremity of the west mole was given directly the name “west mole” because from an architectural and construction point of view it corresponds to the harbour structures located in the south area of the basin.

Fig. 6: (Right) Aerial view of the north extremity of the west mole documented in 2022 (@Christou 2022). (Left) View of the north extremity of the west mole from the north (@ J. Gatt 2022).

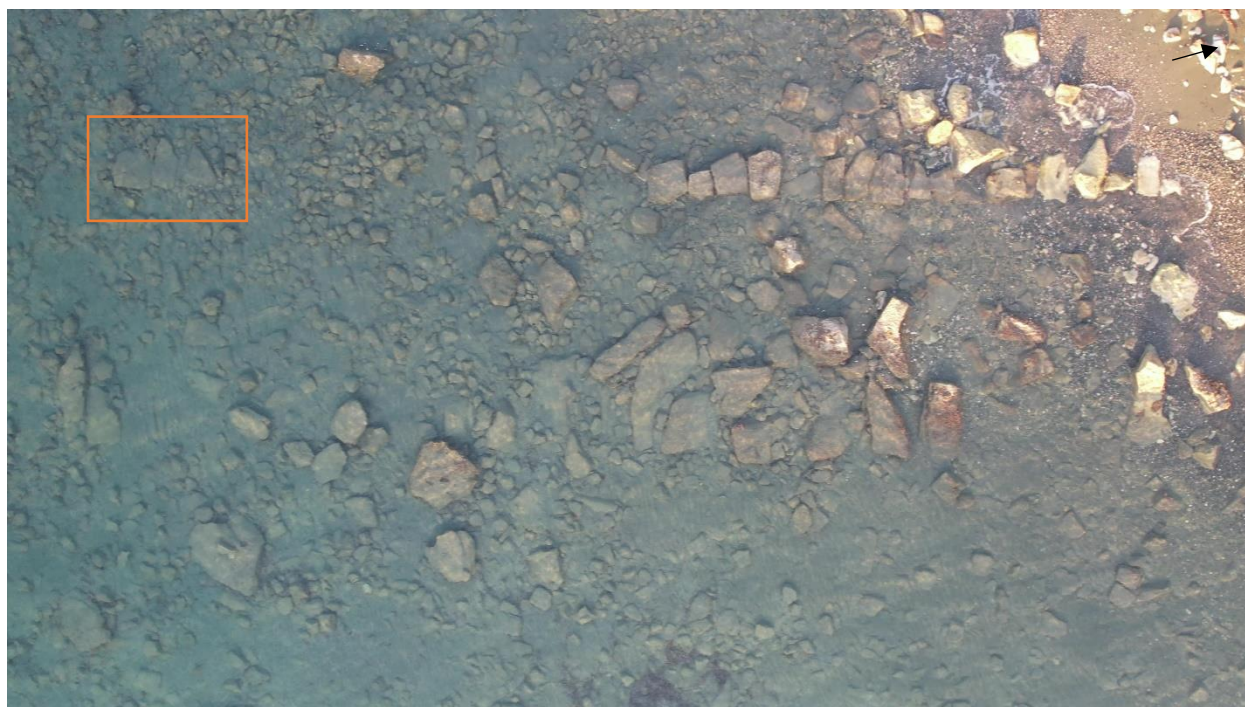
The structure has an N-SW direction (Fig.2). It is parallel to STR1 (to the west) and STR4 (to the east). The total visible length is 10.44m long (based on the architectural drawings) (Fig.8). Due to the frequent movement of sediment, its visible length can interchange between 10-12.5m. One course is visible with a maximum height of 26cm and the maximum width of the single row of blocks (mainly headers and some stretchers) is 1.10 m. Some blocks are concreted together while others are highly eroded. There are no traces of fastenings. No foundation is visible. To the west side of the structure, there is a concentration of blocks of similar size which however do not seem to be *in situ*. Also, approximately 9m south of the structure, there are three ashlar blocks of similar dimensions and with the same orientation and alignment of STR2. These blocks seem to be a continuation of STR2 although no aligned blocks are visible *in situ* along these 9m . Due to the limited time, these blocks were not documented.

Fig.8: Aerial view of STR2. In orange the probable continuation of STR2 to the south (@ Christou 2022).

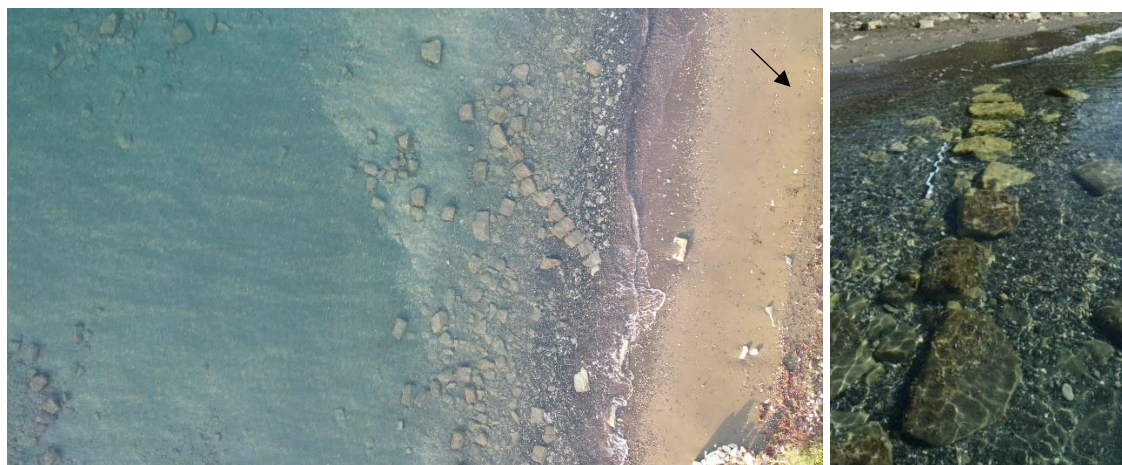
The structure has a NE-SW direction (**Fig.2**). Its orientation does not seem to be aligned with any of the other documented remains for the time being. Its total visible length is 5.24m long (**Fig.9**). It consists of one row of medium-sized blocks which are mainly worked on their western lateral side. Only one course is visible. The maximum visible height is 0.36m and the maximum width of the row of blocks is 0.62m. No foundation level is visible. There are no traces of fastenings.

Fig. 9: Left: Aerial view of STR3 (@Christou 2022). Right: View of STR3 from the south (@ Voutyrea 2022)

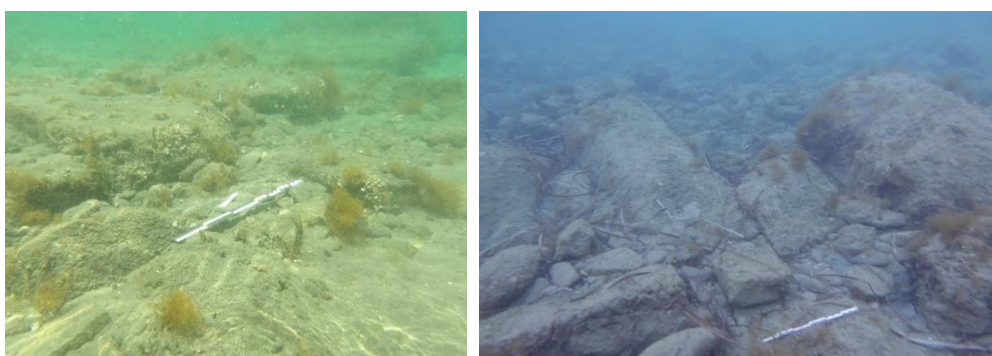
The structure has an N-SW direction (**Fig.2**). It is parallel to STR2. In total this structure is 42.50m long. Its maximum width is 2m and its maximum visible height is 39cm. One row of blocks with only one visible course is preserved. The northern extremity of this structure is not clear, because of a concentration of blocks and boulders⁴. The structure consists of a series of large blocks which vary in shape and size (**Fig.10**). Several ashlar blocks preserve lifting bosses, and others seem to preserve traces of lifting thongs (although for this to be confirmed the blocks must be cleaned). No foundation level is visible. There are no traces of fastenings. Most of the blocks are placed as headers while some are placed as stretchers and present a W-E inclination. Although this structure is visible in the plan published in 2017 (Empereur et al 2017: 16-Fig. 1), its function and role remain to be determined as well as its connection with the rest of the documented remains.

Fig.10: Blocks from STR4 (Gatt 2022).

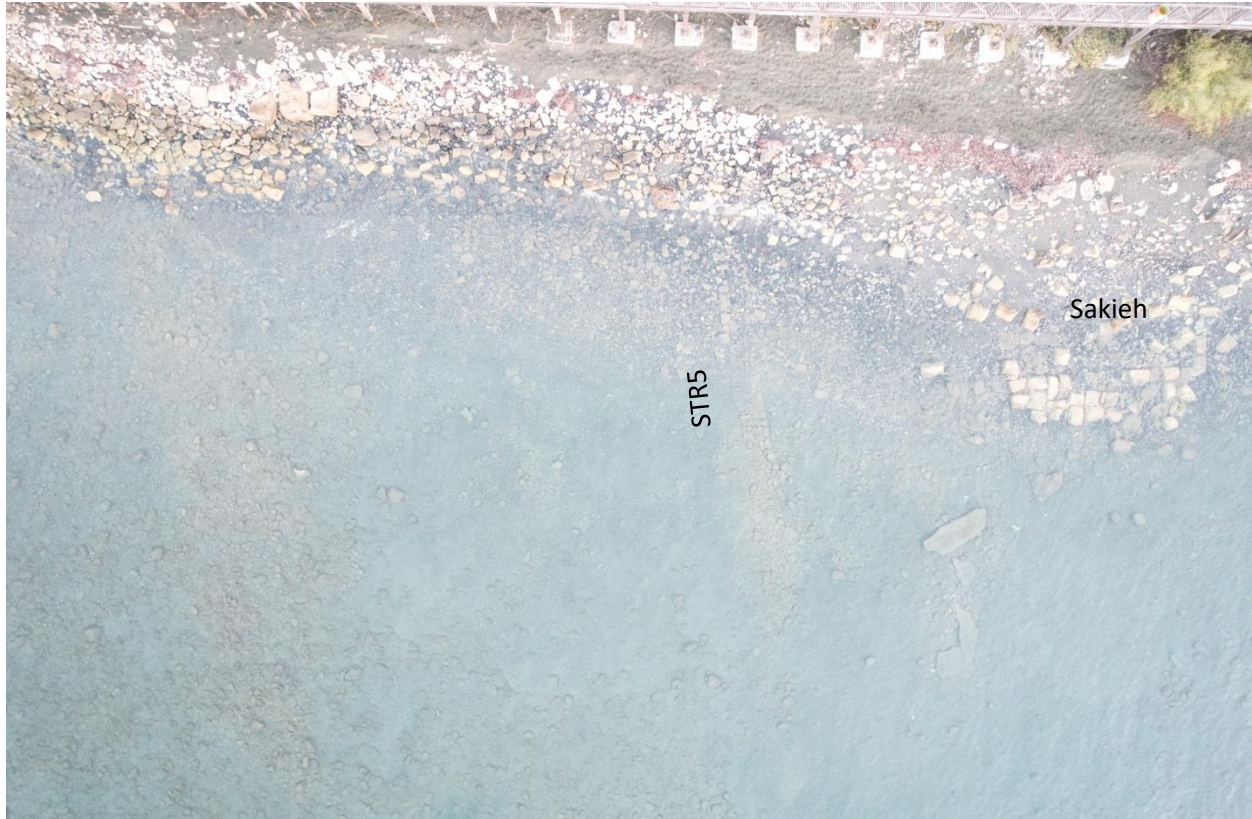
It has a NW-SE orientation, and it is 14.45 m long but only 3.62m were documented with architectural drawing (**Fig.2**). The structure consists of a double row of medium sized blocks and one visible course with a filling in between (construction with core and facings) (**Fig. 11**). Its width is approximately 1.10m. The blocks are mainly worked on the western lateral face, and several seem to be dislocated. The two rows are not preserved in continuity. No foundation level is visible.

Fig. 11: Location of STR5 near the sakieh (@Christou 2022).

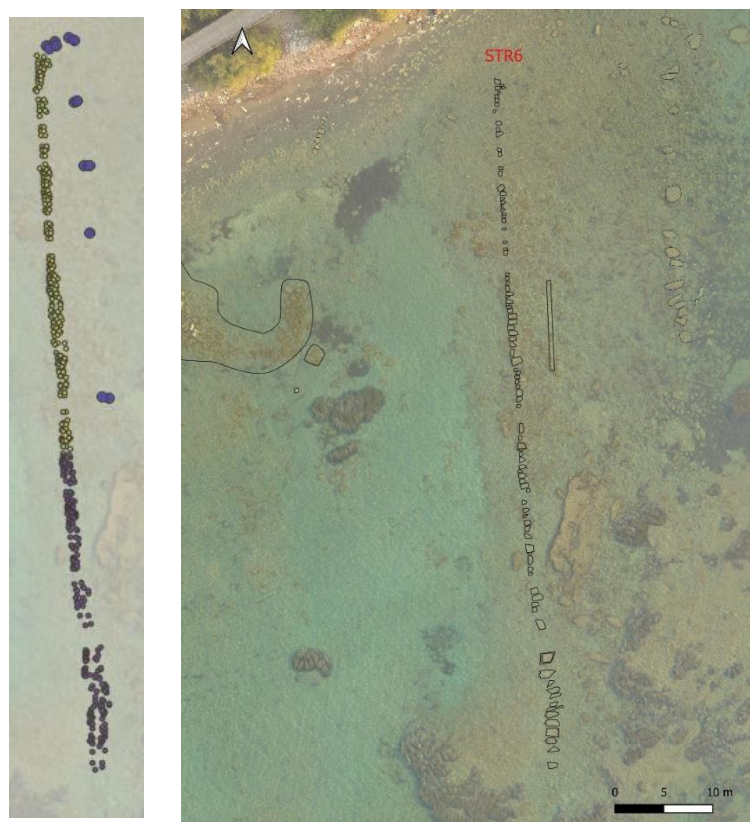
This structure has mainly an N-S direction, although along its extension there are very slight changes in the orientation (**Fig.2**). Its total visible length is 70.75m. This structure is parallel to STR7 (**Fig.12**) and connected to it on its northern extremity. It consists of a single row of blocks and has up to three visible courses of maximum height 0.30m (**Fig.14**). Stretchers and headers are visible along the structure with no visible pattern. The foundation is not visible. No traces of fastenings were observed.

- a) the first 11m from the north extremity consist of small to medium-sized ashlar blocks (maximum width 0.50-0.80m), mainly worked on the western lateral face.
- b) the first 56m from the south extremity consists of ashlar blocks with lifting bosses and are of larger dimensions, like those identified in the known harbour structures of the south area of the harbour basin. In this area, the maximum width of this single row of blocks is 1.50m.

Fig.12: Total station points for the documentation of STR6-STR7 and plan of STR6 (@J. Gatt 2022).

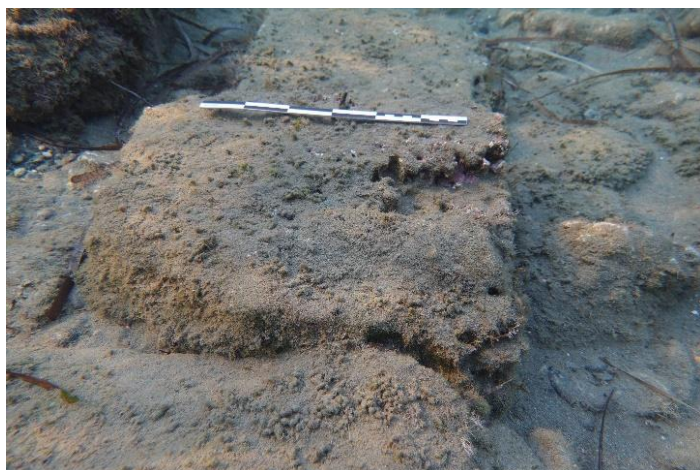
It is probable that reused material was used in the construction of the northern extremity of STR6, as the presence of a block with a potential trace of a cramp indicates (**Fig.13**). The southern extremity of STR6 is not clear as *Posidonia* meadows and sand cover the possible continuation of this structure. Finally, to the east of STR6, a concentration of cobble⁵ and gravel that seem to be the filling placed in between STR6 and STR7 was identified. Although this structure is visible in the plan published in 2017 (Empereur et al 2017: 16-Fig. 1), its function and role remain to be determined as well as its connection with the rest of the documented remains.

Fig.13: Traces of a cramp on the west side of a block of STR6P (© J.Gatt 2022).

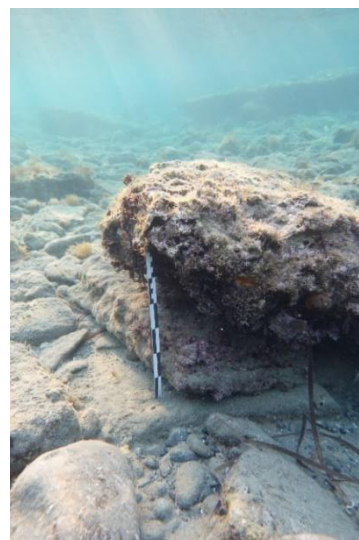
Fig.14: Three visible courses of blocks at STR6 (©J.Gatt 2022).

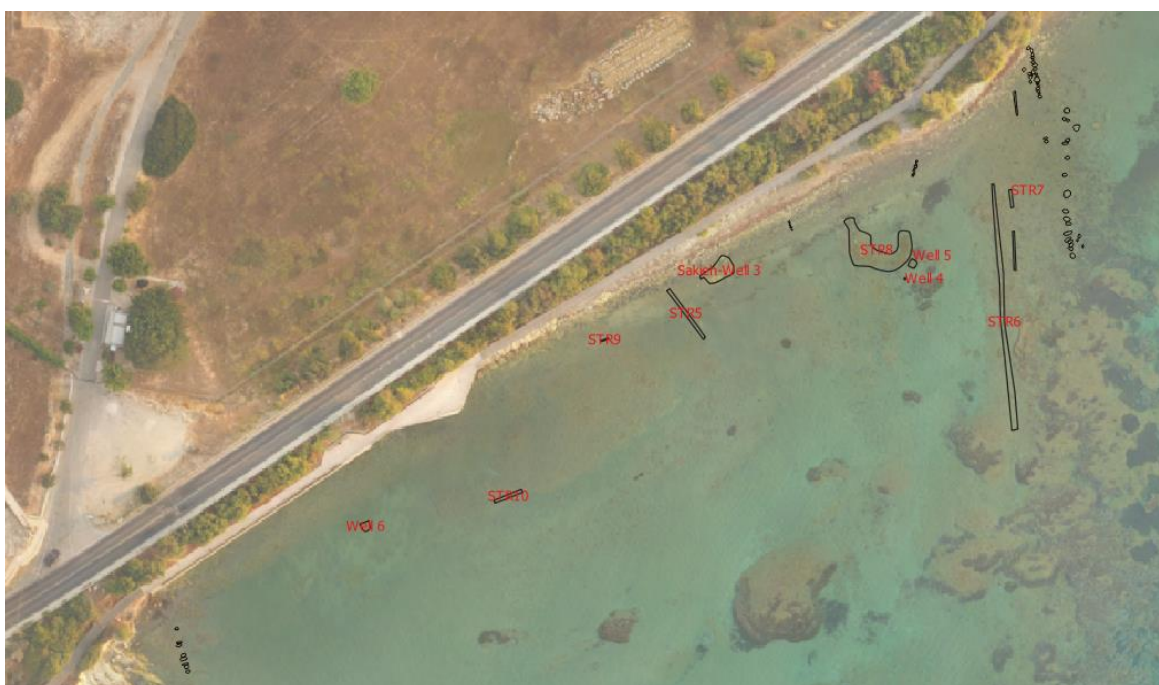
Three new wells were located during the 2022 survey (Well 4-6). The numbering was given based on the three previously documented wells (Well 1-3) found in the harbour basin of Amathus in the 80's. Two are located to the east of STR8 and one to the east of the north extremity of West mole (**Fig.18**). The smallest one named conventionally Well 4 is 1m x 0.77cm, Well 5 is 1.60m x 1.69m, and Well 6 is 1.12m x 1.22m. They are all built with medium sized blocks worked on their exterior face. It is not clear if the preserved height is the actual height of these structures.

Fig.18: Up: Location of wells in relation to other documented structures (J.Gatt 2022, after Orthophoto of Amathus generated after refraction correction using Agrafiotis et al., 2020 method. Image courtesy:2019, Cyprus University of Technology, PVL; University of Cyprus, ARU © ANDIKAT project). Middle: Well 4 to the left and Well 5 to the right (@Gatt 2022) Down: Well 6 (@Papadakis 2022).

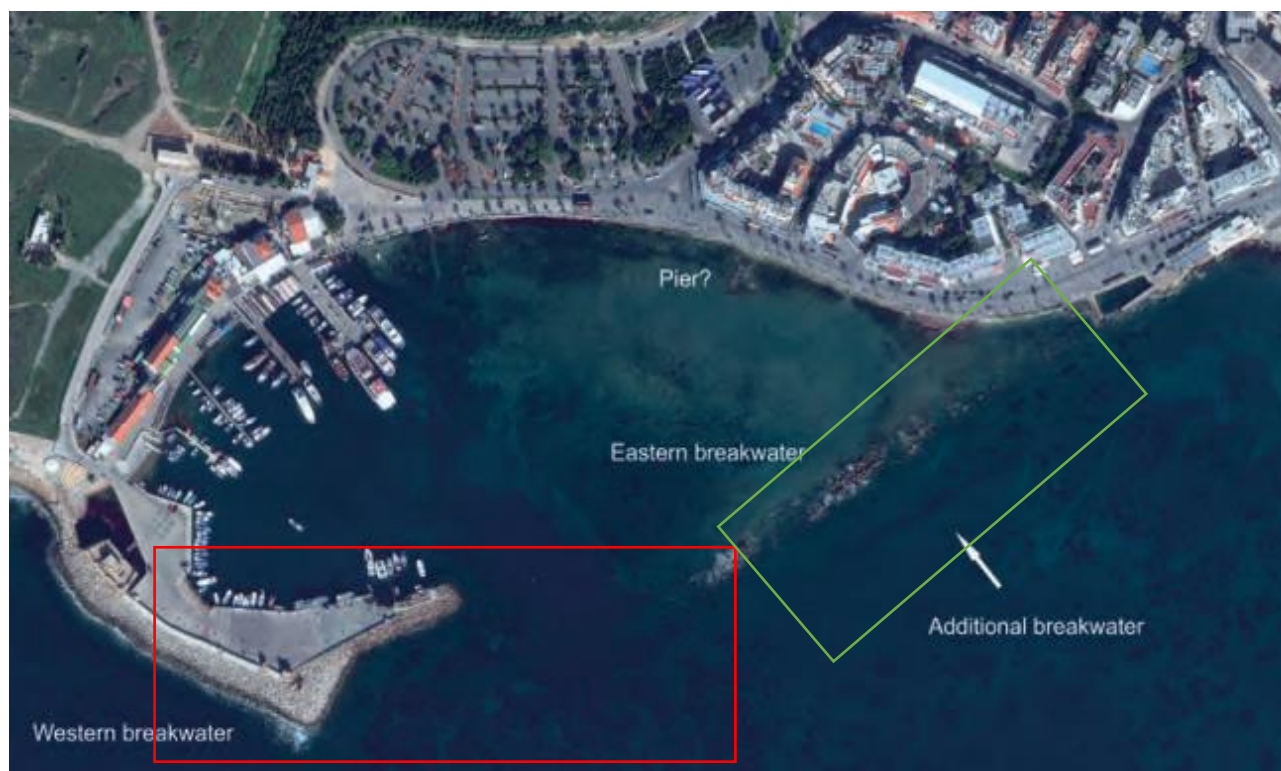
Fig 19: Area in red is a non-bathing area. It was snorkeled with the permission of the Ports Authorities. In this area the spur, west breakwater and western extremity of east breakwater were surveyed. The green area, is the bathing area, were the east breakwater and parallel breakwater were surveyed (after Misk & Wladyka 2016: 10, fig.3).

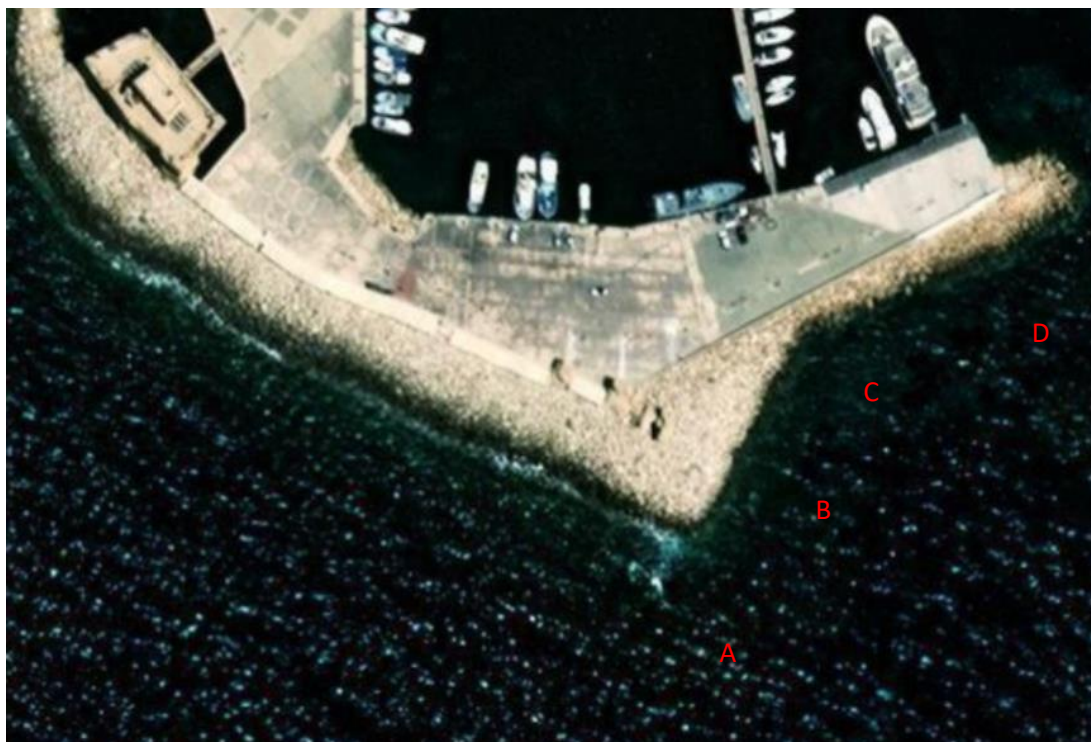
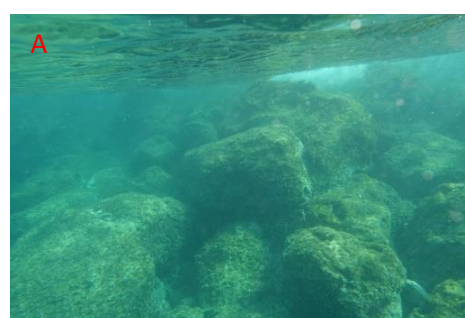
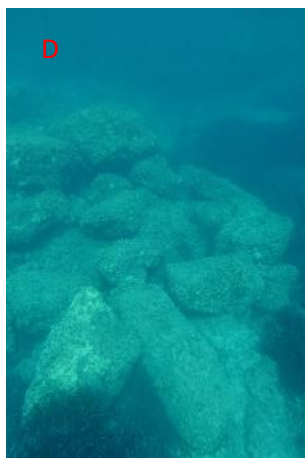
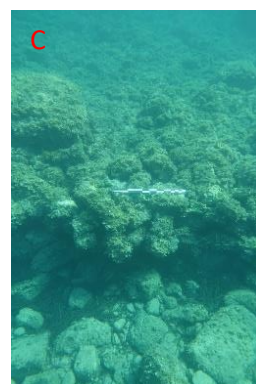
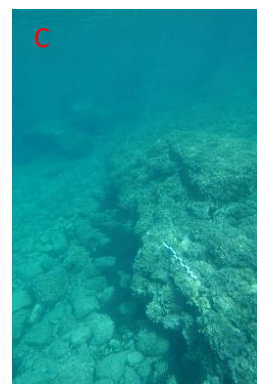
At the curve of the west breakwater, a concentration of blocks 70-50 meters long was identified. The spur consists of blocks of 1.80-2.70X1.60-2.70X0.85-1.15m and 0.32-0.45X0.20-0.22X0.16-0.21m. It is now 3m below current sea level (Daszewski 1981: 3-4; Leonard & Hohlfelder 1993: 376-378). During the survey, it was difficult to discern which were the blocks that belonged to the spur and which belonged to the recent reinforcement of the west mole, given the diversity of the seabed morphology (**Fig.20**). Starting from the corner of today's west mole large boulders are concentrated. Further to the east the seabed is covered by cobble and sand. Then a compact concentration of cobble is visible, followed by boulders that probably belong to the modern west mole.

Fig.20: Location of different type of materials along the seaward side of the west mole (@J.Gatt 2022). You need to explain here what each letter/picture shows

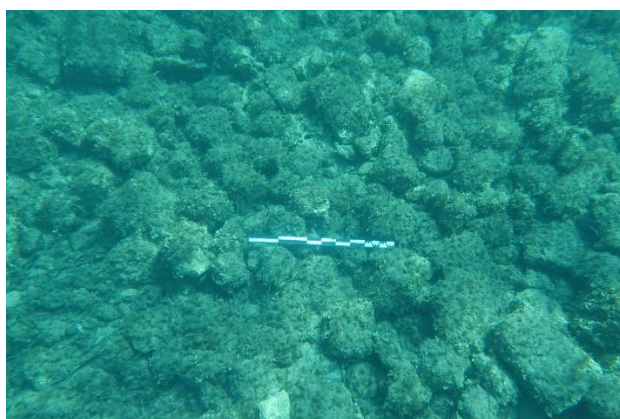
The west extremity of the east breakwater, right on the entrance channel of the modern harbour, has been severely damaged by the dredging of the harbour basin. Although this area was documented by Hohlfelder (1995), surveying revealed interesting aspects regarding the construction of this structure. The structure's upper part has been destroyed, thus, what remains is the foundation of the breakwater almost to the level of the current seabed. Cobble is the main material found in this area with only some ashlar blocks and other architectural members (such as columns) located in the north and south extremities of the breakwater (Fig.21;22). Moving though further towards the east, the boulders reappear above the layer of cobble (Fig. 23). Some boulders have particular shapes (Fig.25) that differentiate from the rest, probably indicating material added in a later phase. Also, a rocky formation (Fig.24) located to the south of the east breakwater was identified. Its connection with the structure remains unclear.

Fig.21: The cobble of the west extremity of the east breakwater (@J. Gatt 2022).

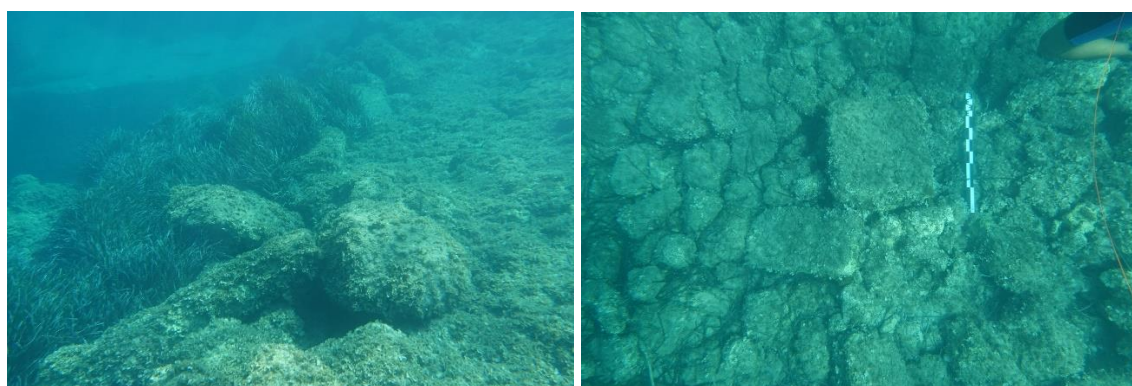
Fig.22: Architectural remains along the north and south extremity of the east breakwater (@J.Gatt 2022).

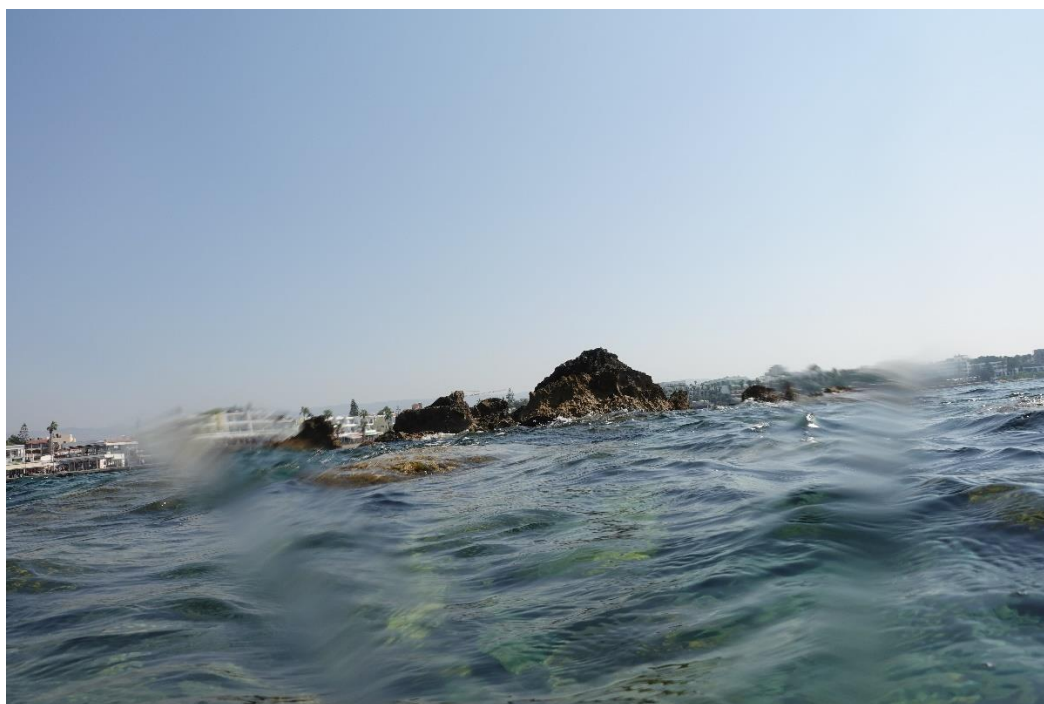
Fig.23: Area of the East breakwater where the boulders appear above the layer of cobble (@J.Gatt 2022).

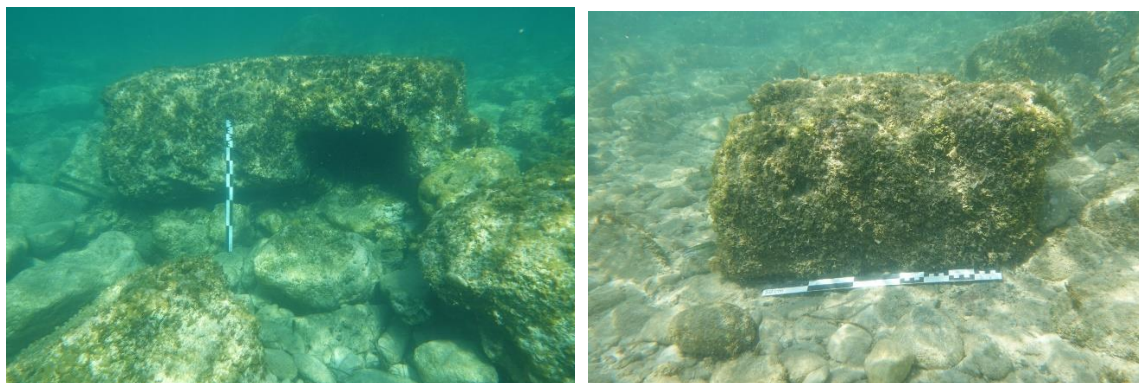
Fig.25: Blocks and boulders along the east breakwater (@J.Gatt 2022).

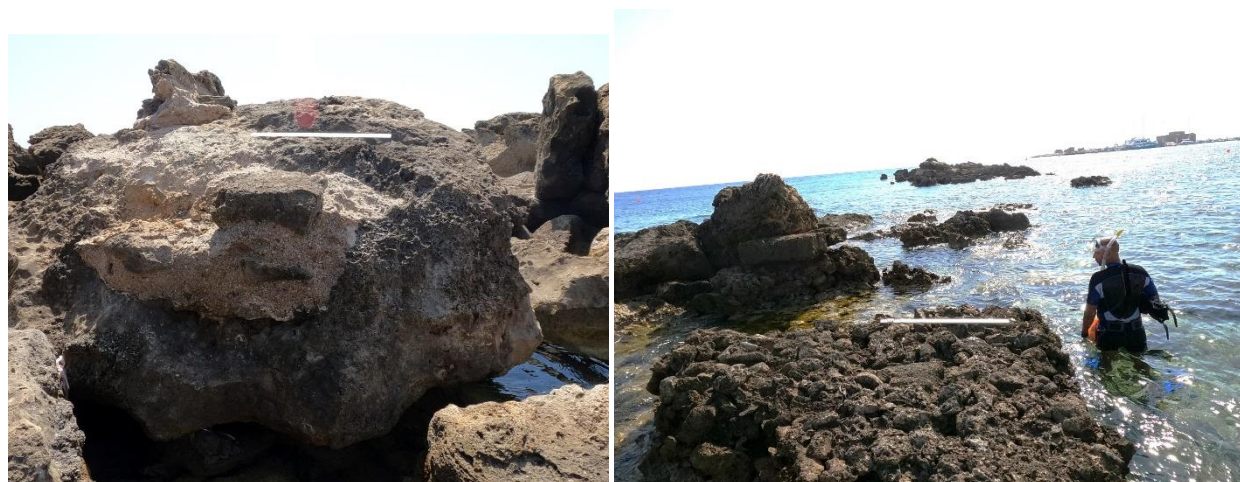
The eastern extremity of the east breakwater could be surveyed via snorkeling or walking above the remains. In this area four distinct parts of the structure can be seen. The cobble at the bottom of the structure as seen in the western extremity of the structure (**Fig.21**), the large boulders above the cobble (**Fig.23**) that surpass the current sea-level, ashlar blocks (**Fig. 27**) and remains of cemented rubble⁷ (**Fig.26**). Upon what type of foundation, the cemented rubble is built on remains unknown. (**Fig.27**).

Fig.26: Traces of cemented rubble on the upper structure of the east breakwater (@J. Gatt).

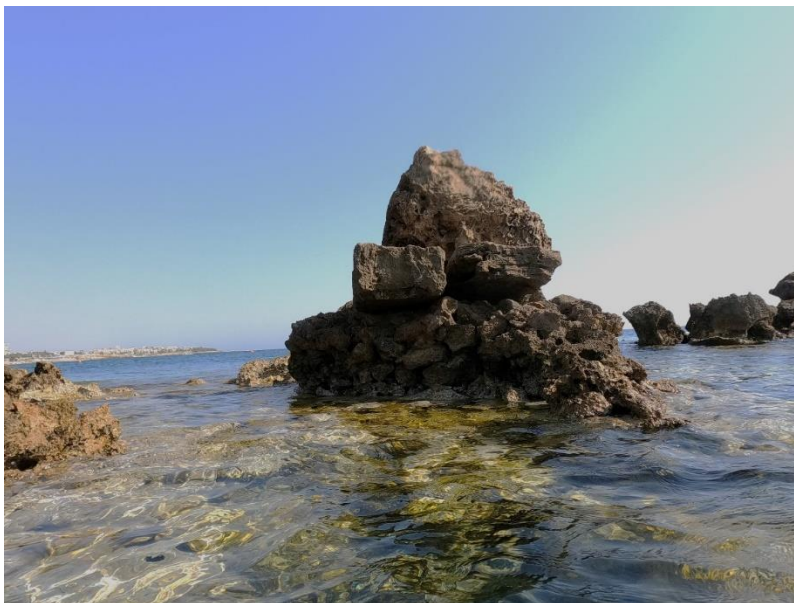
Fig.27: The layer of cemented rubble upon which ashlar blocks are placed (@J. Gatt).

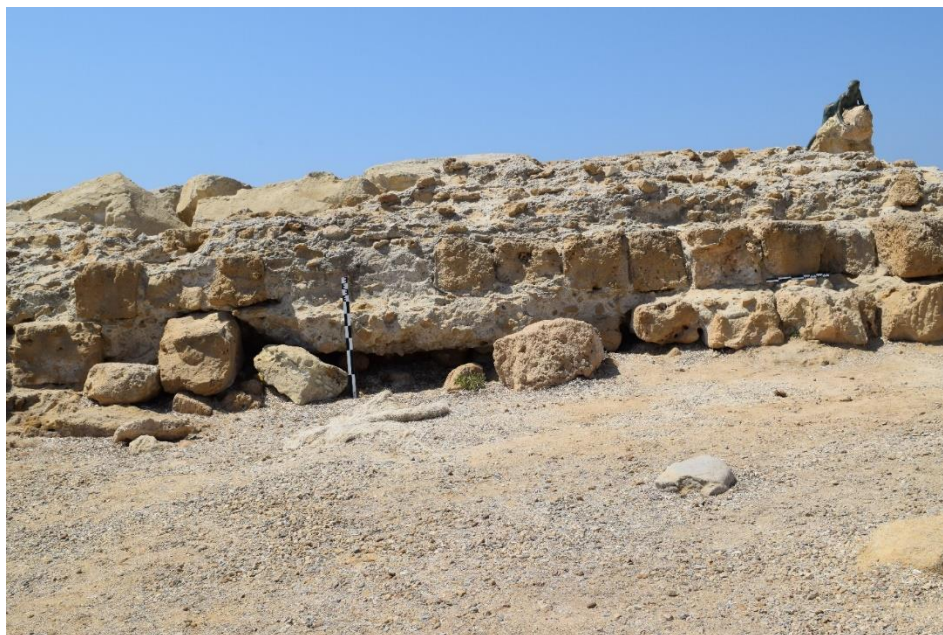
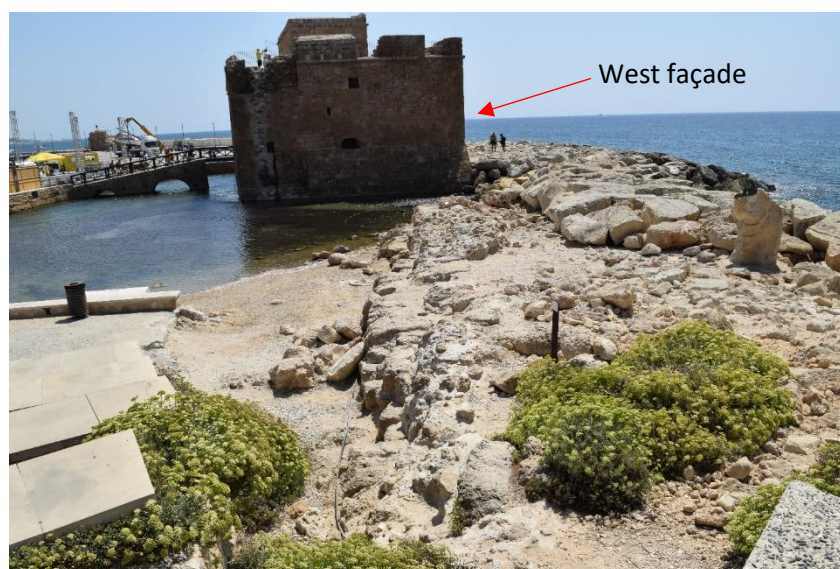
To the north of the Castle there are remains of the possible west mole, built of ashlar blocks and mortar (**Fig.29**). It is preserved ca. 15 m in length and its height is approximately 2m. Its width is not clear as it is partially covered by cemented rubble and the boulders of the modern west breakwater. The cemented rubble was used to join the ashlar blocks and it seems also to have been used in the upper and lower part of the structure. Interestingly this mole seems to continue

Fig.29: View of the west mole from the east (above) and from the north (below) (@J.Gatt 2022).

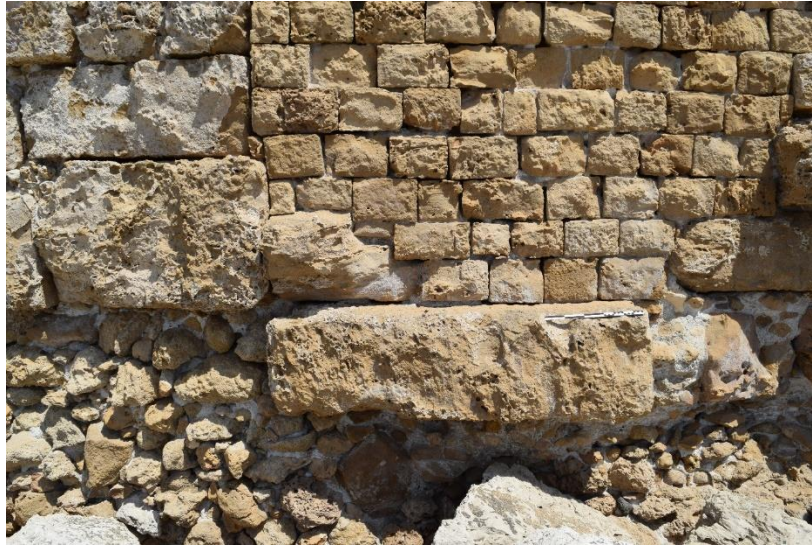
towards the direction of the castle. At the lowest courses of the west façade of the castle there are remains of ashlar blocks as well as cemented rubble like that of the west mole (Fig.30).

Fig.30: Possible remains connected to the west mole at the lowest courses of the west façade of the castle (@J.Gatt 2022).
