STRUCTURAL AND CONSERVATION SOLUTIONS FOR THE TREATMENT OF THE SEA FRONT WALLS OF OLD AKKO (ACRE), ISRAEL

Eng. Yaacov Schaffer¹, Jacob Sharvit² and Dror Planer²

Abstract. *Between the years 2009-2013, the southern sea wall of the Old city of Akko underwent planned rehabilitation and conservation works funded by the Old Akko Development Company. The southern section of the wall, measuring some 300 m long with an average height of 8 m, was severely damaged by years of marine erosion and flaws in the ancient structural foundation techniques that were comprised of materials unsuited to a marine environment. Moreover, stabilization and rehabilitation attempts carried out in the 1930's of the 20th century also caused irreparable damage to the wall's foundations. The ancient city and its walls are subject to statutory limitations and considerations, as it has been declared an antiquity site by the Israel Antiquities Authority and a world heritage site by UNESCO, and is also a modern bustling town. In addition to these limitations, there are implementation restrictions for construction inside an ancient port, lacking the option to carry out works in an underwater environment. These limit

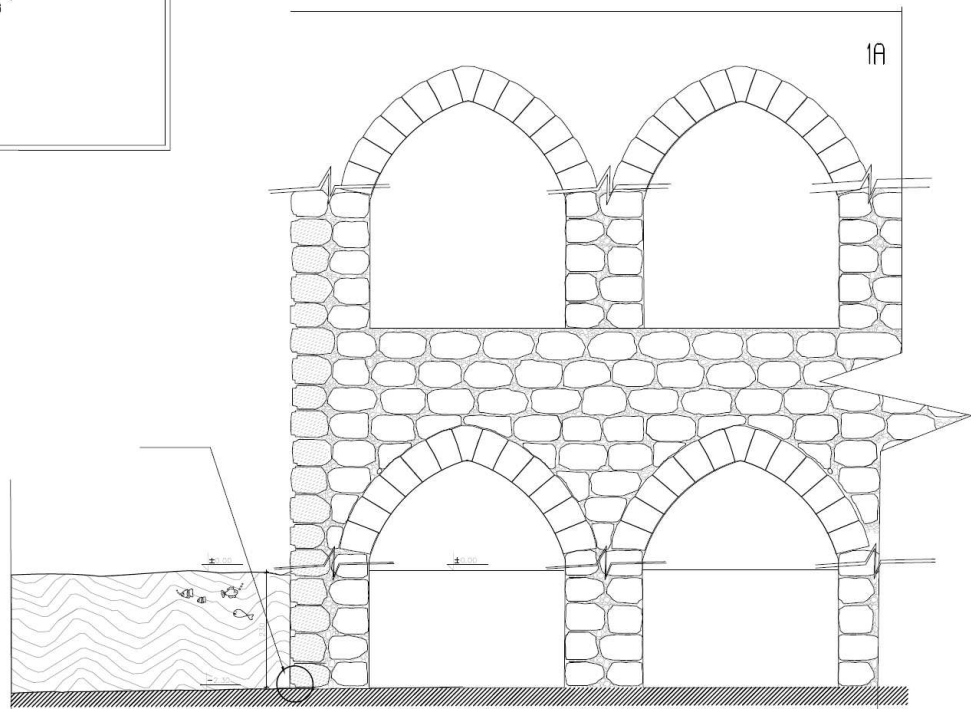
Fig.9 sect. A'

Excavation revealed that its foundations are also built on the bedrock at a depth of 2.5 m below sea level, with terrestrial-type chiseled kurkar stone blocks(Fig 9).

The Ottoman period pyramid-form foundation built upon the bedrock lying at 2.5 m below sea level. The foundation was constructed of a mixture of field stones bonded together with a kind of cement made of lime and animal bones. Two layers of granite, marble and kurkar Roman columns of secondary use were placed horizontally over the foundation and on them the first stone layer of the seawall was constructed(Fig. 9).

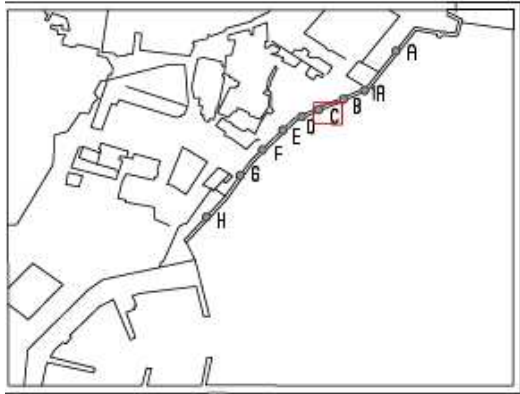
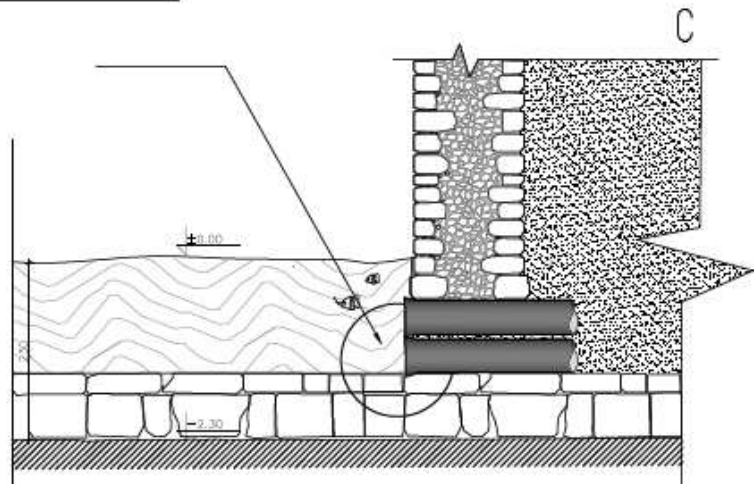
Fig.11 sect. C

In the gap between the rectangular structure (area E) and the Hellenistic docking platform (area C), a 30 m long rockslide of chiseled building blocks (0.6x0.6x1.2 m) was uncovered, with some intact building blocks. Under the rockslide there was a sealed layer of port sludge lying on the bedrock containing Hellenistic finds. It seems that the blocks belonged to a large collapsed building (Fig 11)..

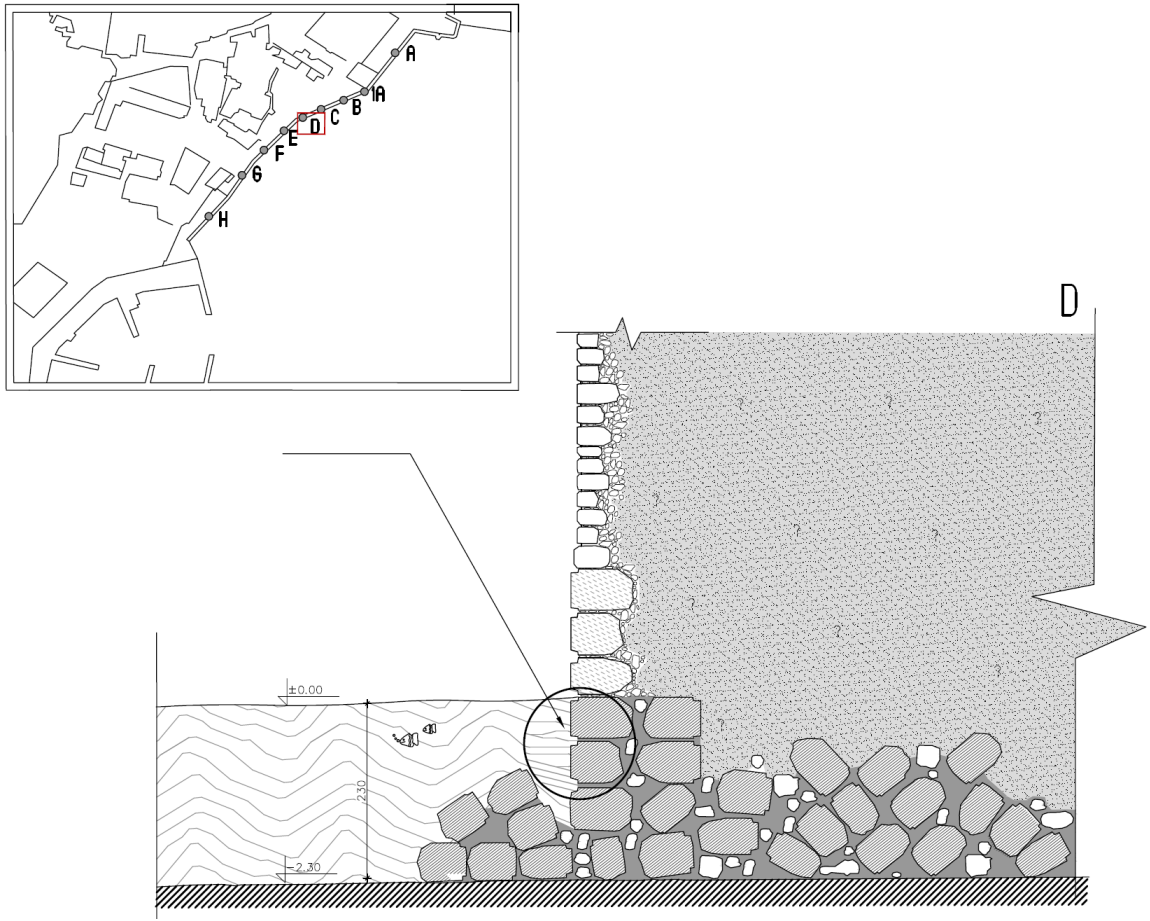
Fig.12 sect. D

A rectangular structure was discovered (oriented east-west); its entire east section was fully exposed under the wall, as well as sections of the northern and southern walls of the structure that continues underneath the wall. The structure was built directly on the bedrock and includes the remains of a building with 5 layers of cut kurkar rock blocks, about 8 m long and some 1.6 m high (Sharvit, *et.al* 2013: 6) (Fig. 12).

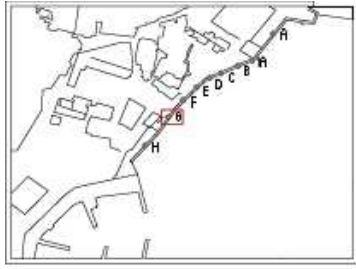
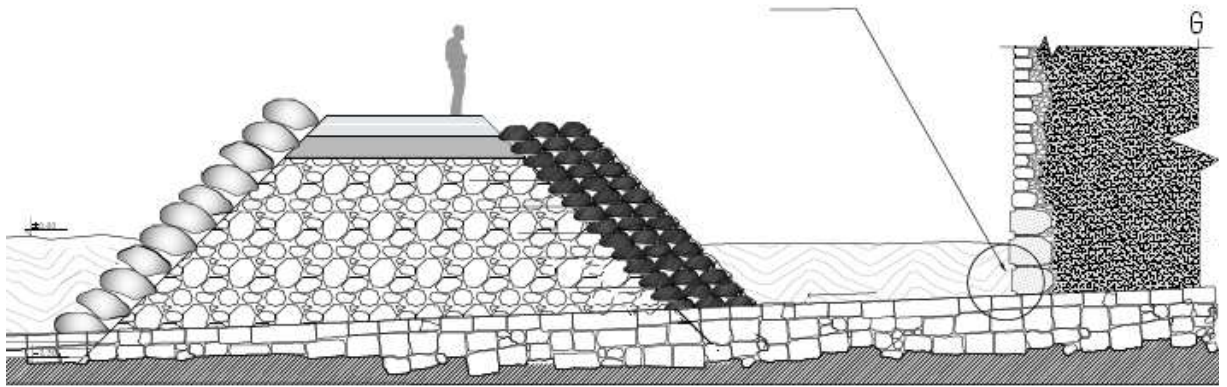
Fig.15 sect. G

The Ottoman seawall exterior stone leaf lies on debris but the inner core layers on an ancient layer may be crusader seawall (Fig. 15)..
